Nisqually River 2009

Source to Sink

Nisqually Field Trip Overview

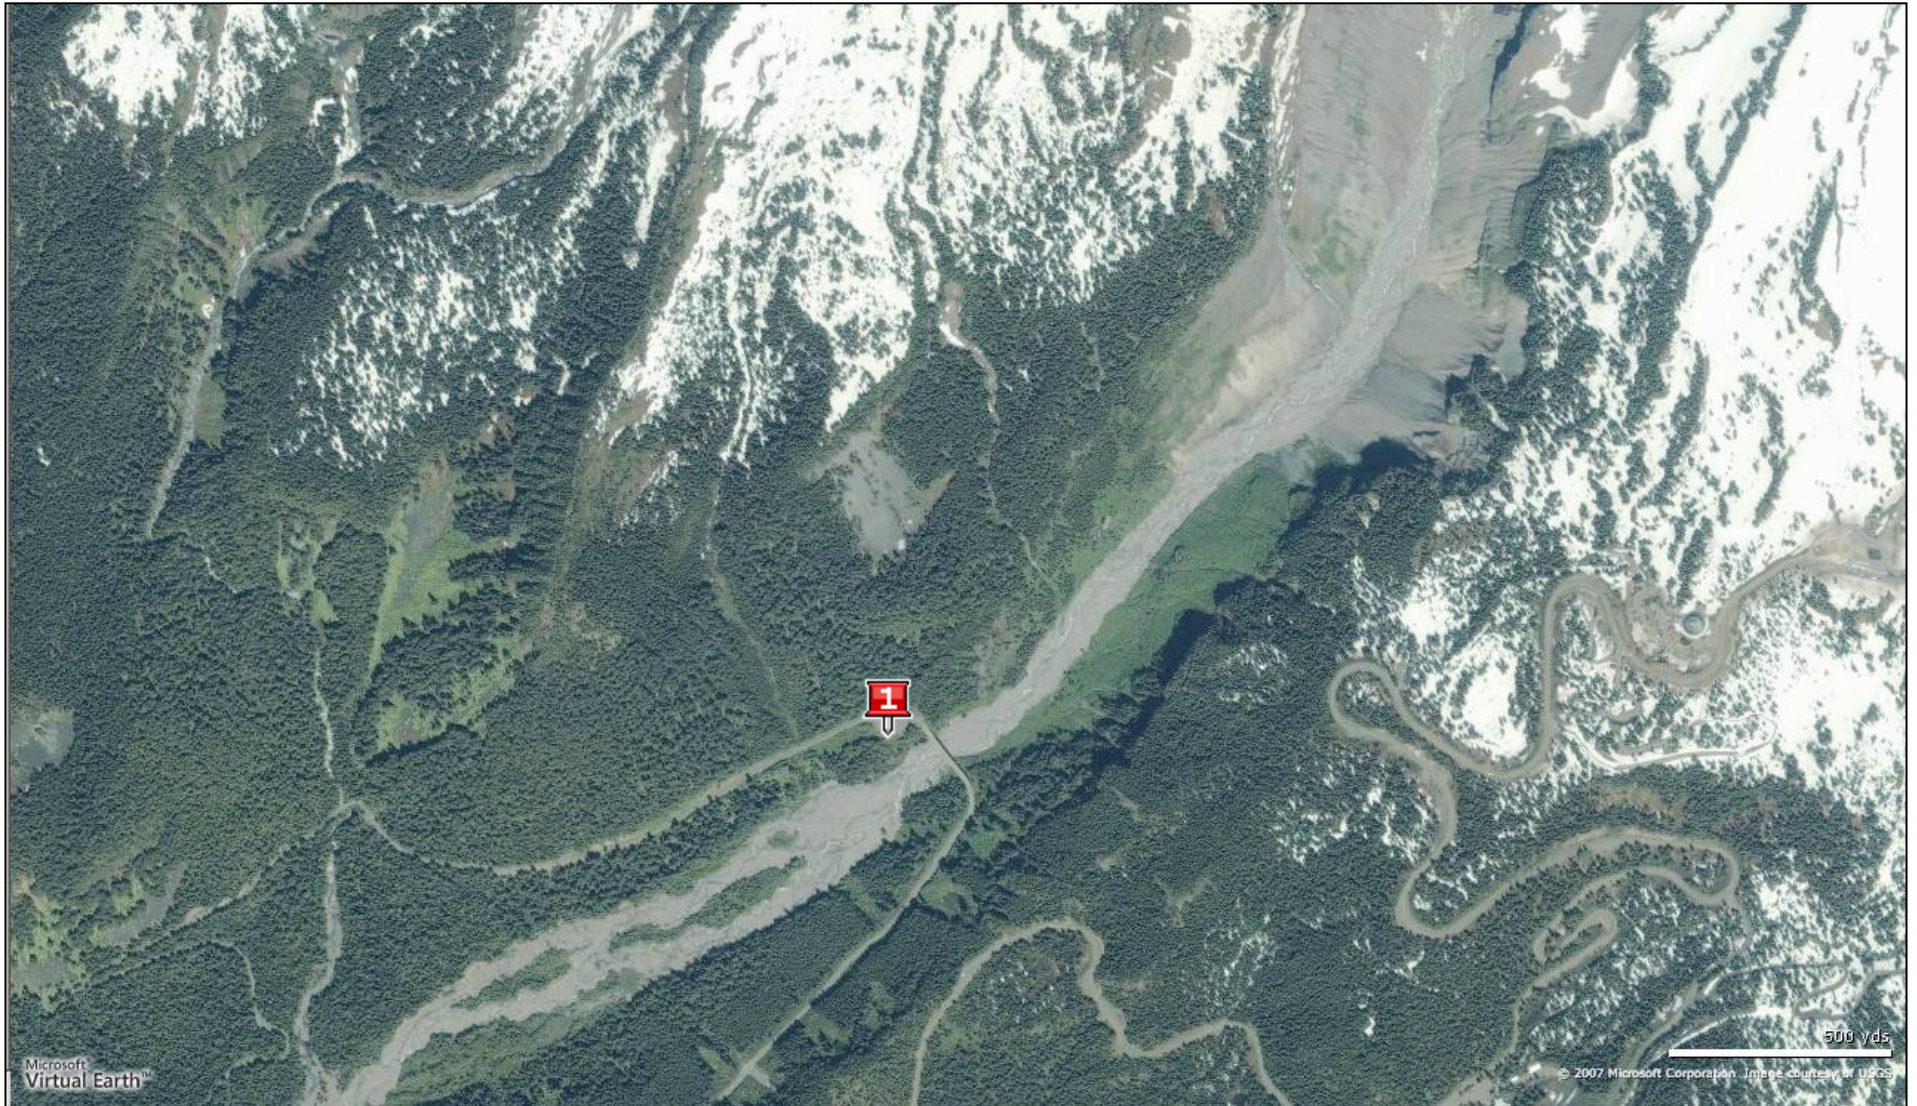
Paradise Rd. Bridge

This is where we will park on a parking lot, and walk over a car bridge with a scary low handrail. It offers a good view up to the barren rocky glacier-clad slopes, and down to the lush forested alluvial valley.

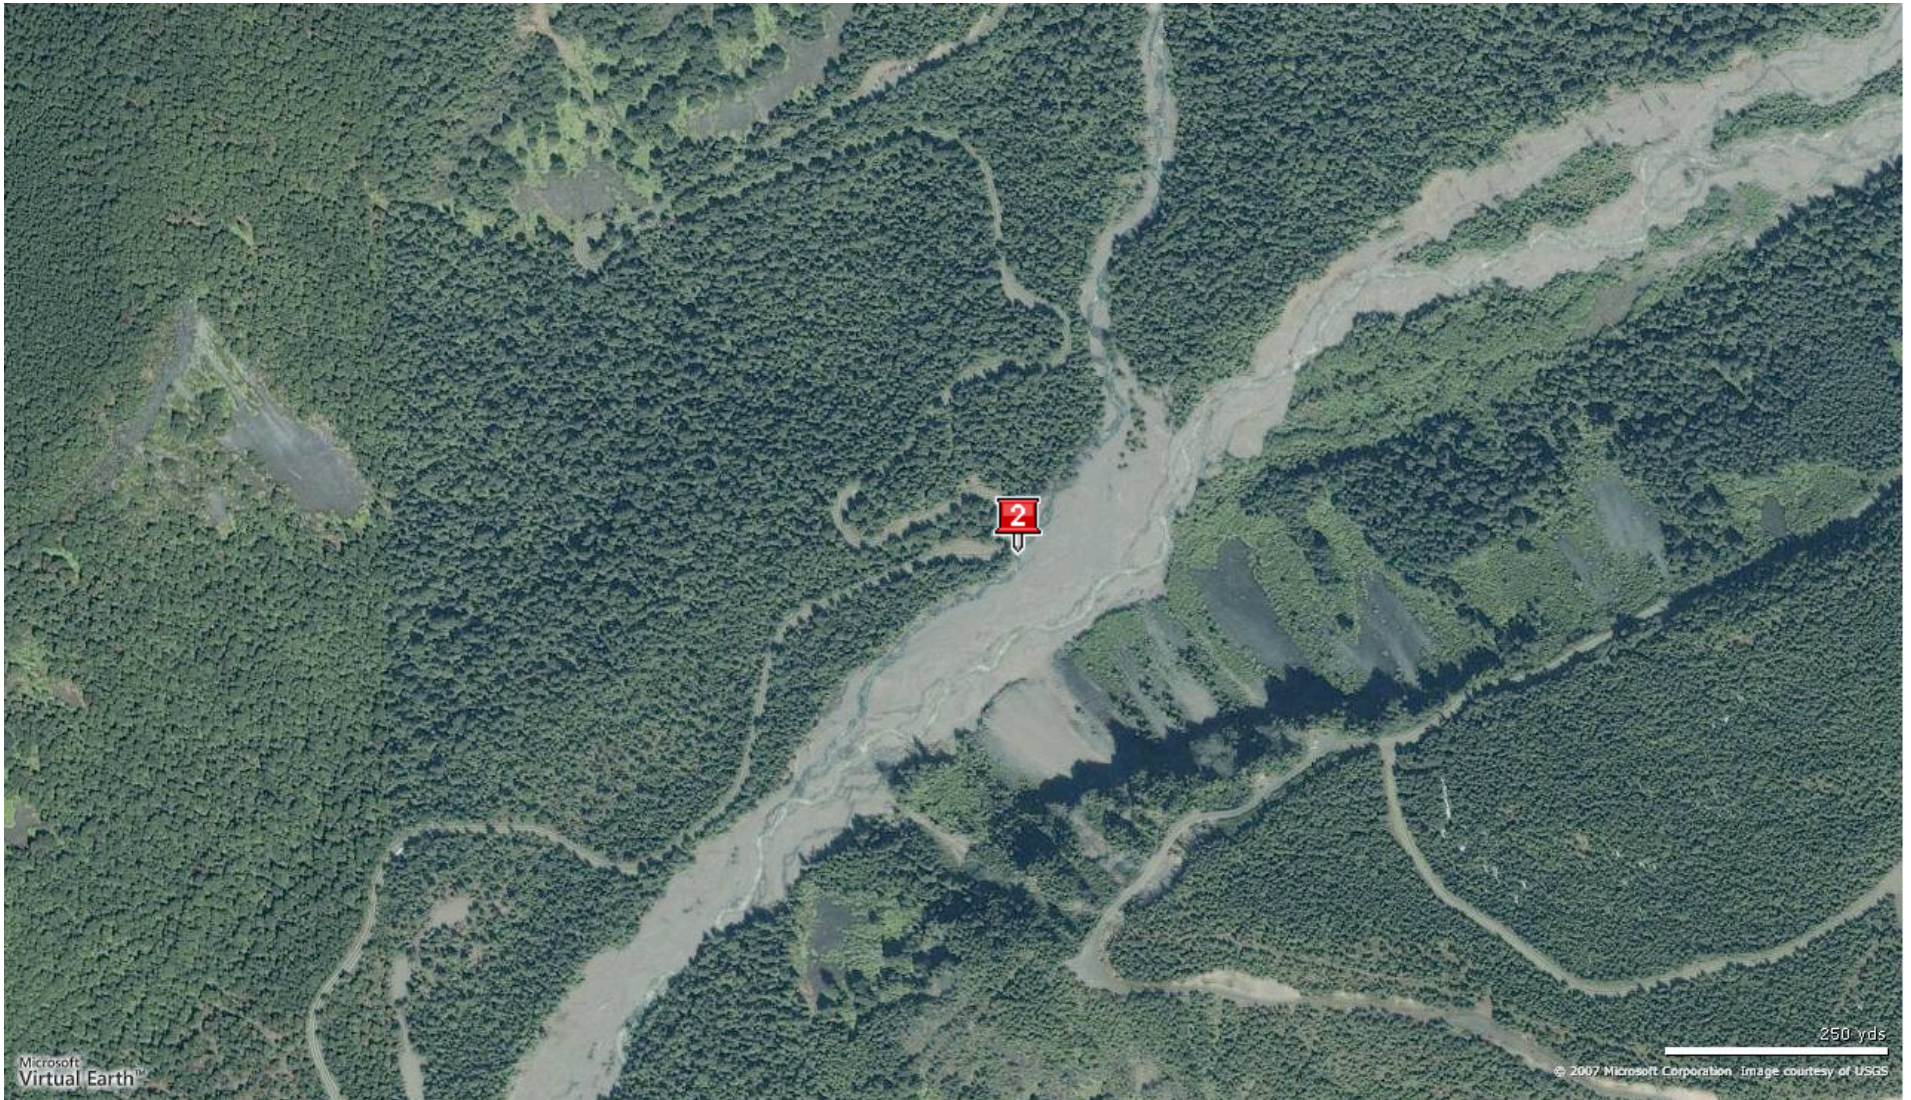
Nisqually@ Abraded Tree

This is a site where wood and river begin to interact. There is demonstration of sediment concentration in the flow, and the erosive power of suspended sediment. Nice boulder and cobble bed and aggraded gravel bars.

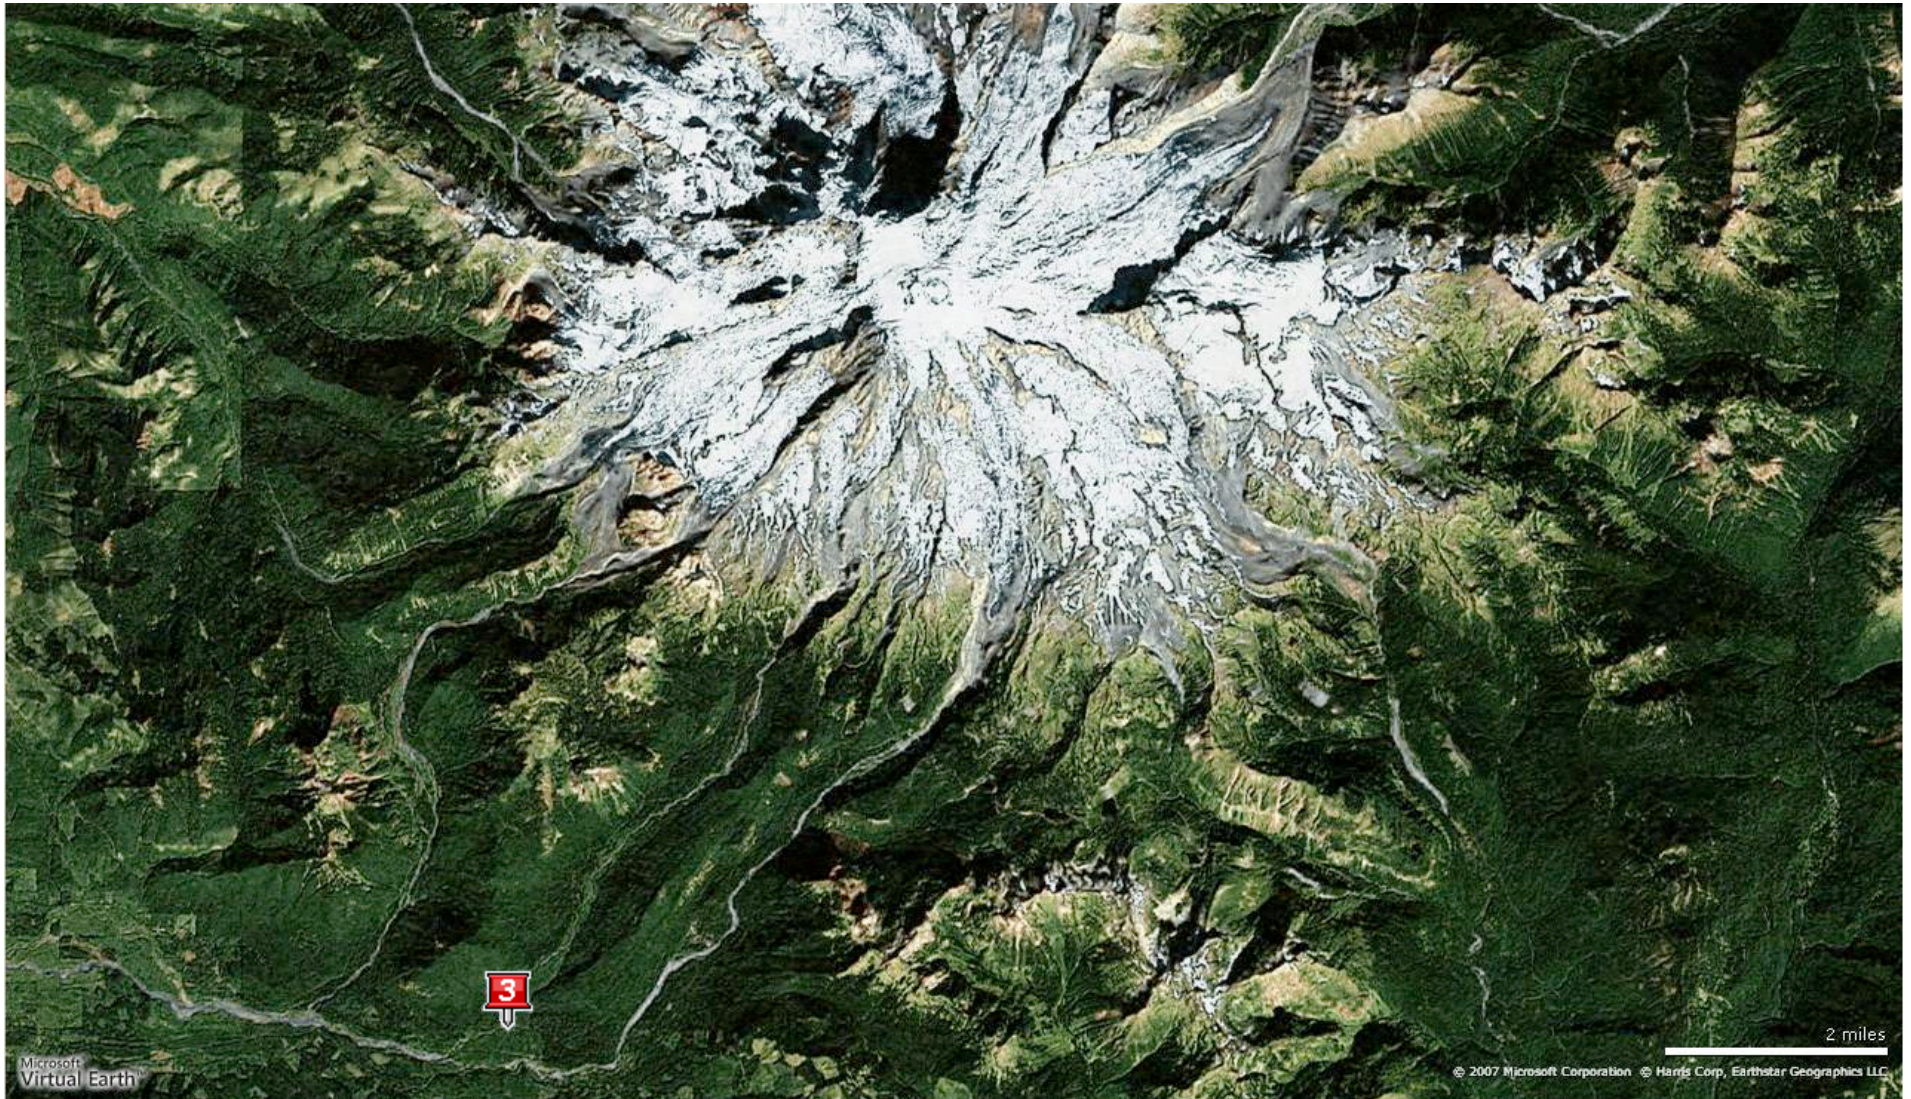
Kautz Creek

The largest debris flow in park history occurred here on 2-3 Oct., 1947. Heavy rain apparently triggered an outburst flood from Kautz Glacier. The flood eroded a gorge through the ice, then transformed into a debris flow continuing downvalley. The road was buried by 9 m of mud and debris. About 40 million cubic meters of sediment were moved, including boulders up to 4 m in diameter.

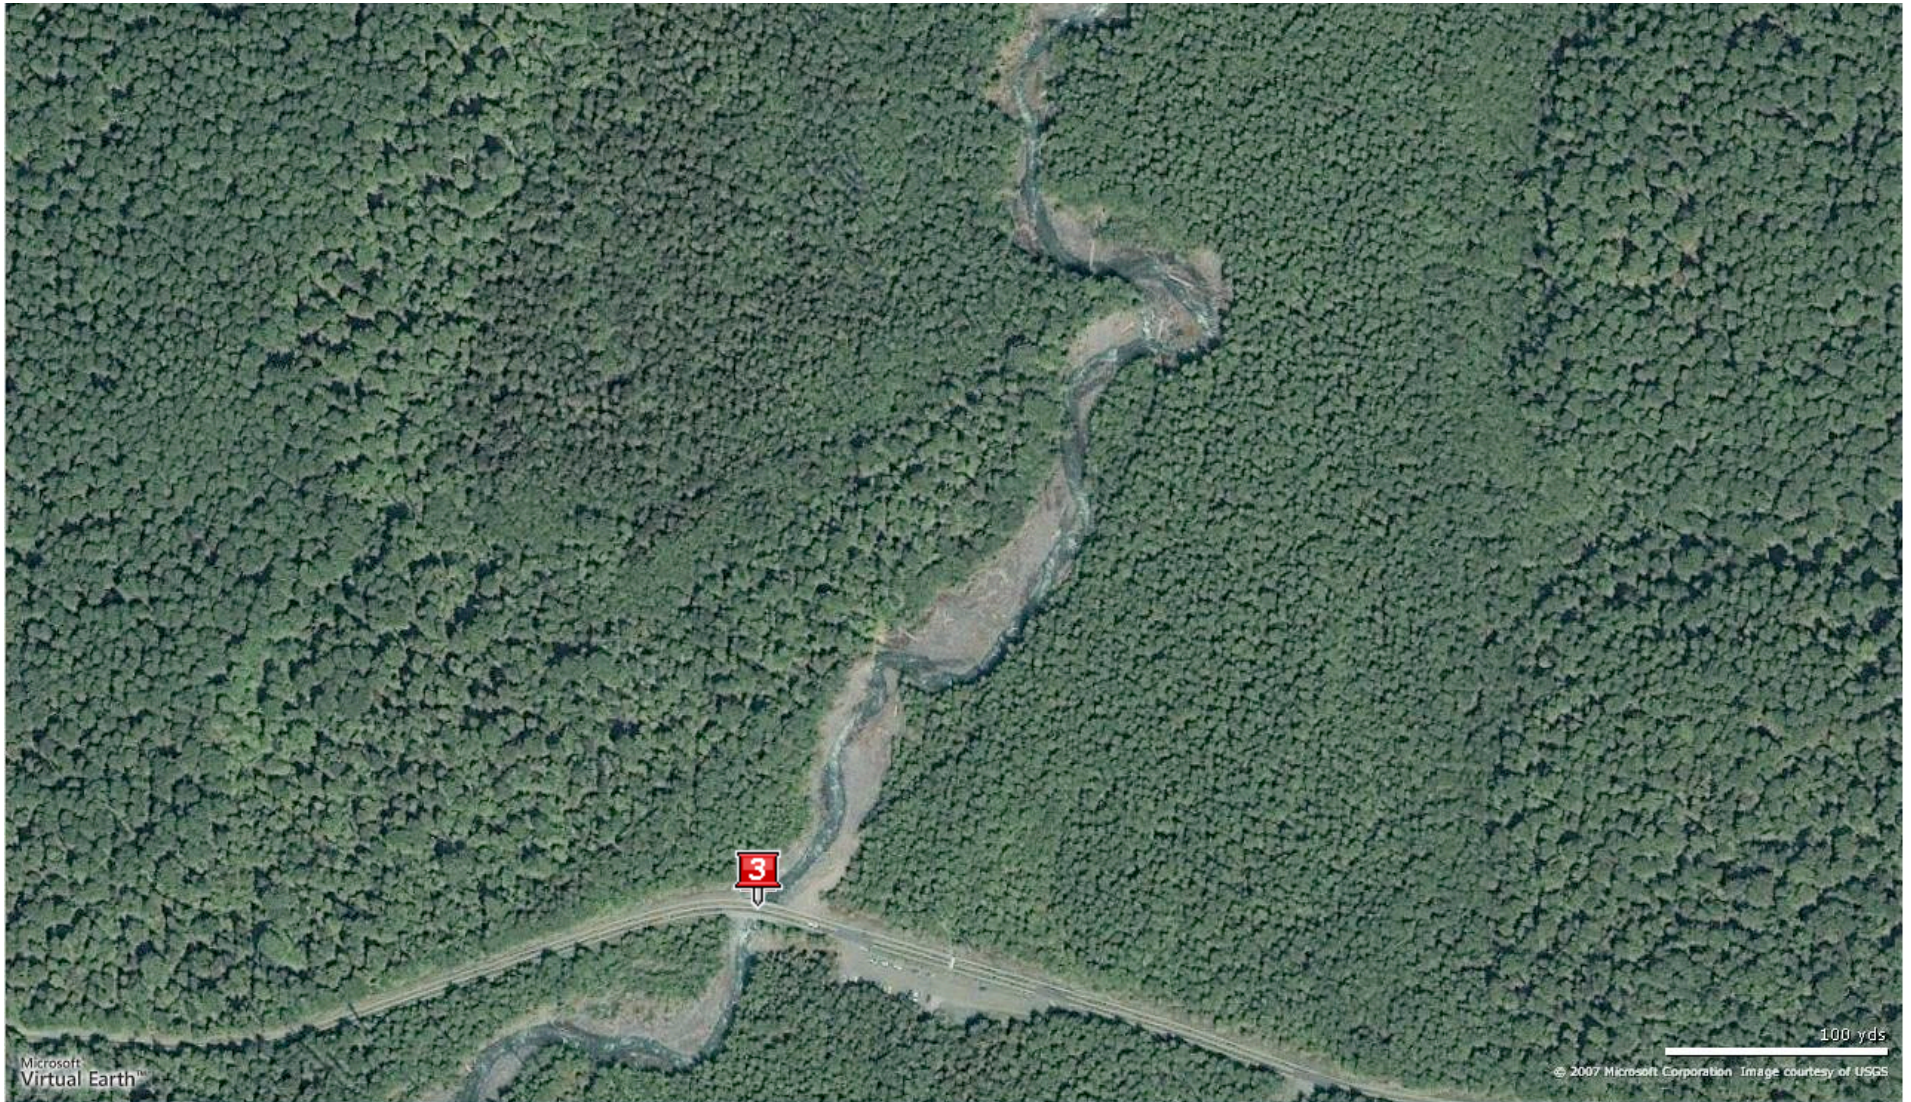
Kautz Creek Bridge

Kautz Creek has cut down through those deposits, but the road approach now goes uphill to the creek. Deposits of the 1947 event can be observed, along with upright dead trees partly buried by those deposits, and scoured out again by later flows. Smaller debris flows have moved along Kautz Creek in 1961, 1985, 1986, and perhaps at other times. ([modified from USGS](#))

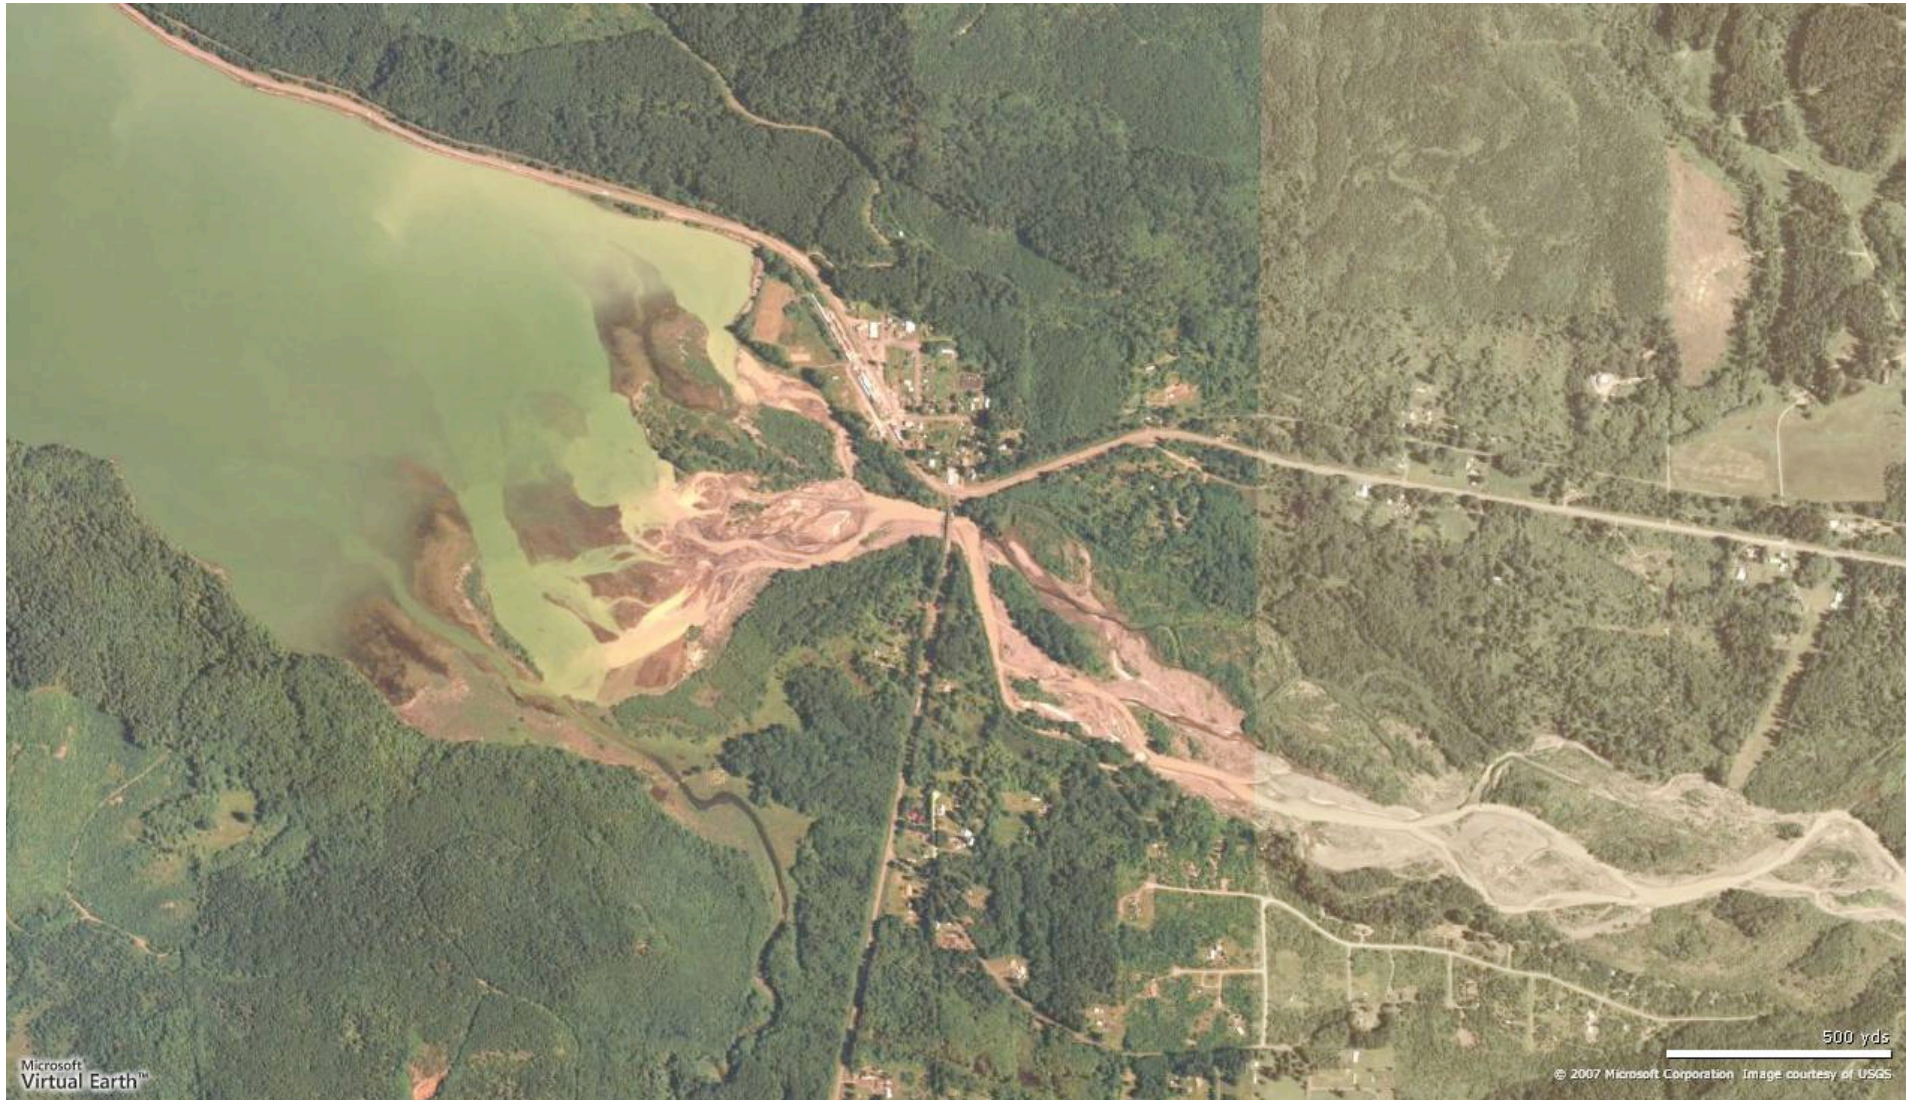
Nisqually river @ Alder lake (Elbe)

The river rapidly deposits sediment at the delta because all but the finest sediment settles into the lake. Note how the channel widens and forms distributaries. These channels rework the sediment as the delta front advances.

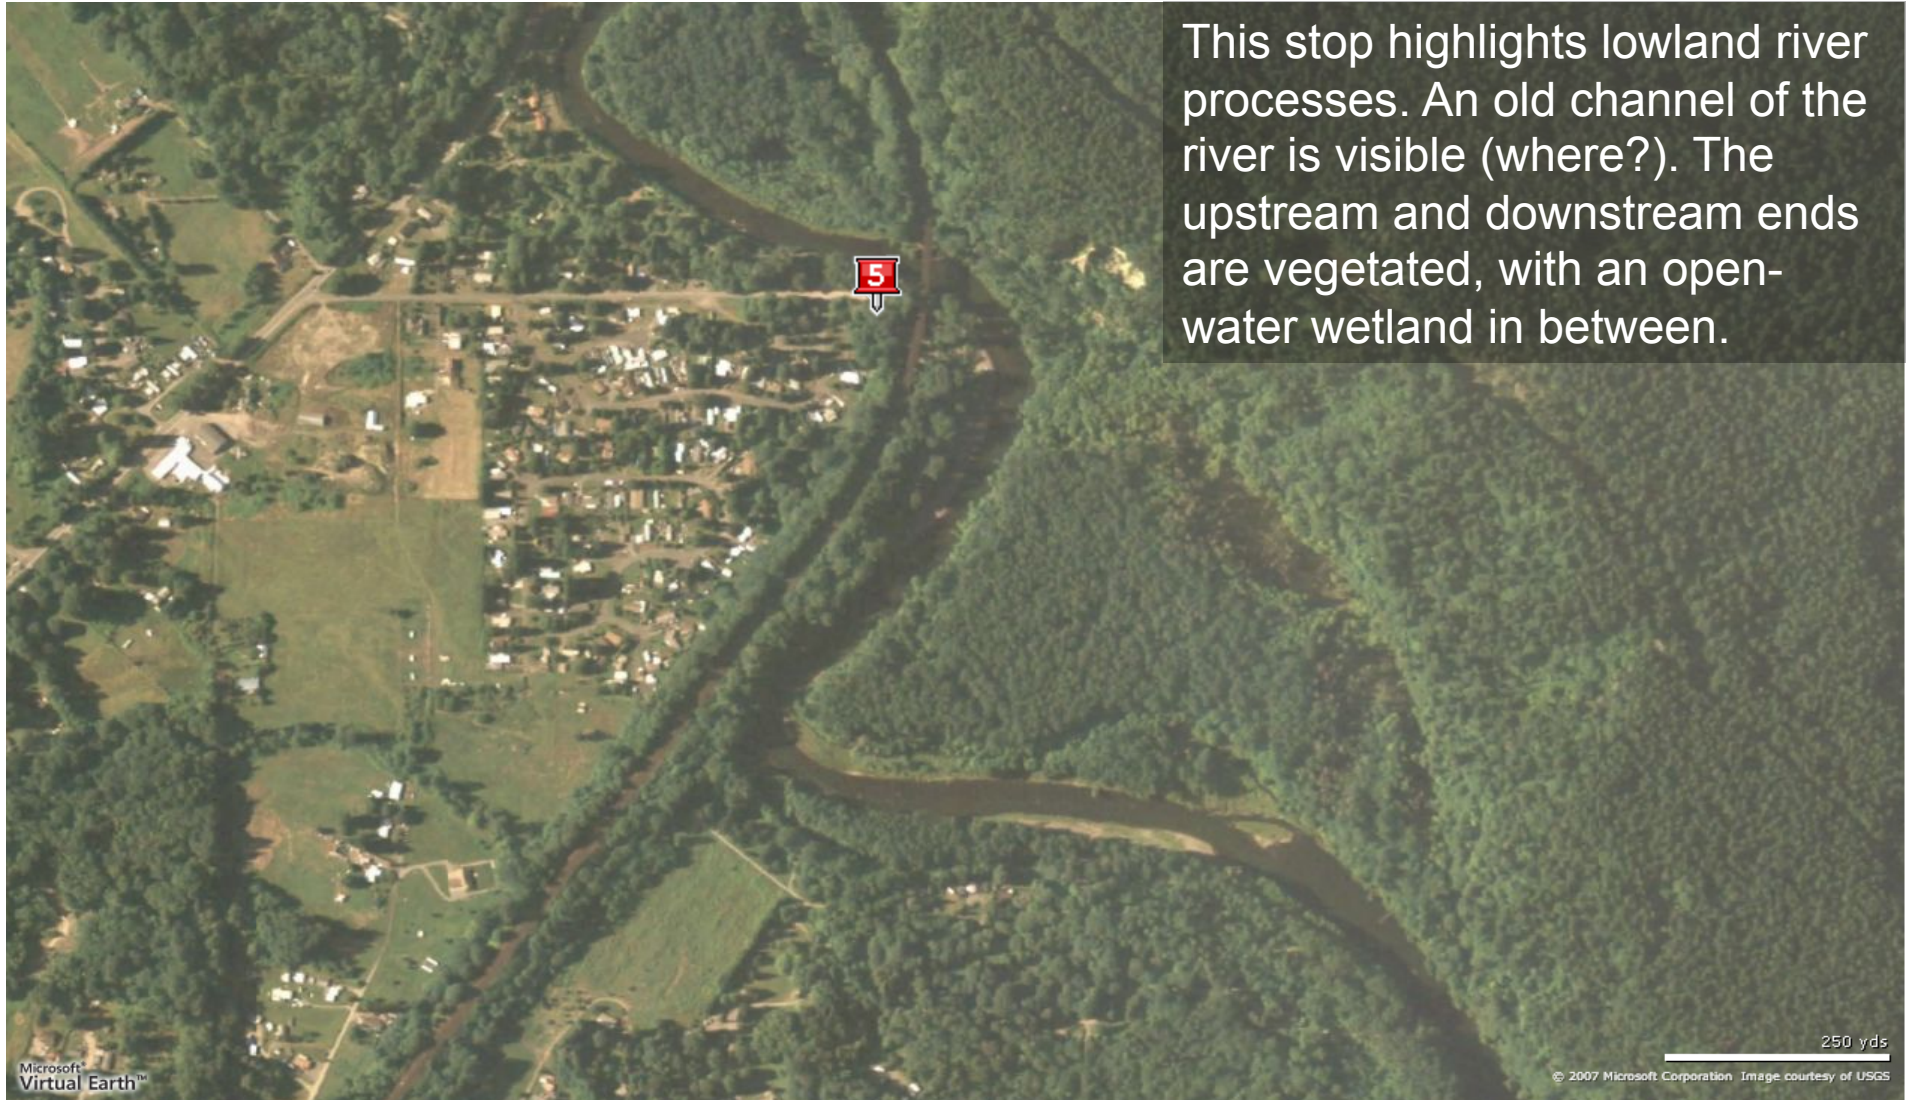
Nisqually@WDFW HNDTCP

This stop highlights lowland river processes. An old channel of the river is visible (where?). The upstream and downstream ends are vegetated, with an open-water wetland in between.

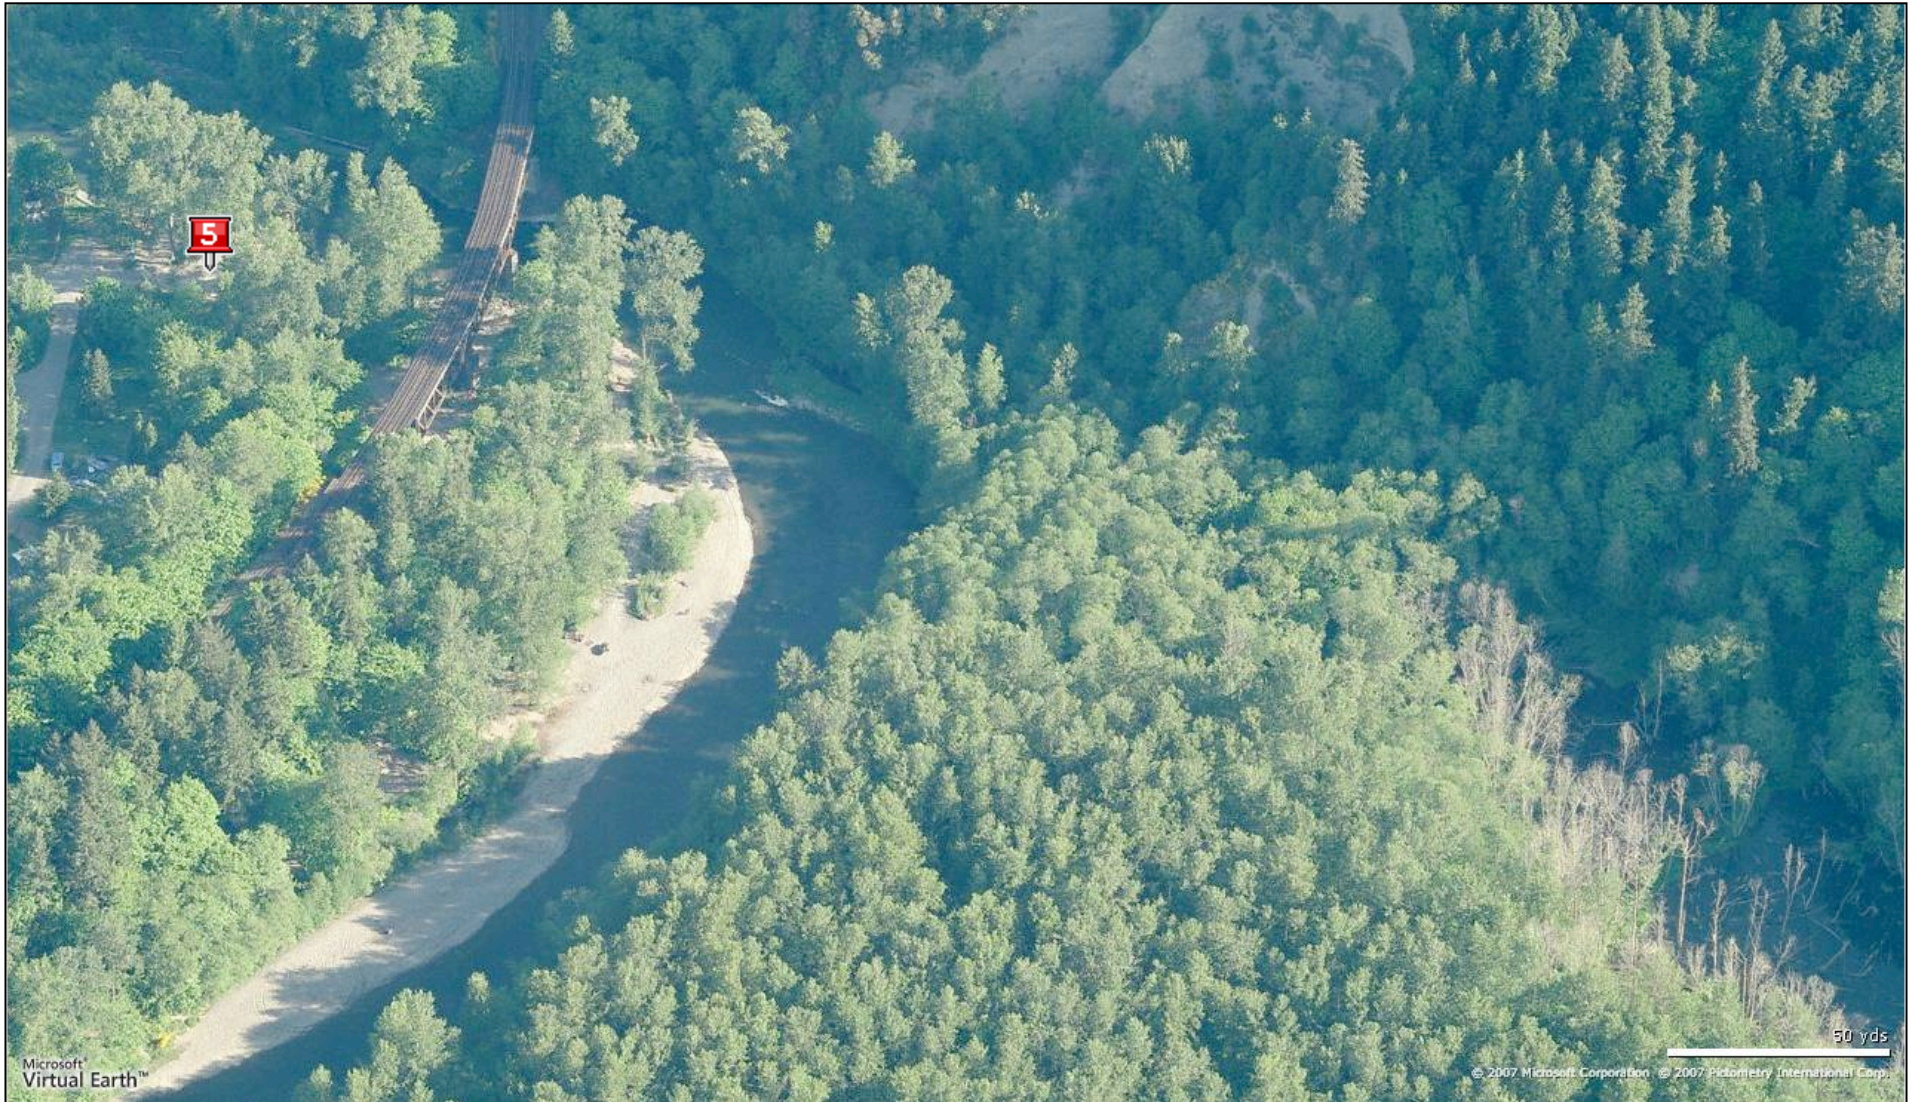
Nisqually River @ Nisqually HNDCP

This site has a nice gravel bar, and wood is visible on the right bank in aerial imagery. Also the hardwoods on the RB occupy an old side channel that looks like a sweet little coho nursery.

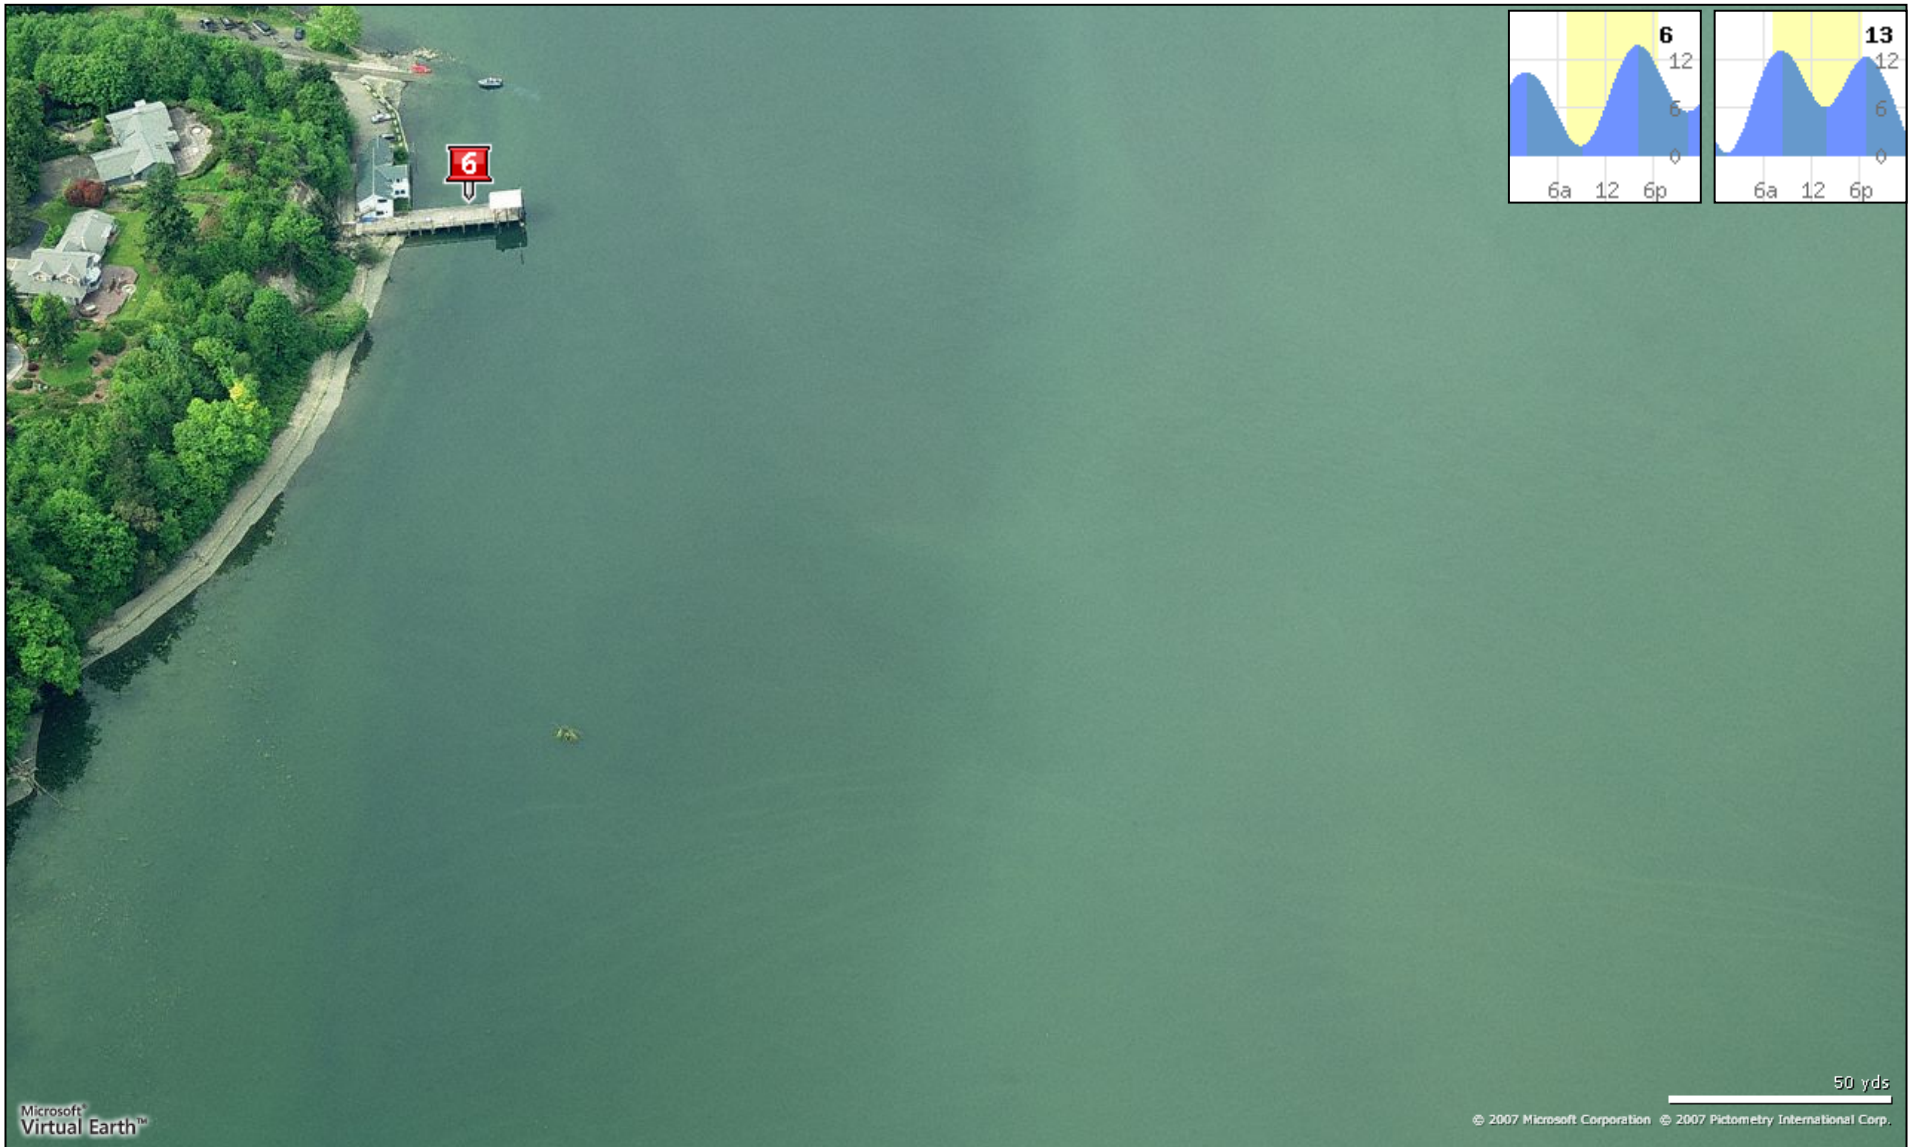
Nisqually Estuary @ Nisqually Nature Ctr.

This is an aerial of the Nature Center at
~high tide.

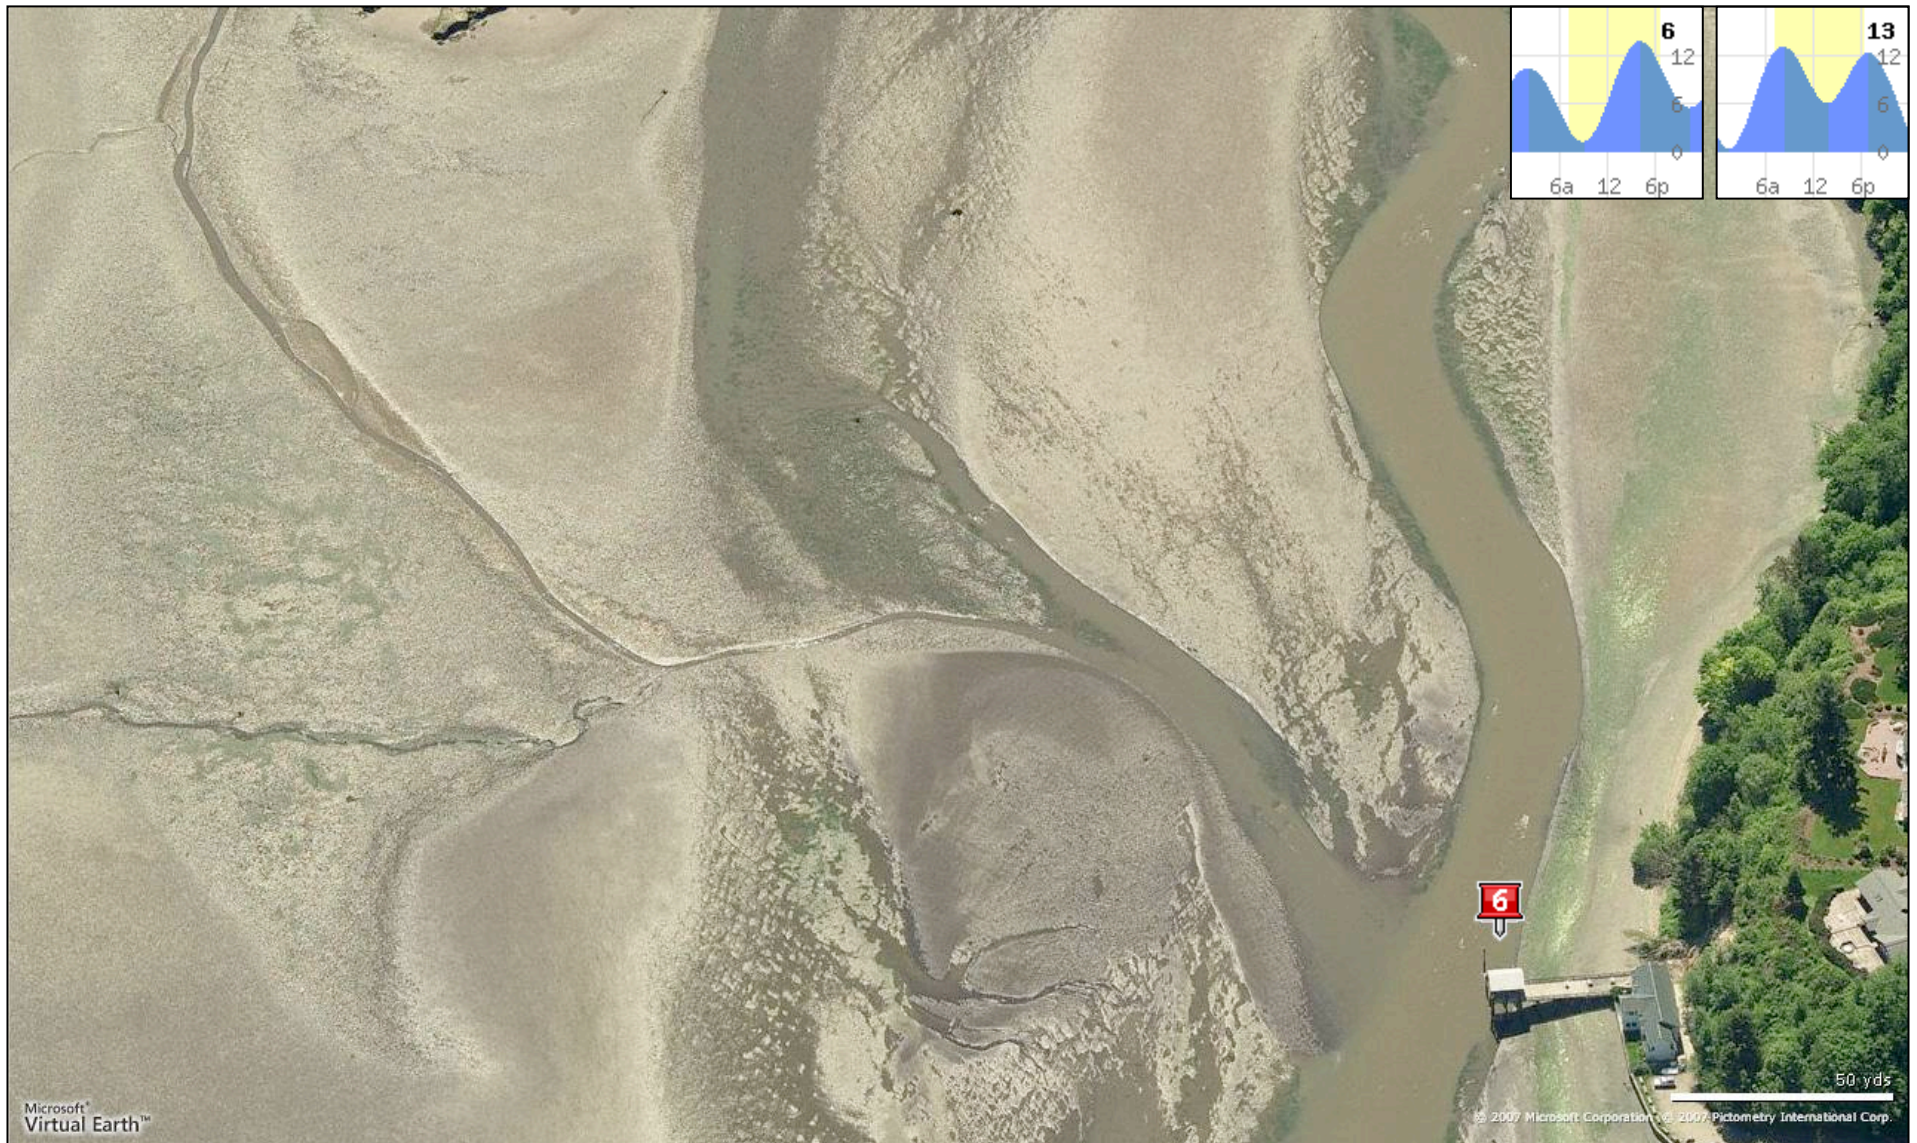
Nisqually Estuary @ Nisqually Nature Ctr.

This is an aerial of the Nature Center at
~low tide.
