Mount Rainier National Park

November 2006 Flood Damage

On November 6 and 7, 2006, Mount Rainier National Park received 18 inches of rain in 36 hours. This presentation summarizes the extensive flood damage that occurred throughout the park.

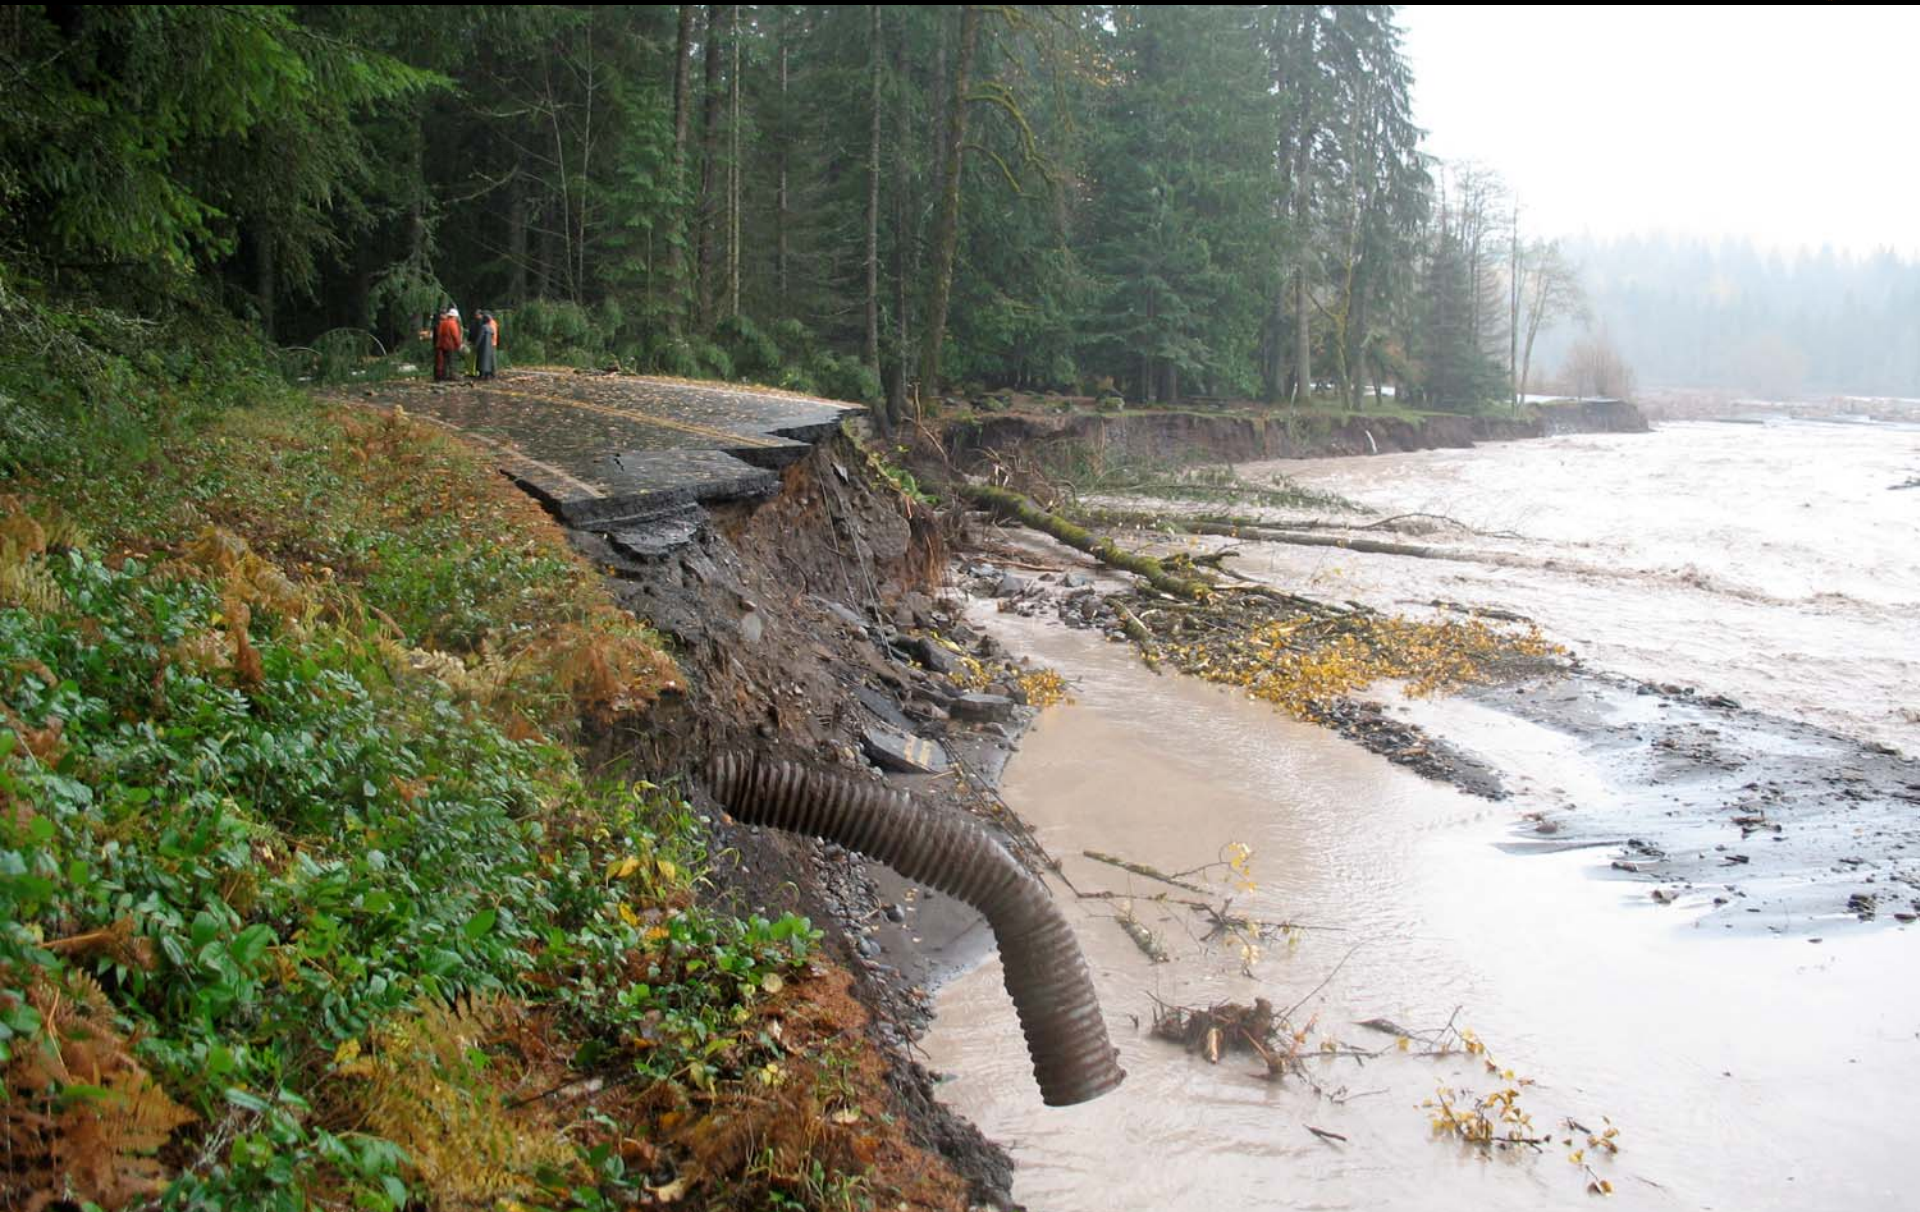
- The section of dike which protected Sunshine Point Campground was destroyed in the flood. Only a small section of the campground remained. The rest is now river bed.
- The Nisqually Road was washed out for 200 yards.
- The main power line (serving Longmire and Paradise) was severed where it crossed Sunshine Point.

The Nisqually Road and site of the former Sunshine Point Campground

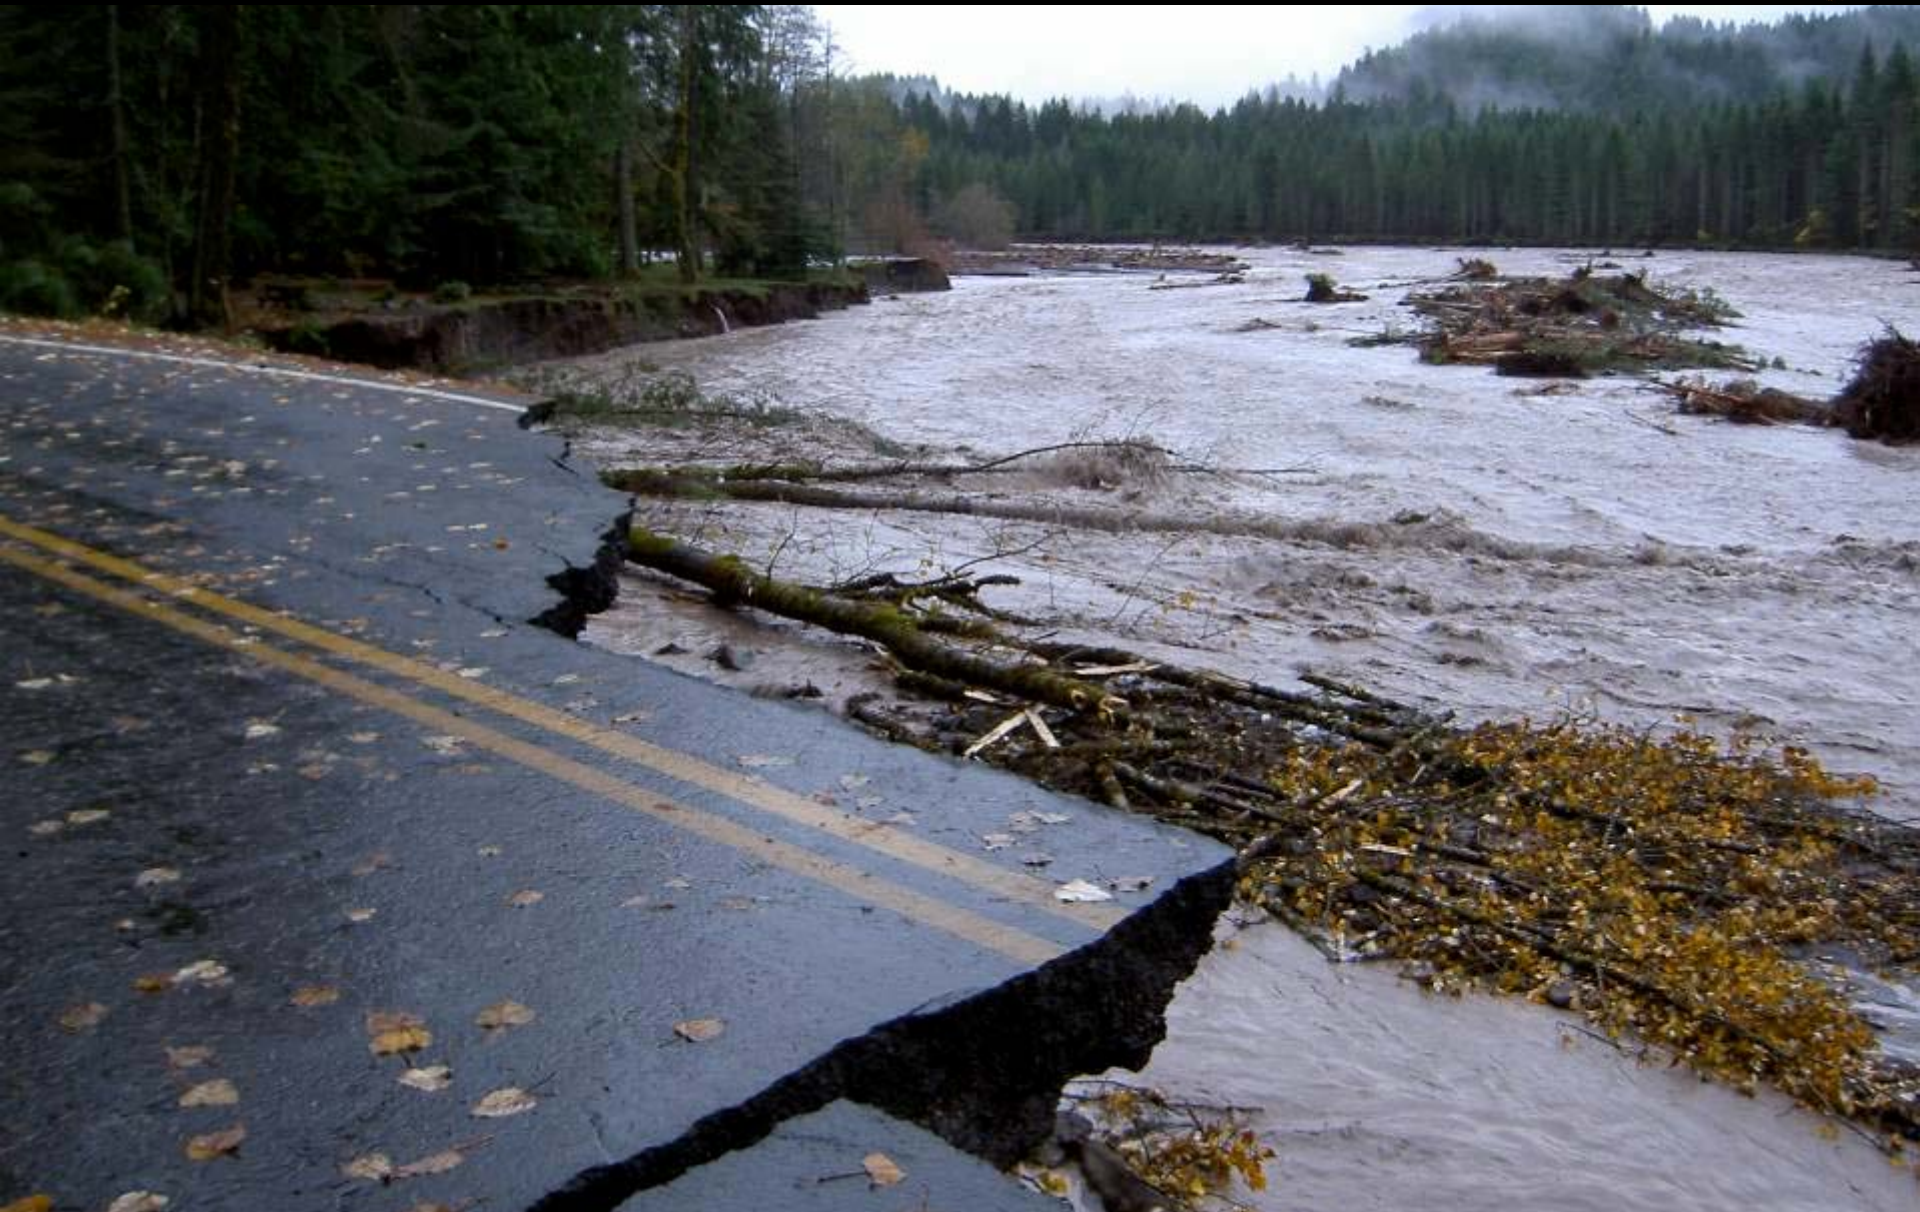
Most of the campground and adjacent road were washed away

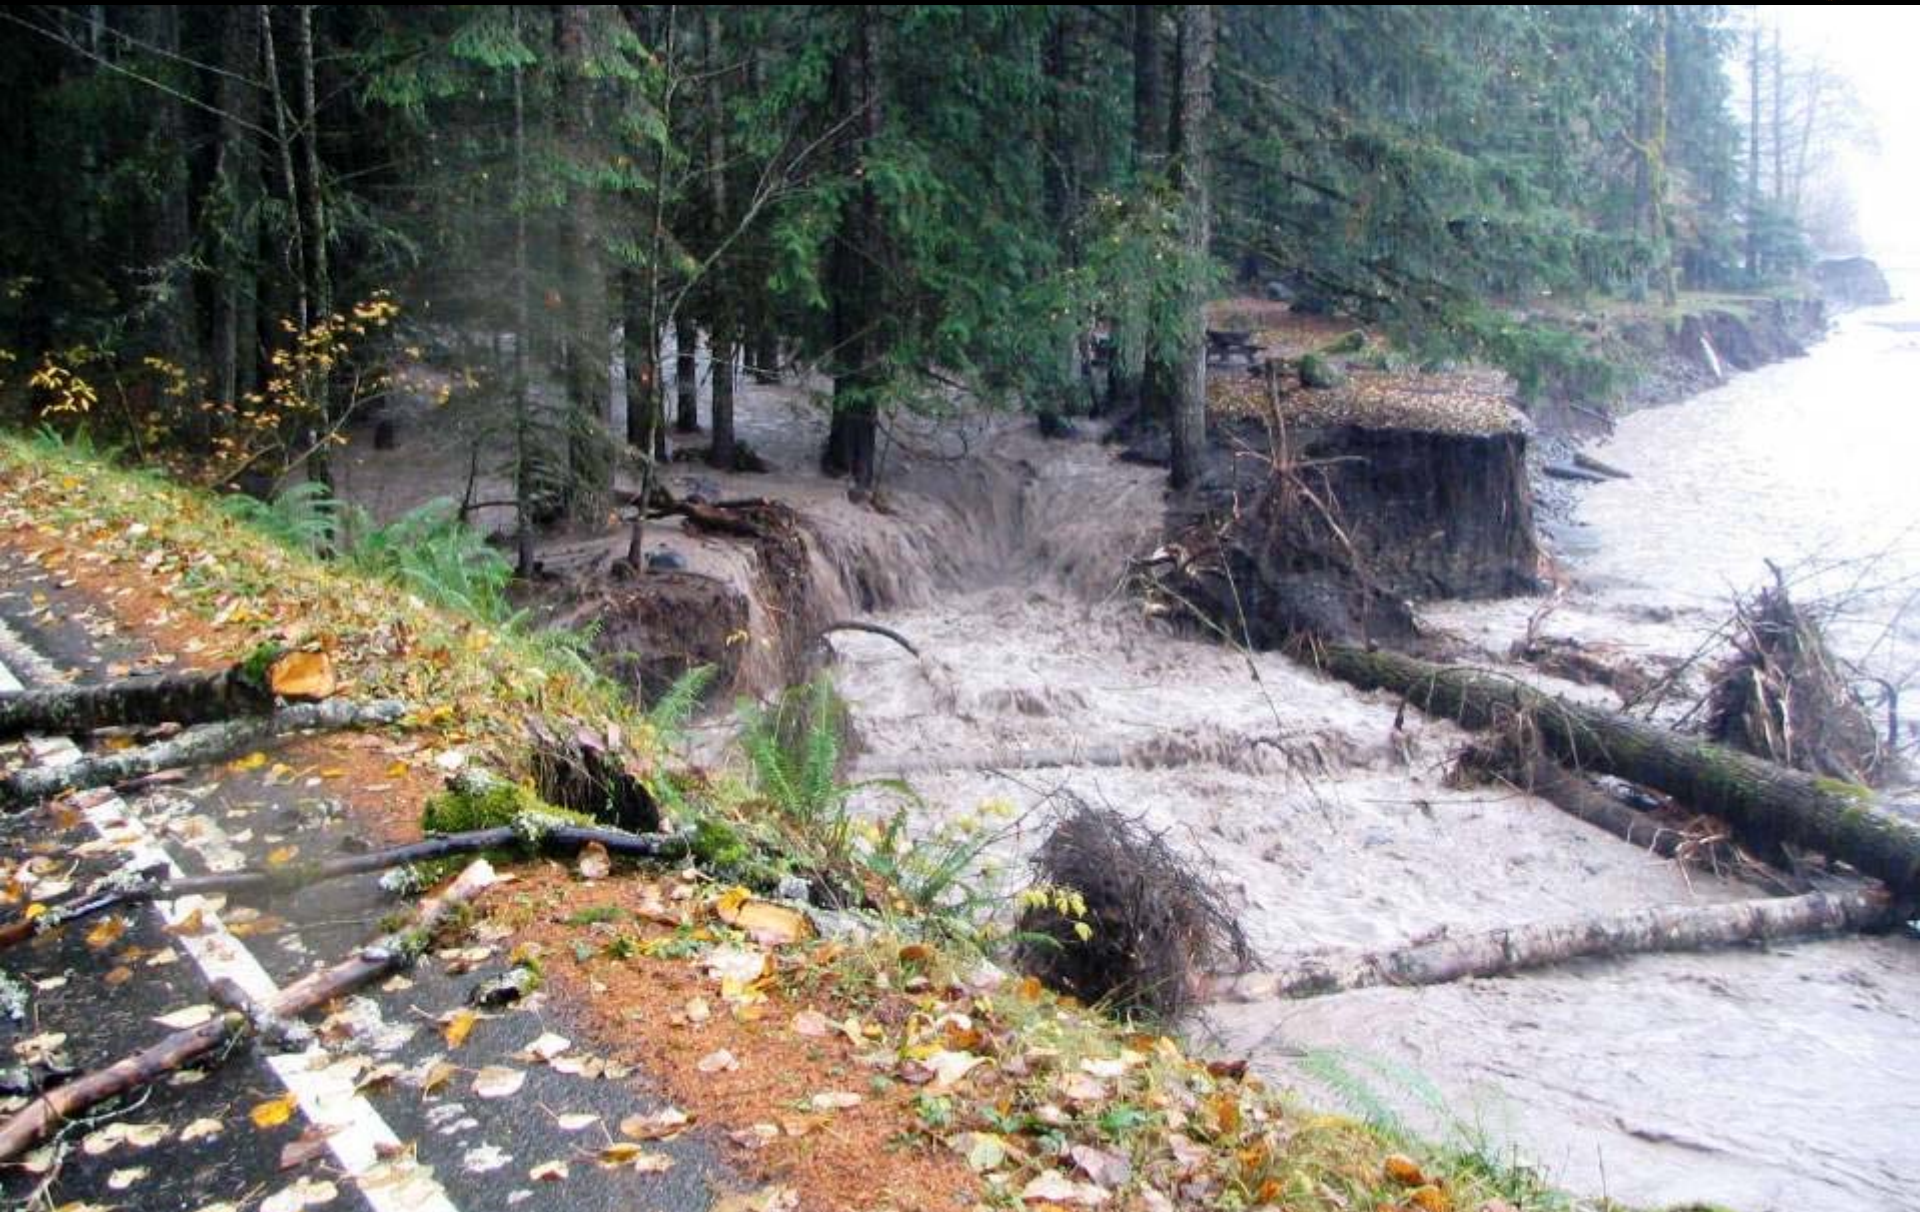
Water flowing through the remains of the Sunshine Point Campground

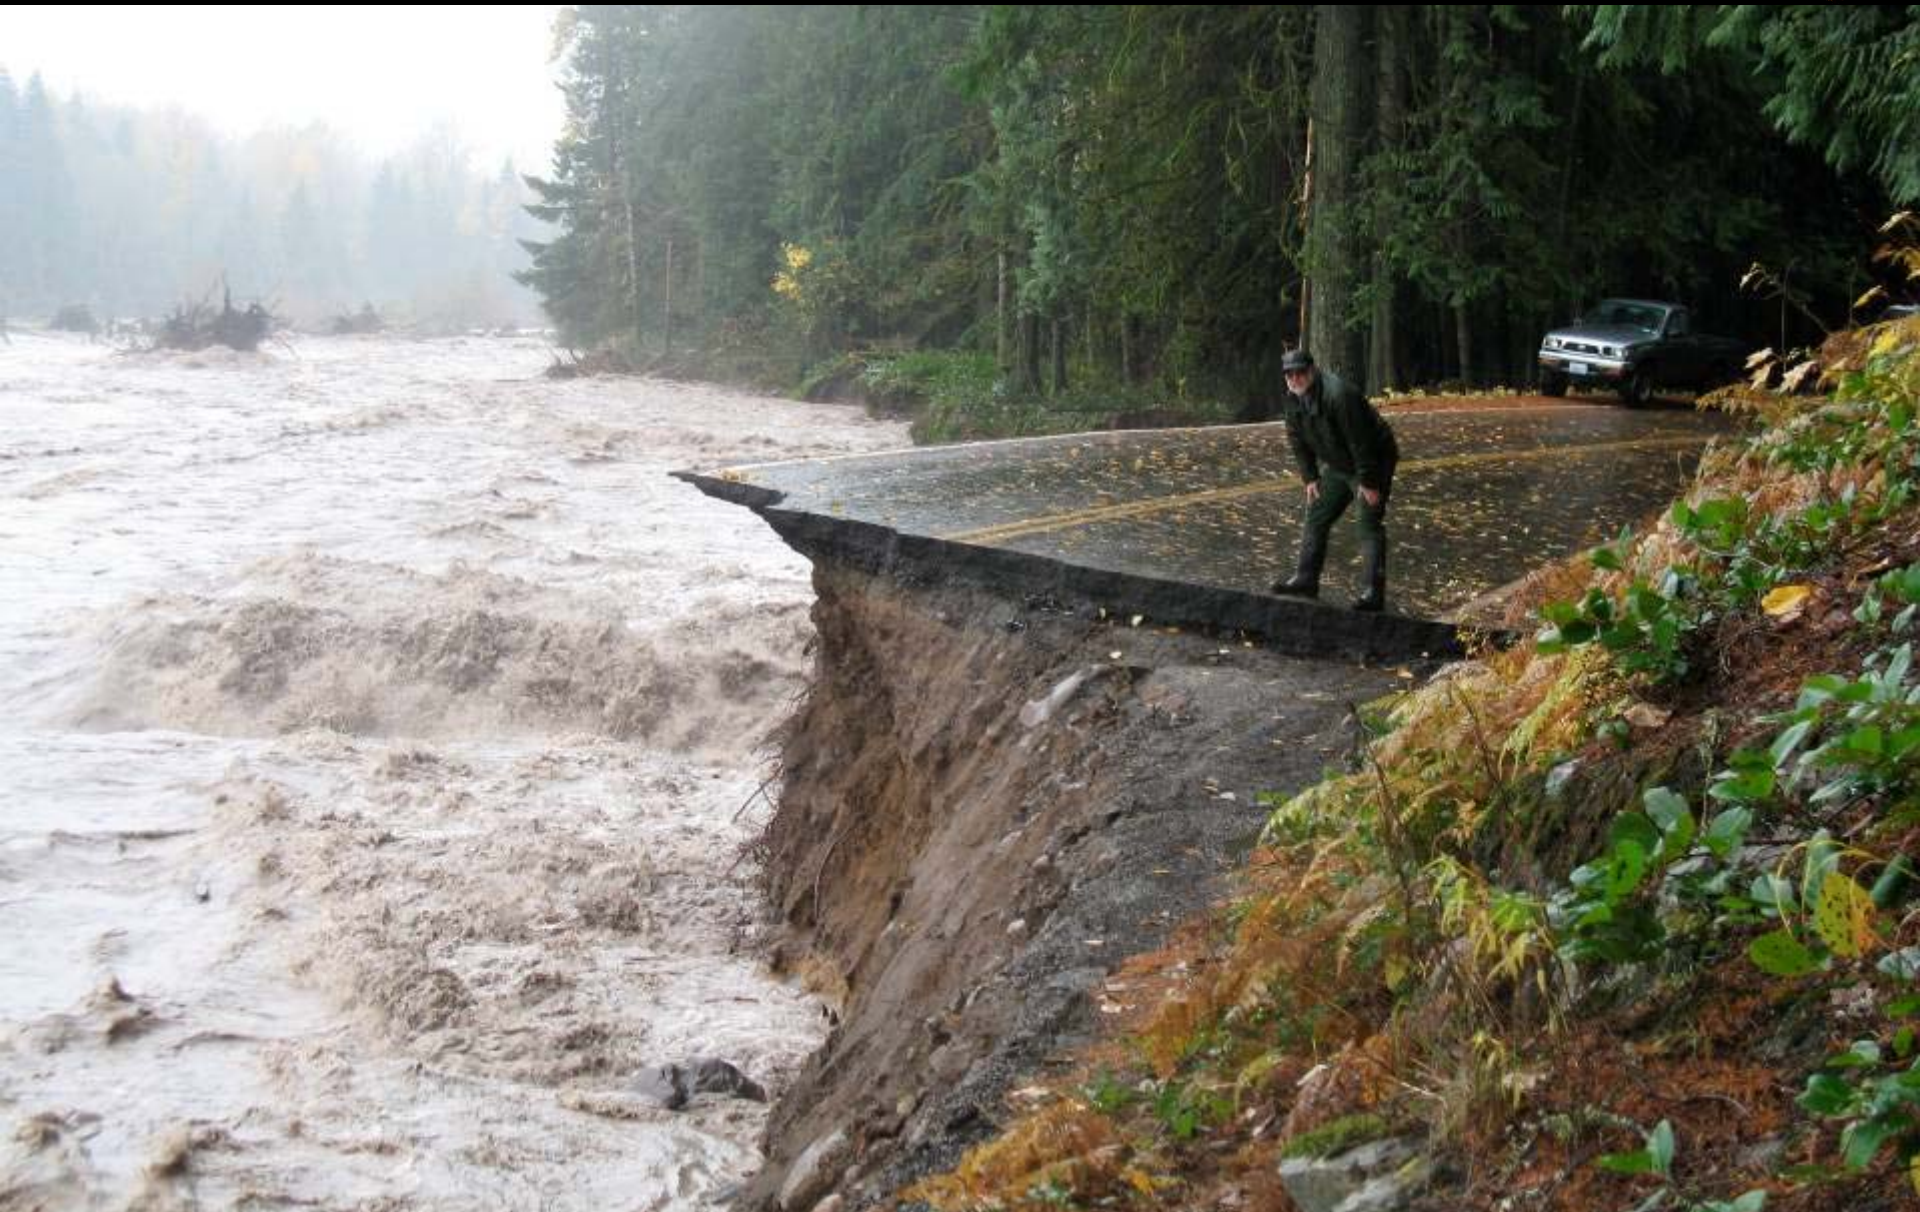
The broken edge of the Nisqually Road

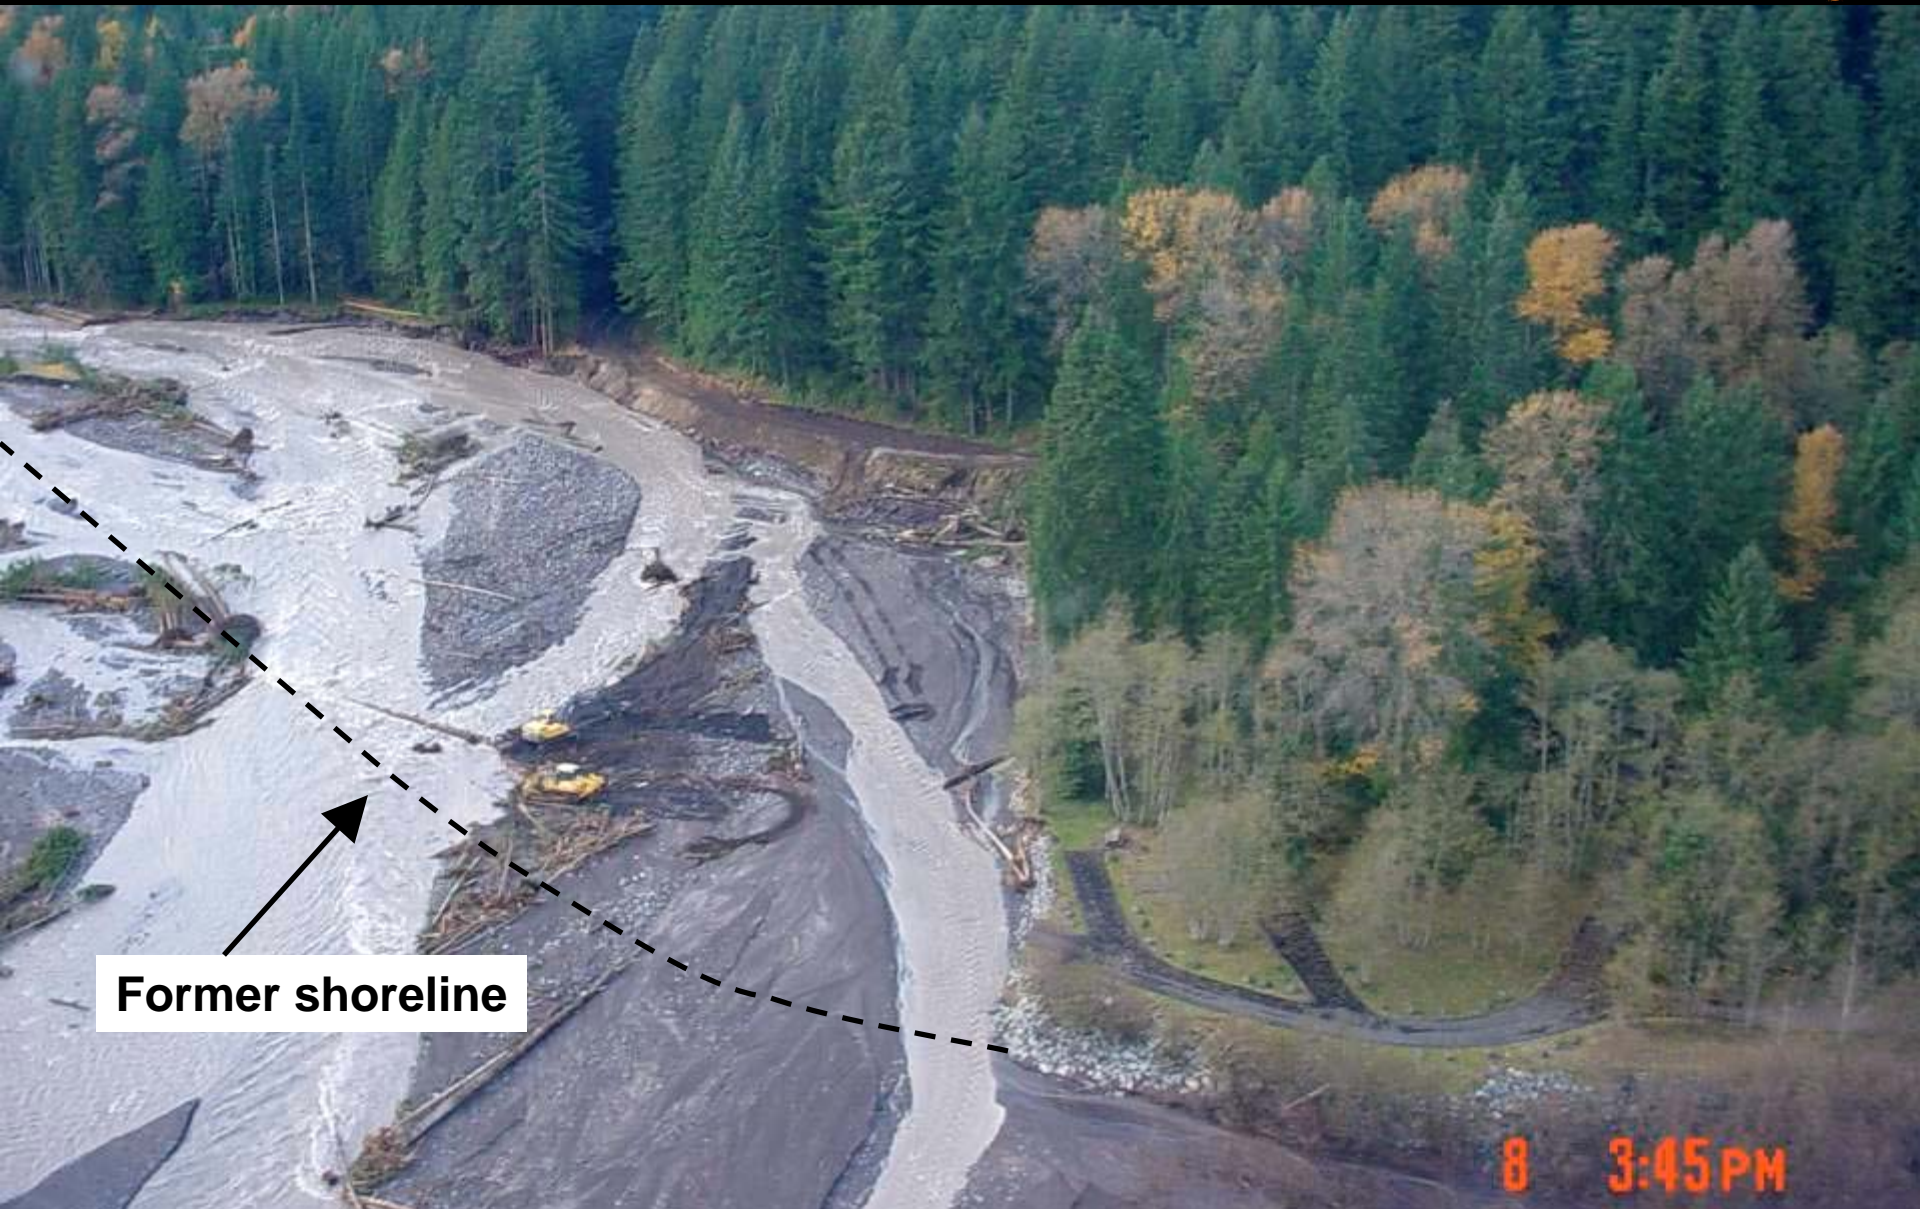
Former shoreline

An aerial view of the former Sunshine Point Campground

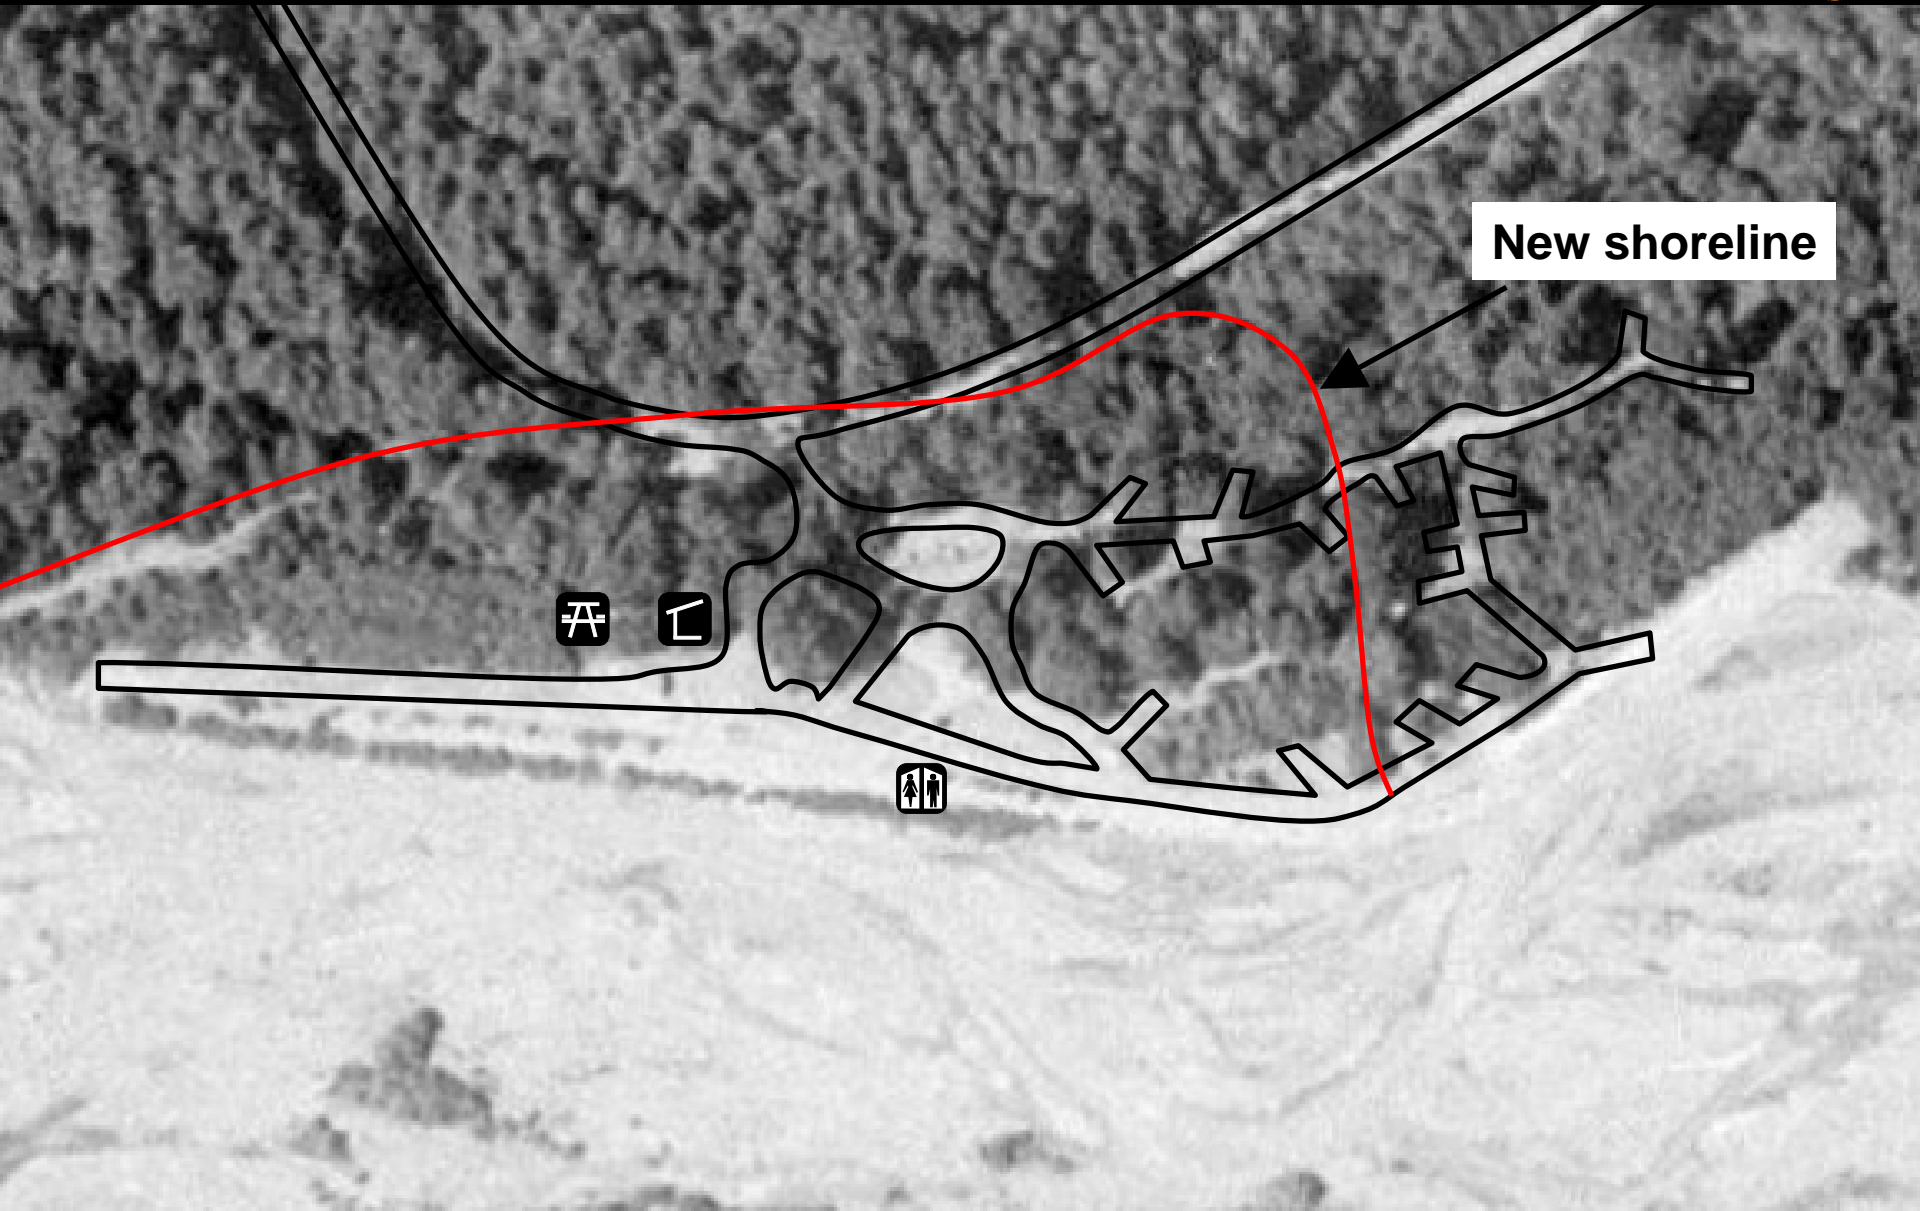
Satellite image of the Sunshine Point Campground, showing new shoreline

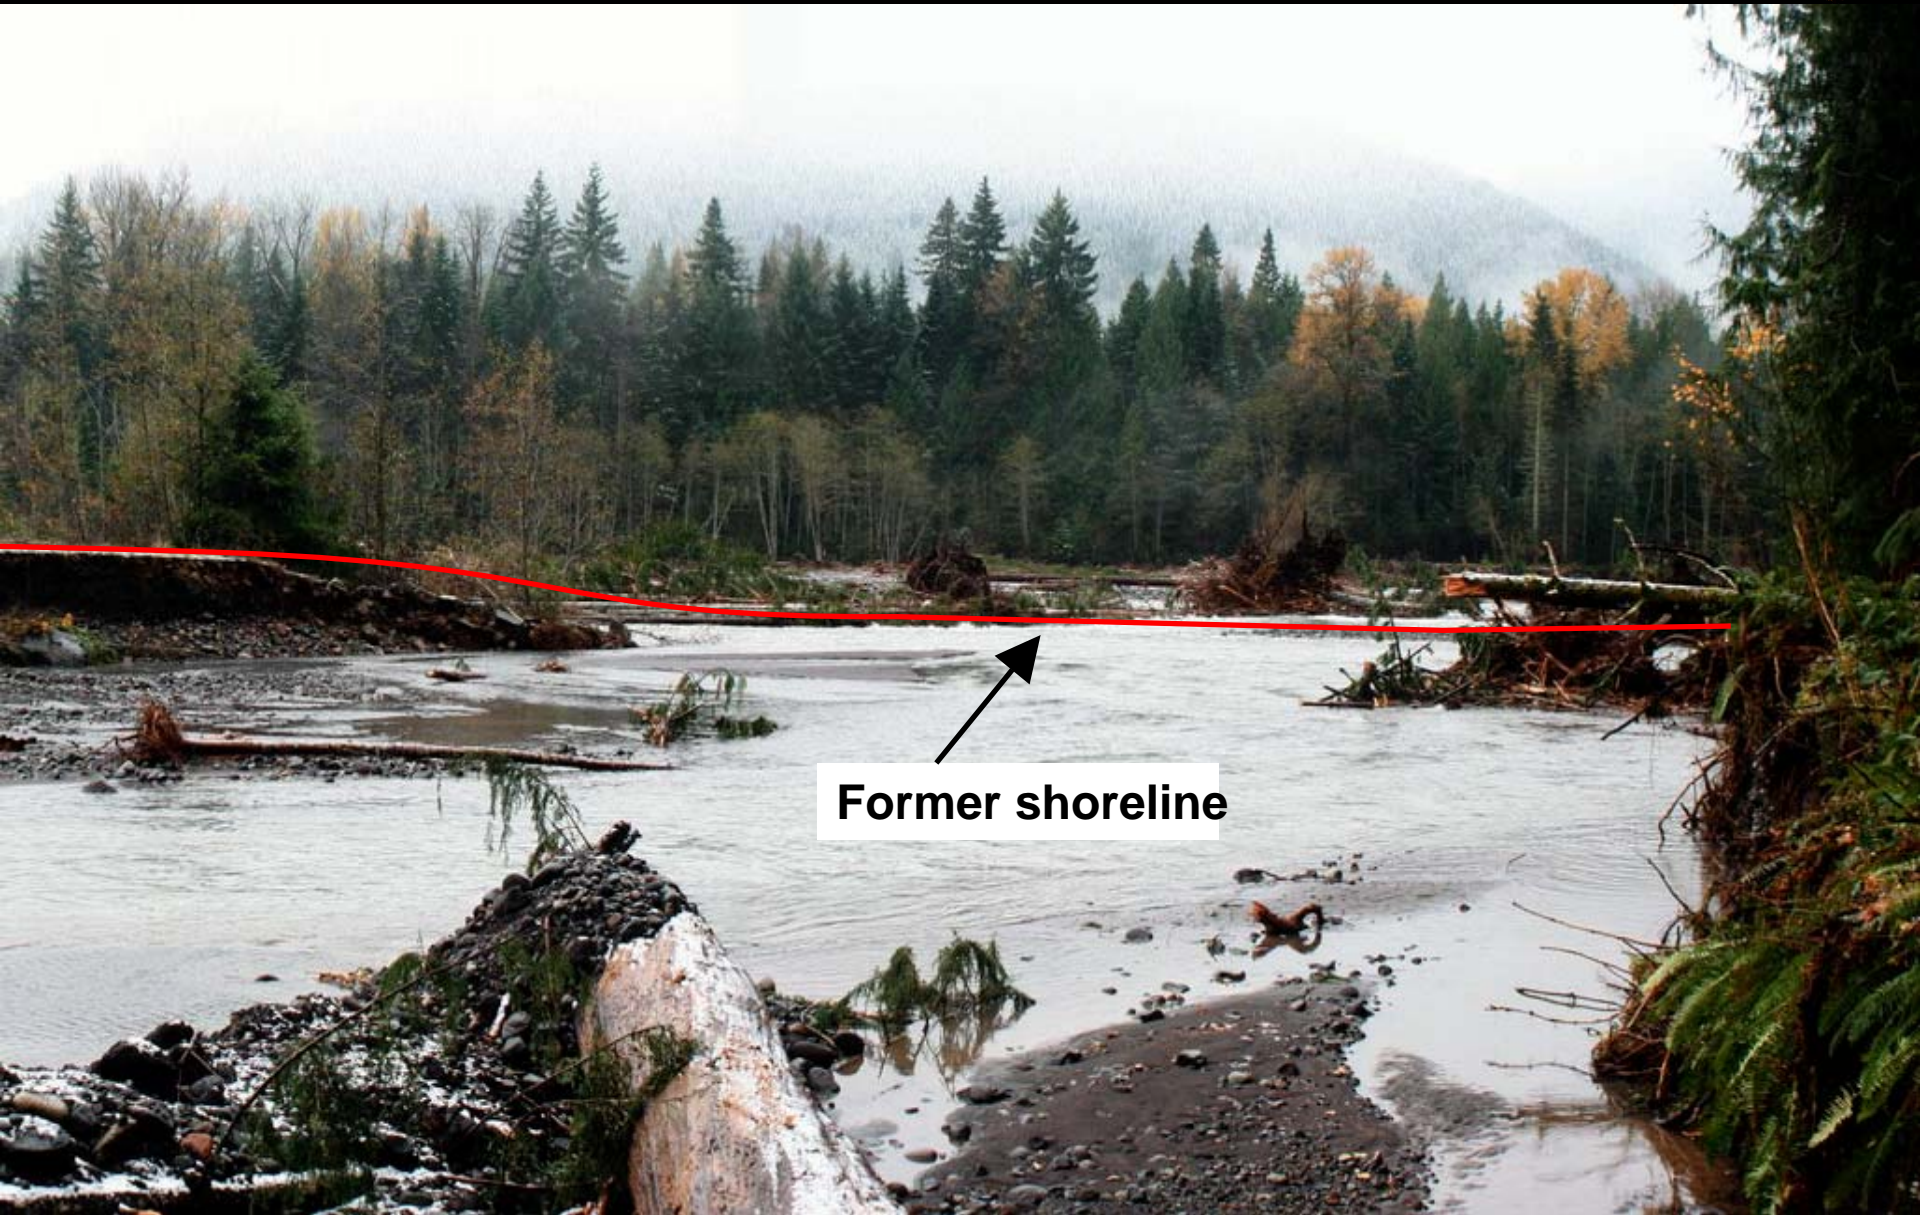
Former shoreline

New and former shoreline at Sunshine Point Campground

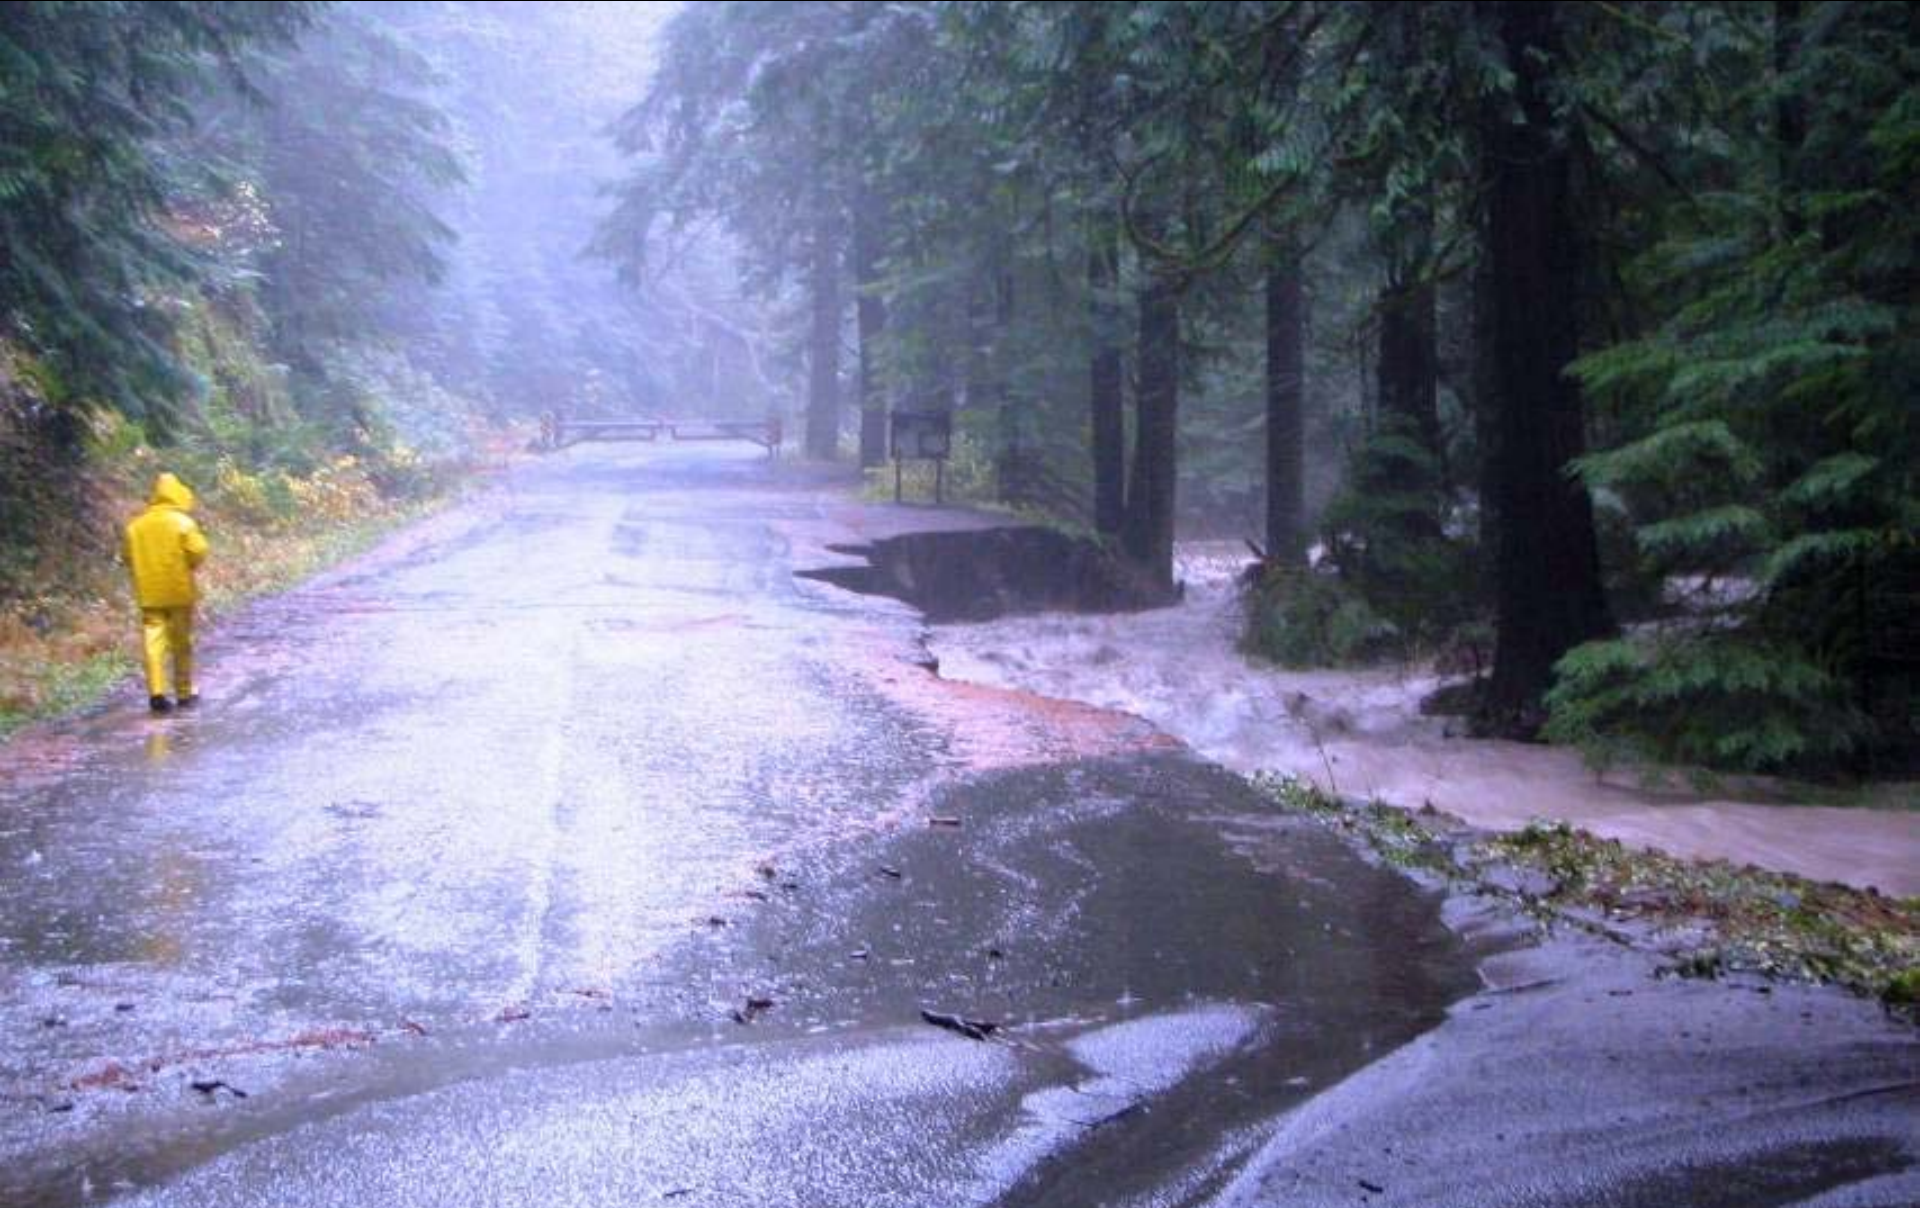
- Water crossed the Westside Road at its junction with the Nisqually Road. Parts of both roads were washed out.
- Part of a lane collapsed near the gate at Dry Creek. The roadway upstream was significantly damaged.

Washout at the beginning of the Westside Road

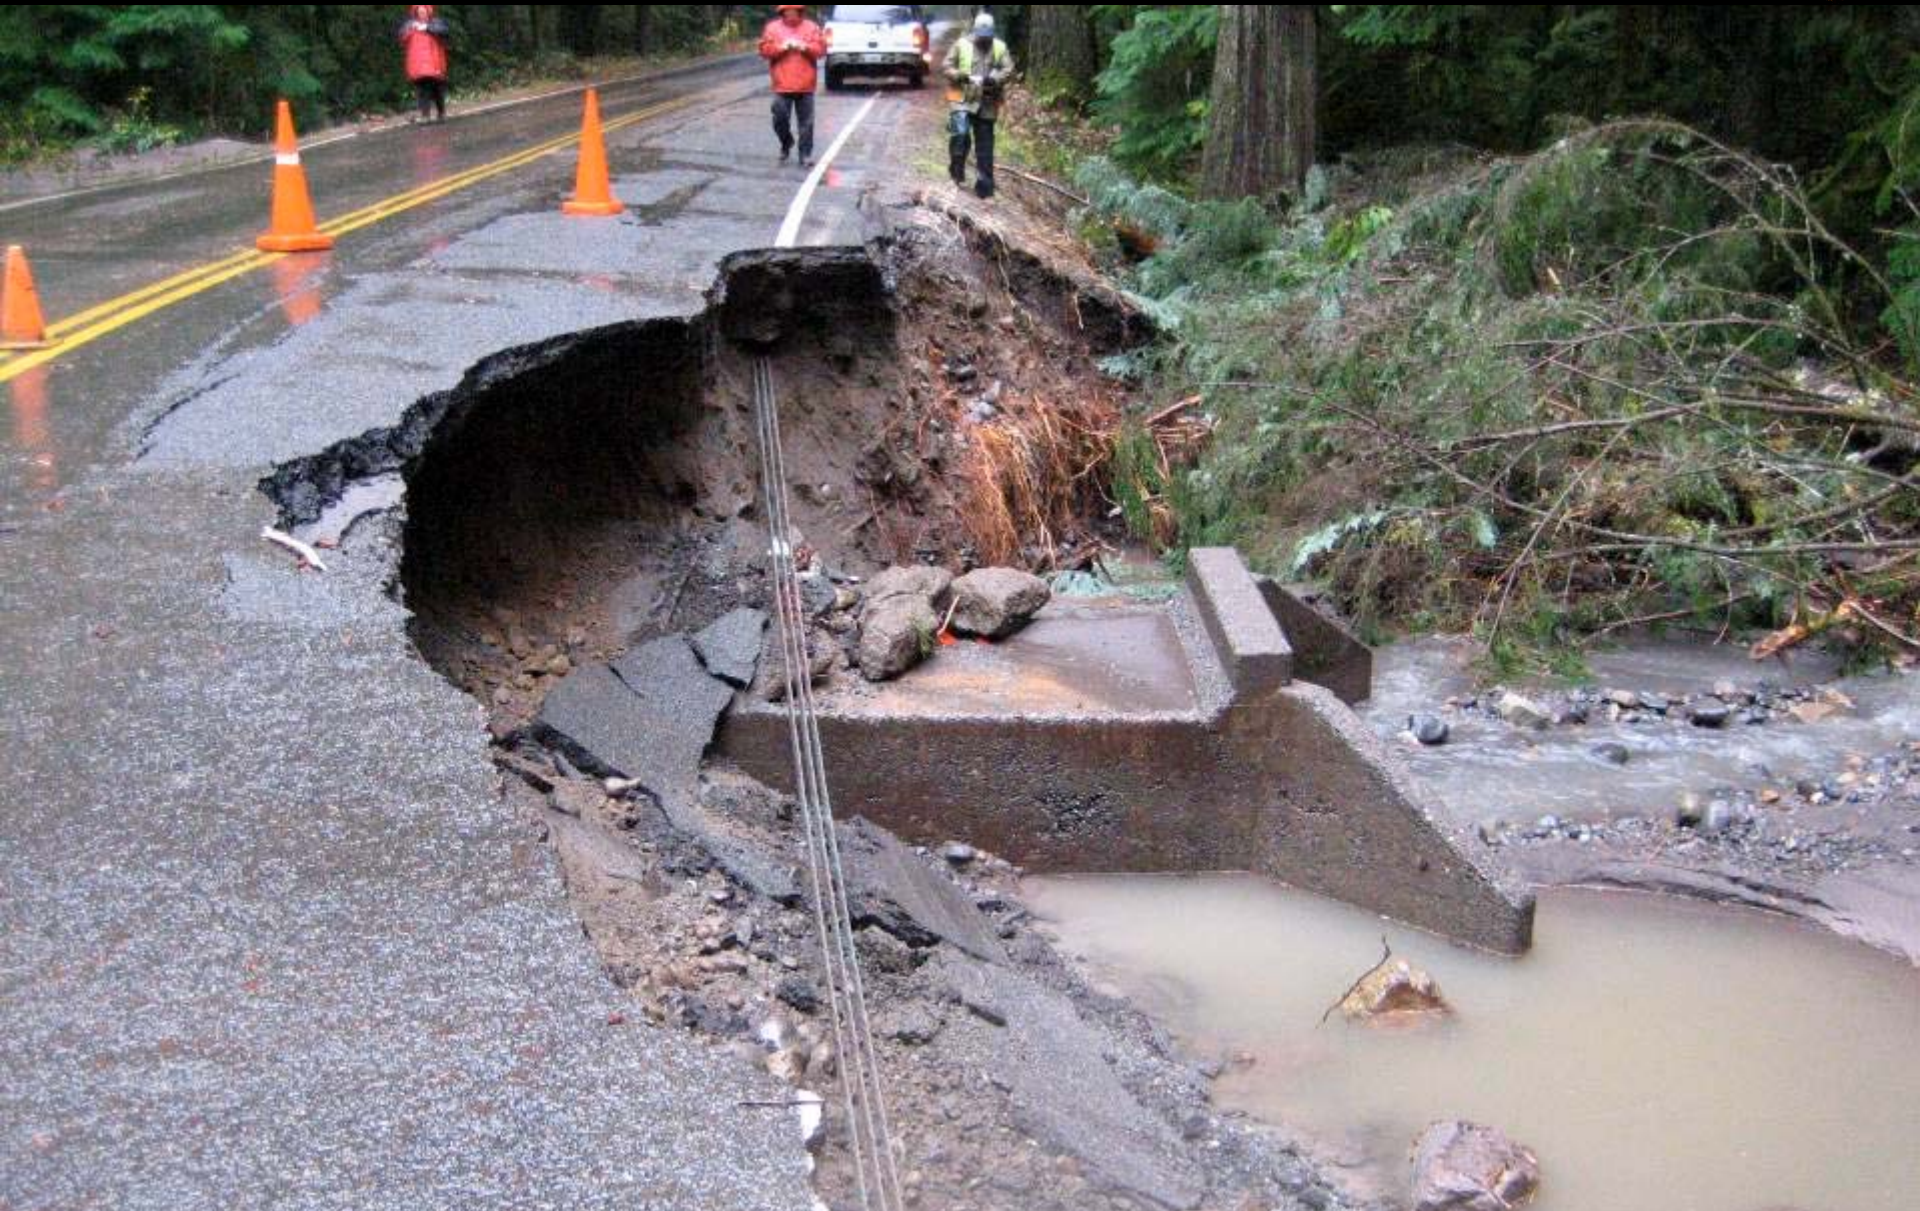
Damage to the Nisqually Road across from the Westside Road junction
