Mount Rainier National Park

November 2006 Flood Damage

On November 6 and 7, 2006, Mount Rainier National Park received 18 inches of rain in 36 hours. This presentation summarizes the extensive flood damage that occurred throughout the park.

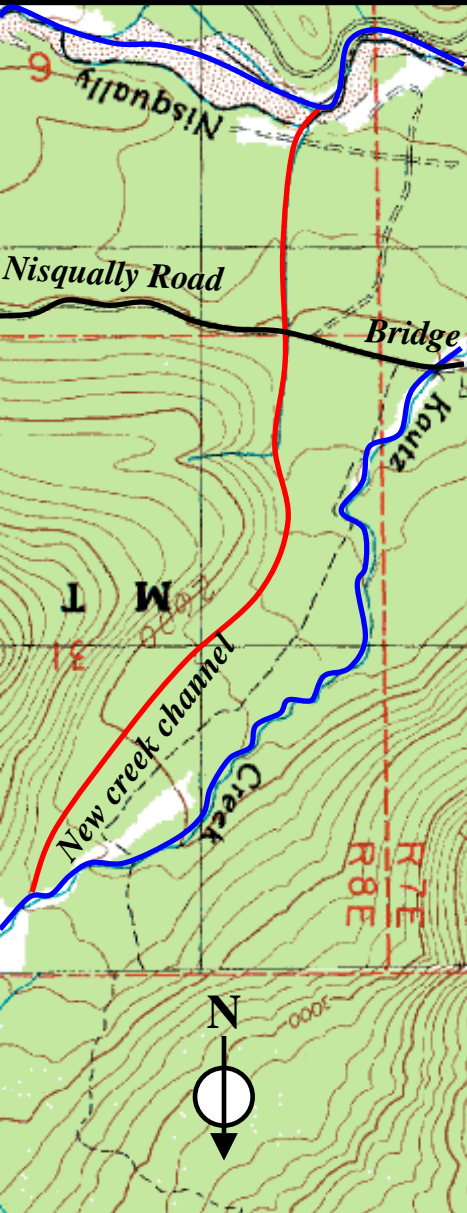
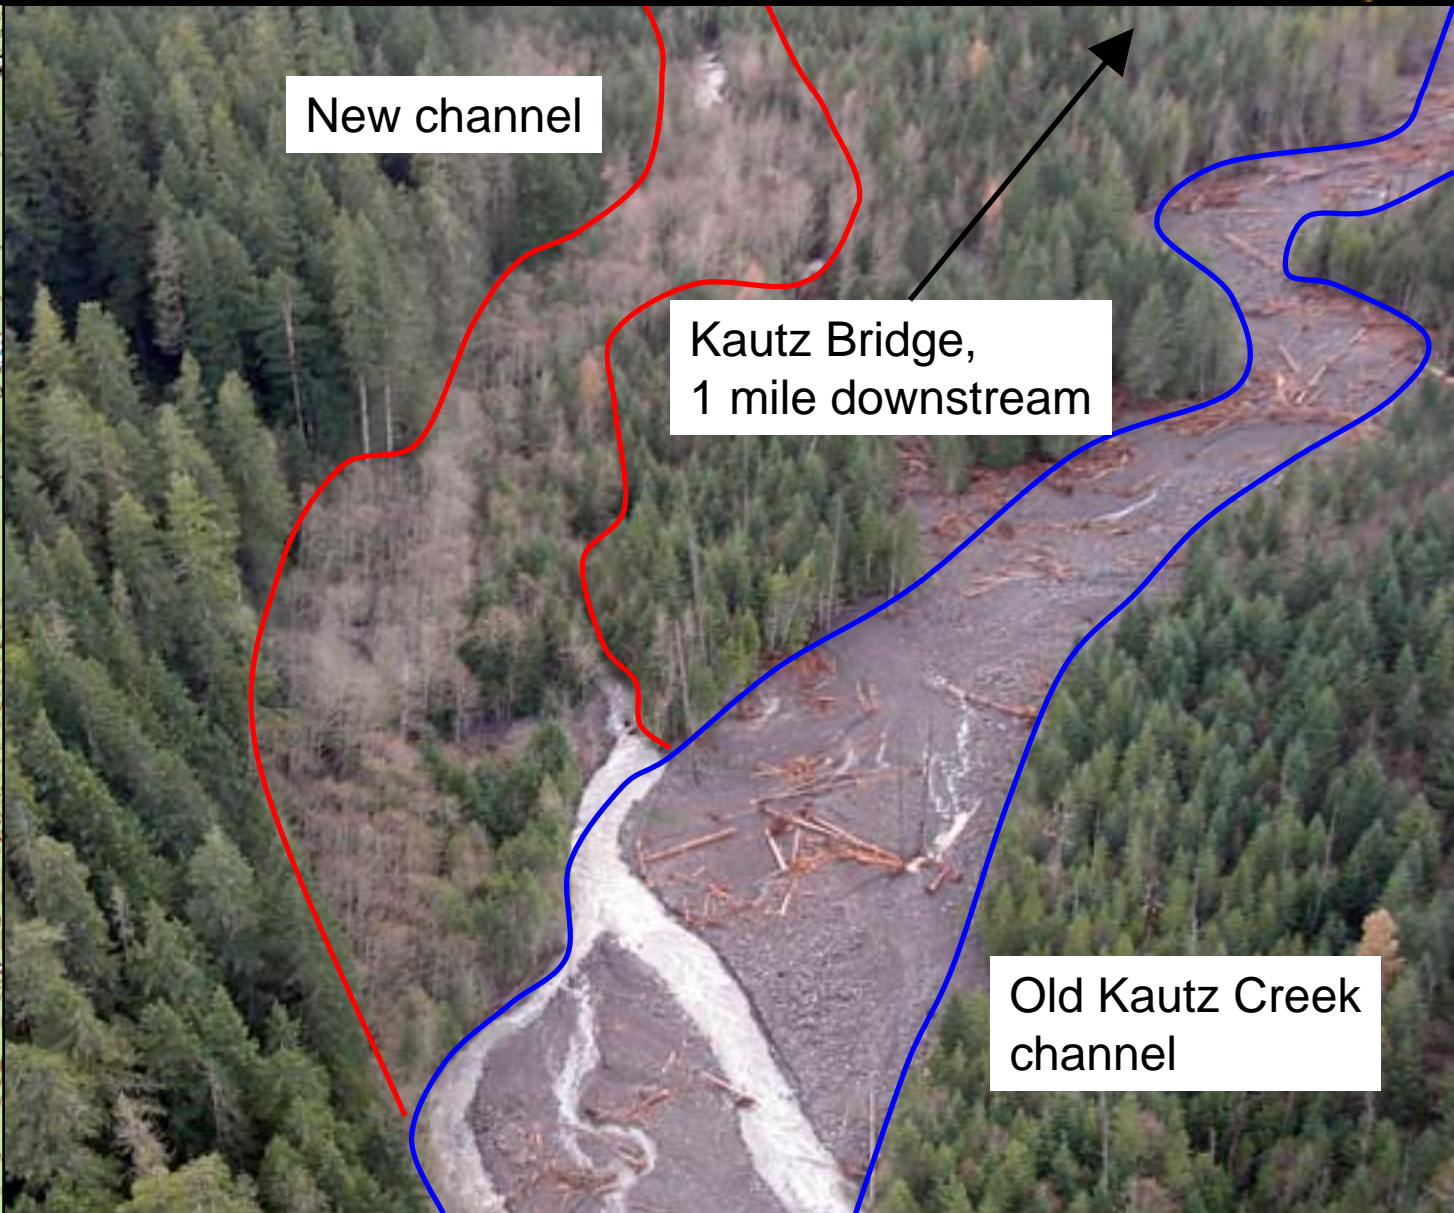
New channel

Kautz Bridge,
1 mile downstream

Old Kautz Creek
channel

Kautz Creek changed its channel a mile above the road bridge

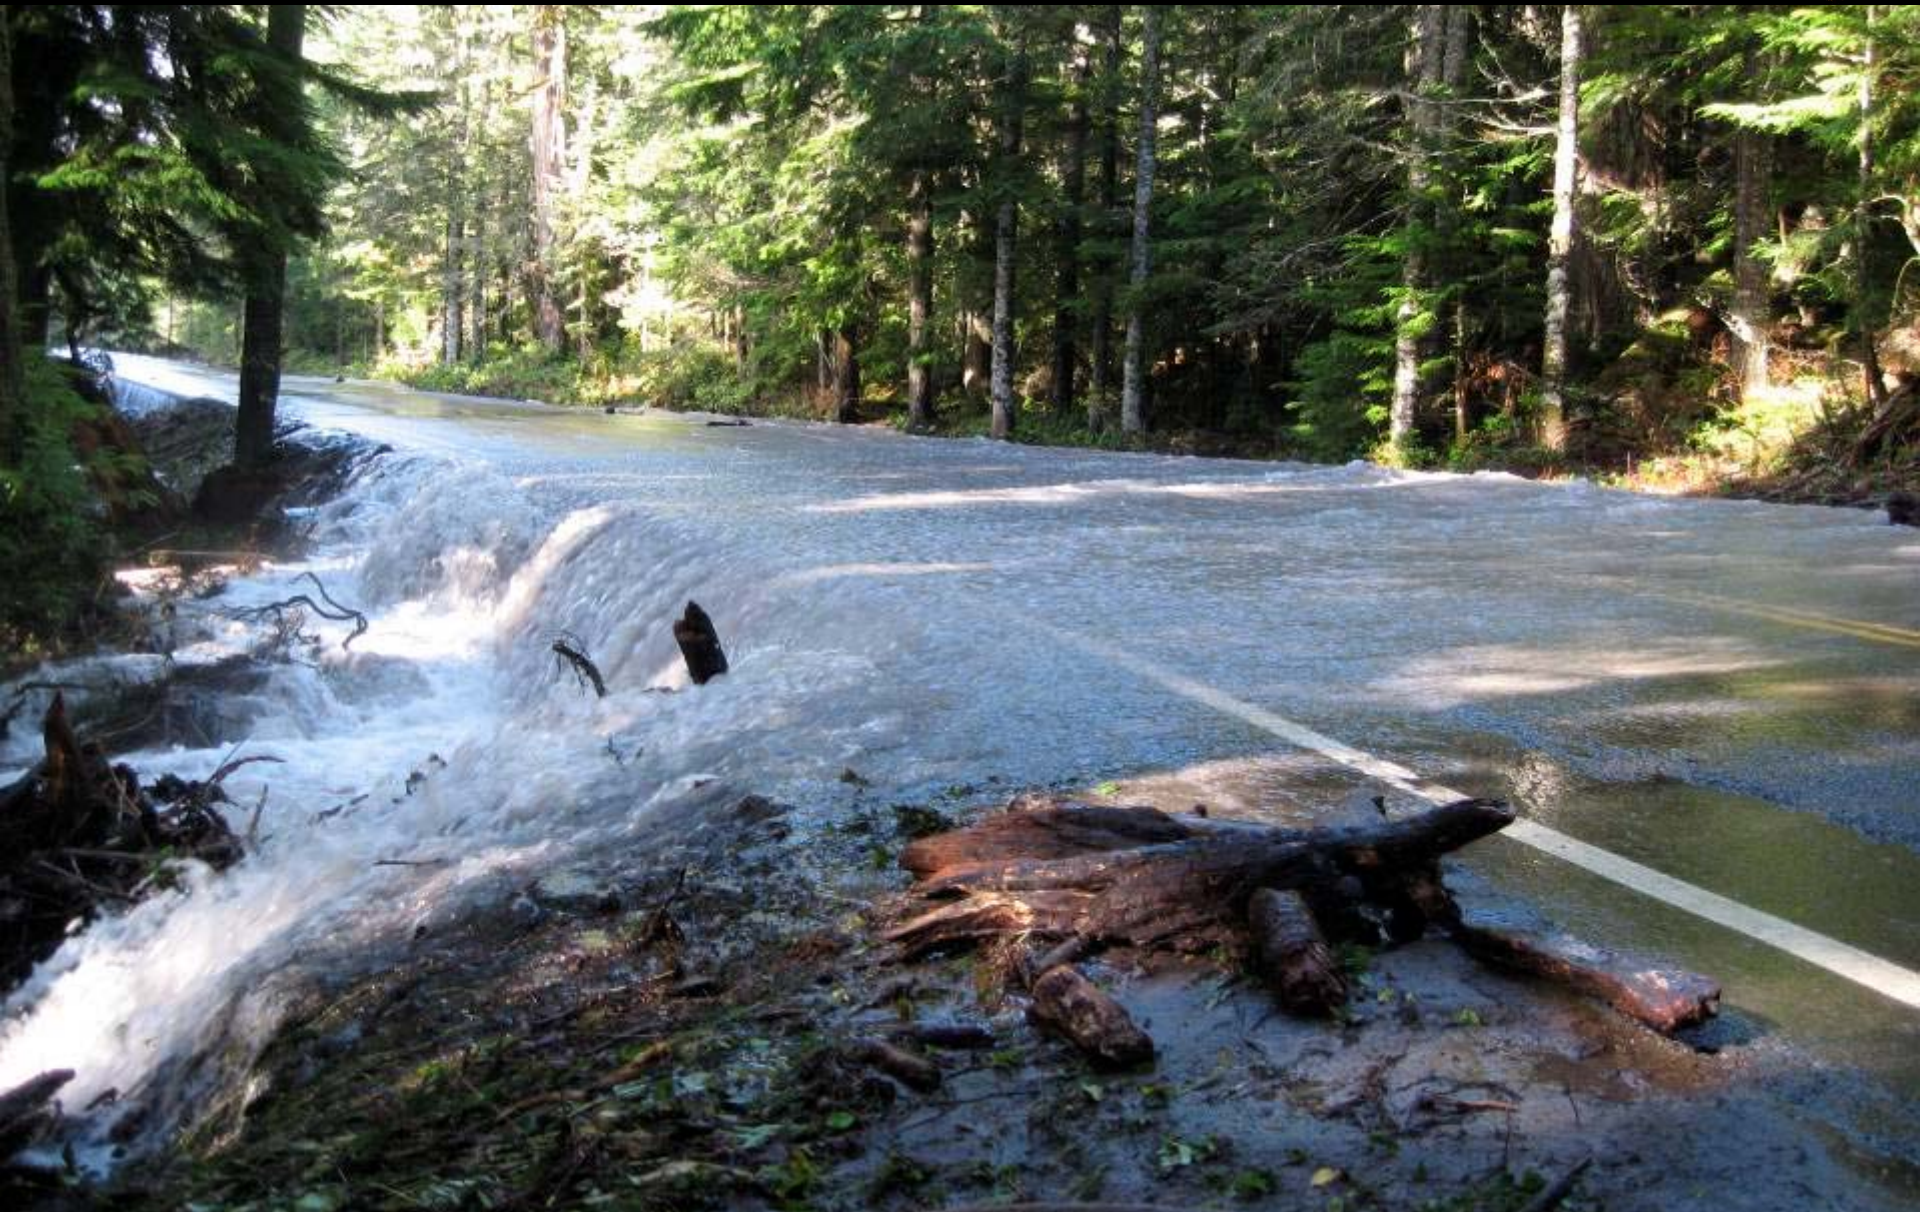
- Kautz Creek changed its channel a mile above the road bridge, and is now flowing over and undermining the Nisqually Road for a distance of 50 yards.
- The Kautz Helibase sustained major erosion damage from the redirected water flow.

Kautz Creek flowing across the road east of the bridge

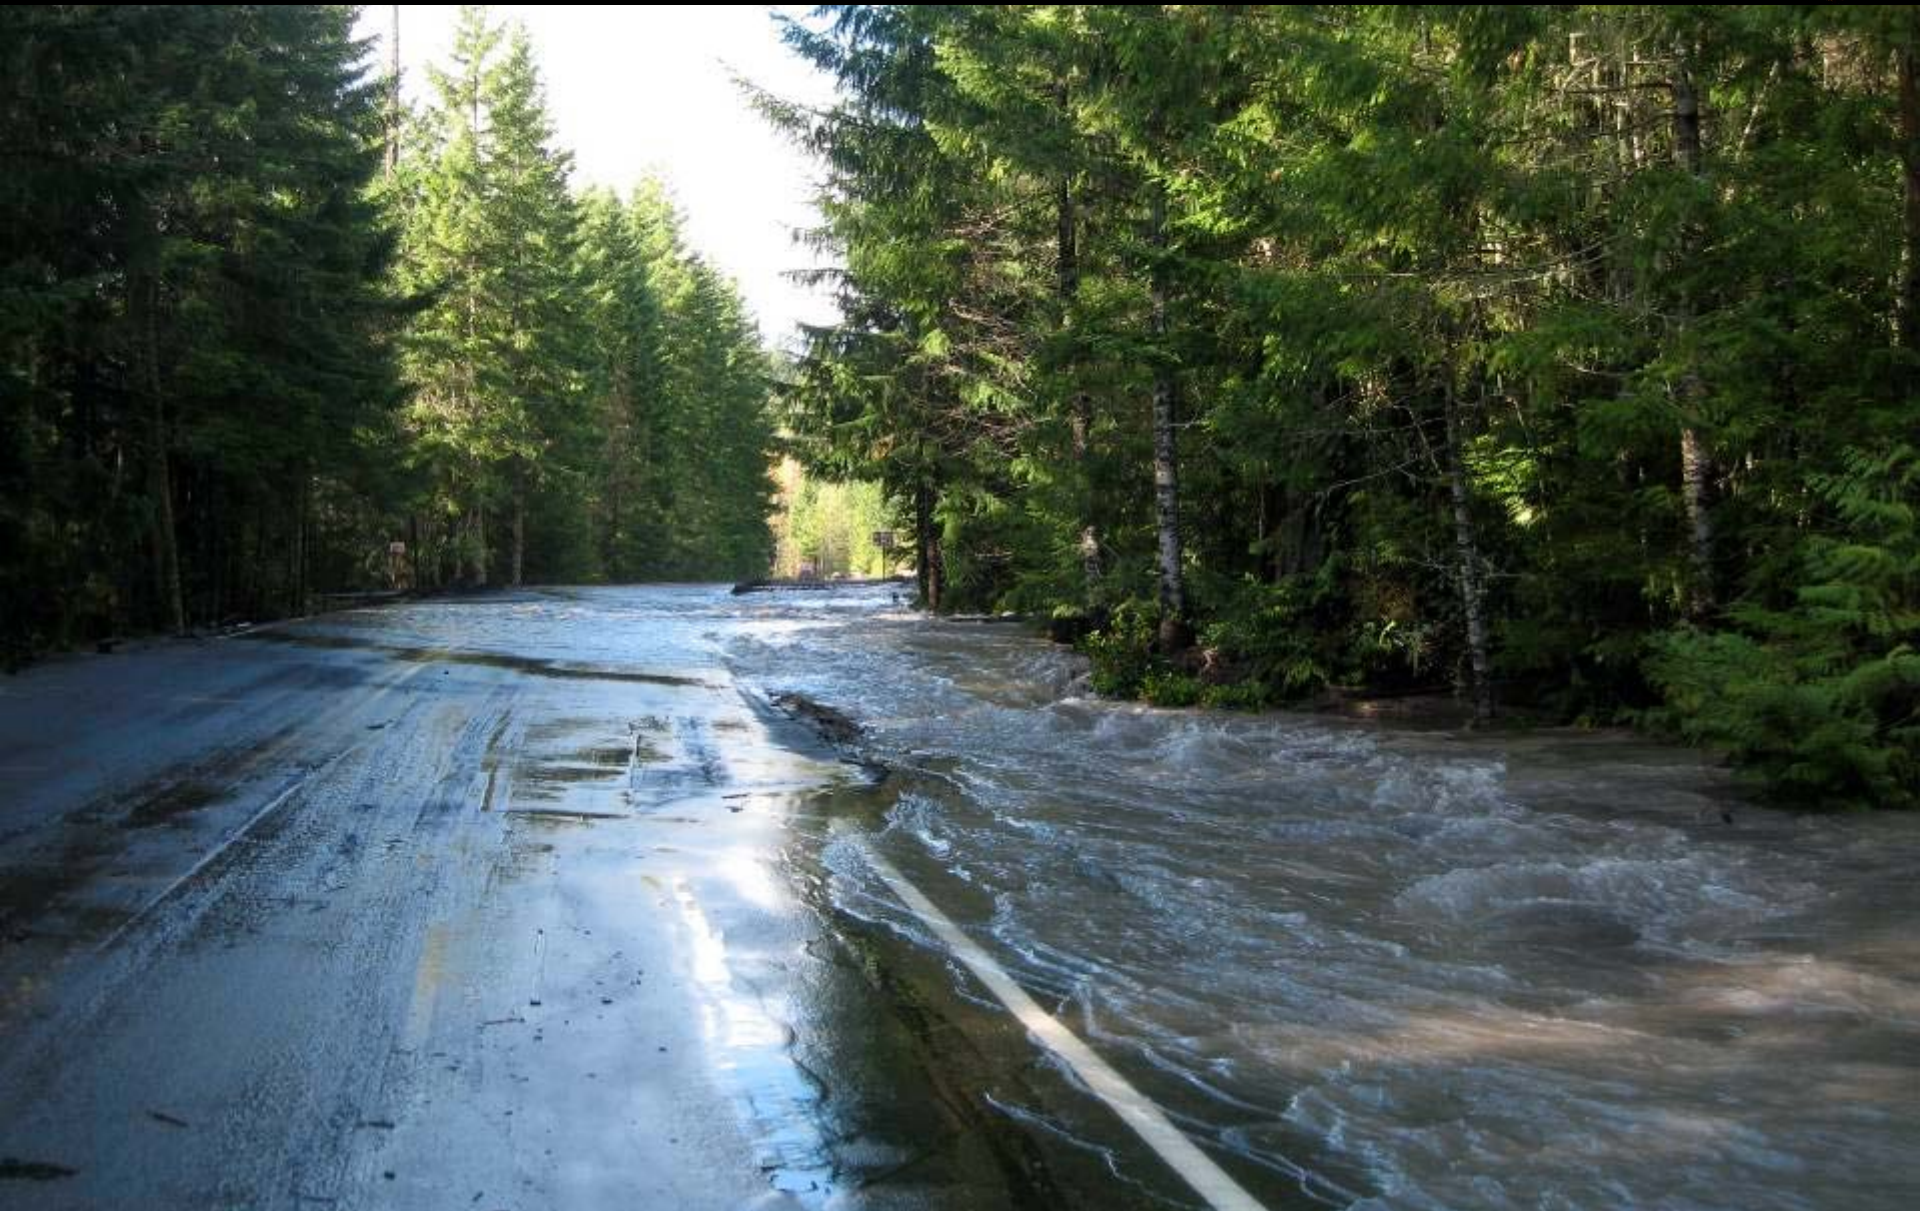
Kautz Creek continues to erode the edges of the Nisqually Road

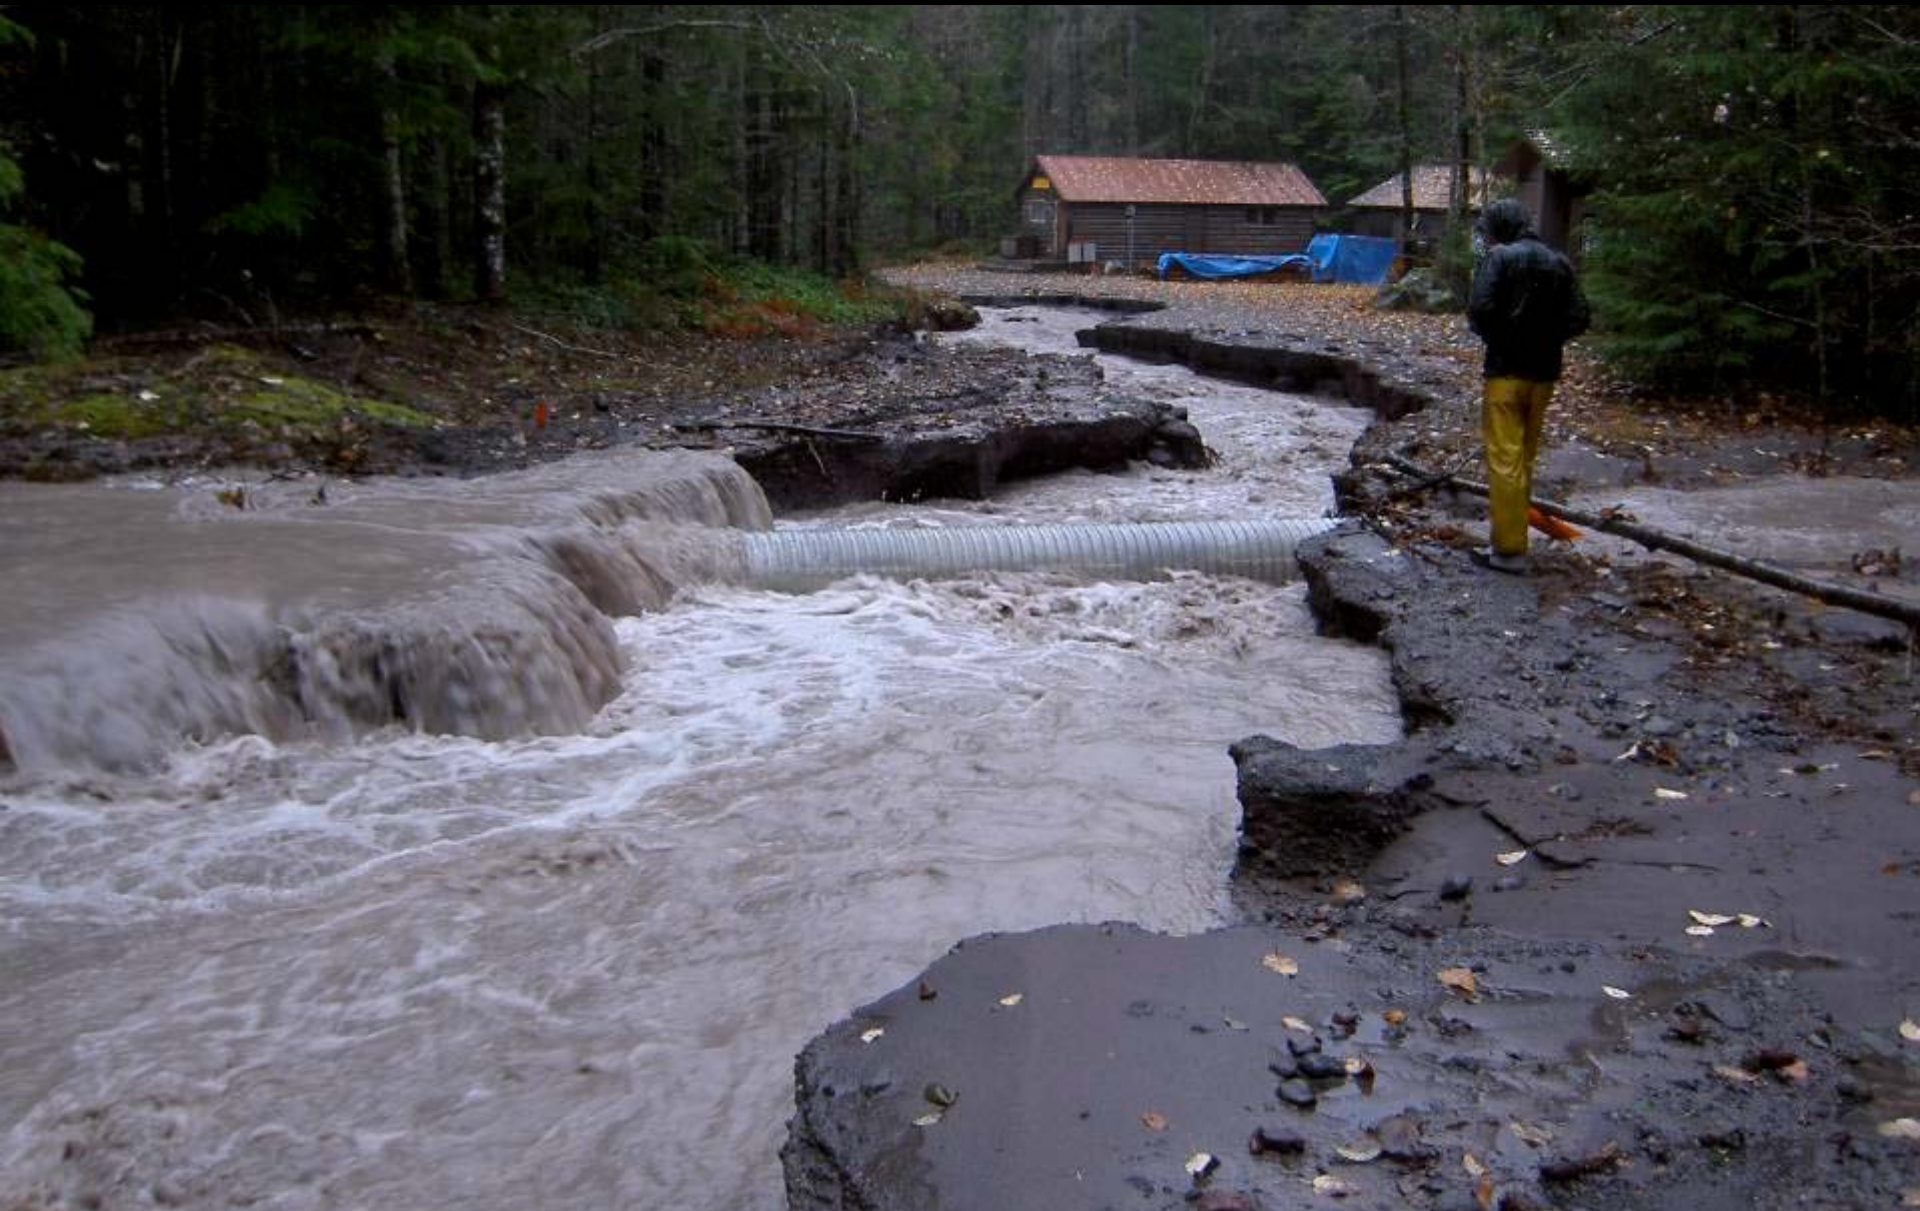
The new creek channel flows through the middle of the Kautz Helibase

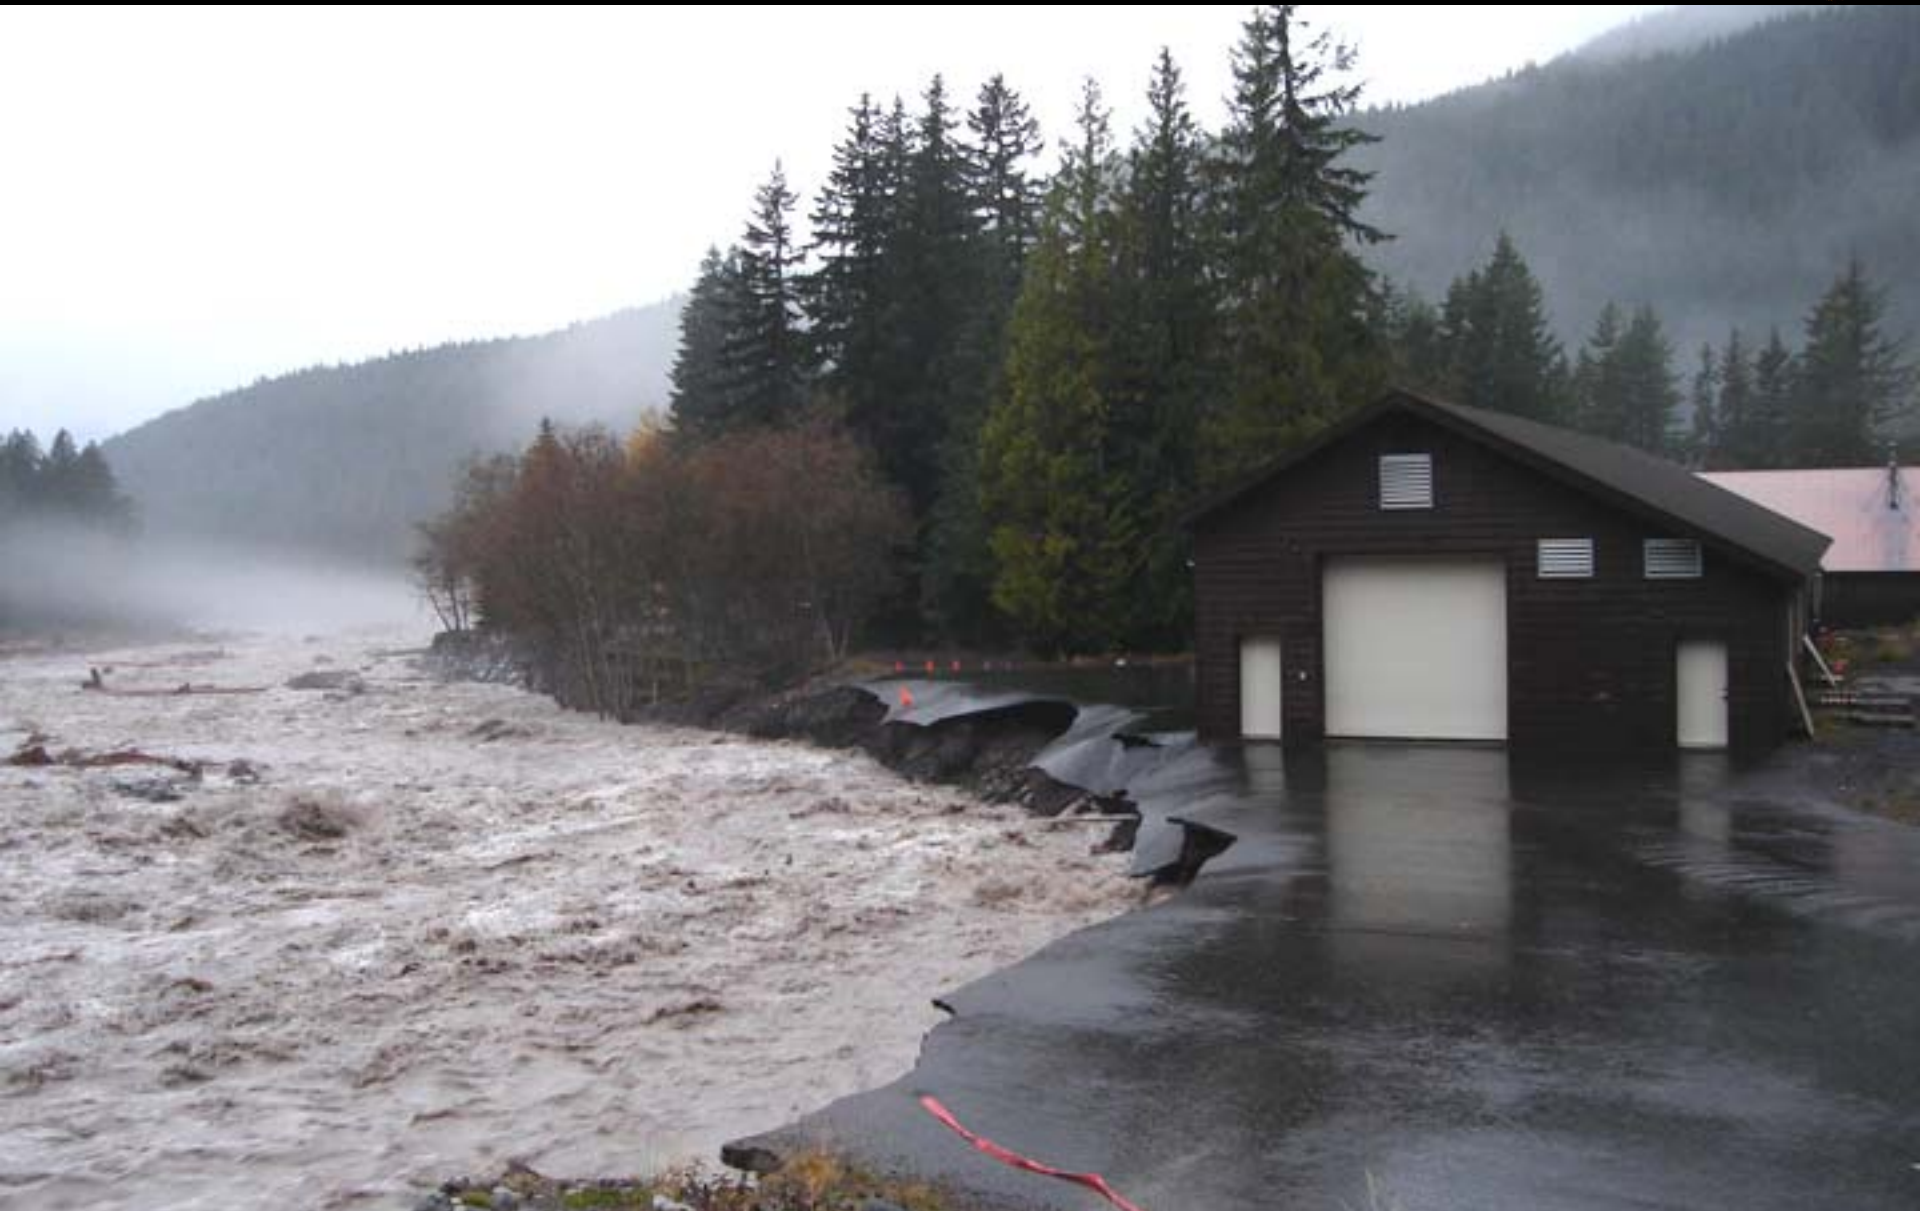
The Emergency Operations Center at Longmire, during the flood

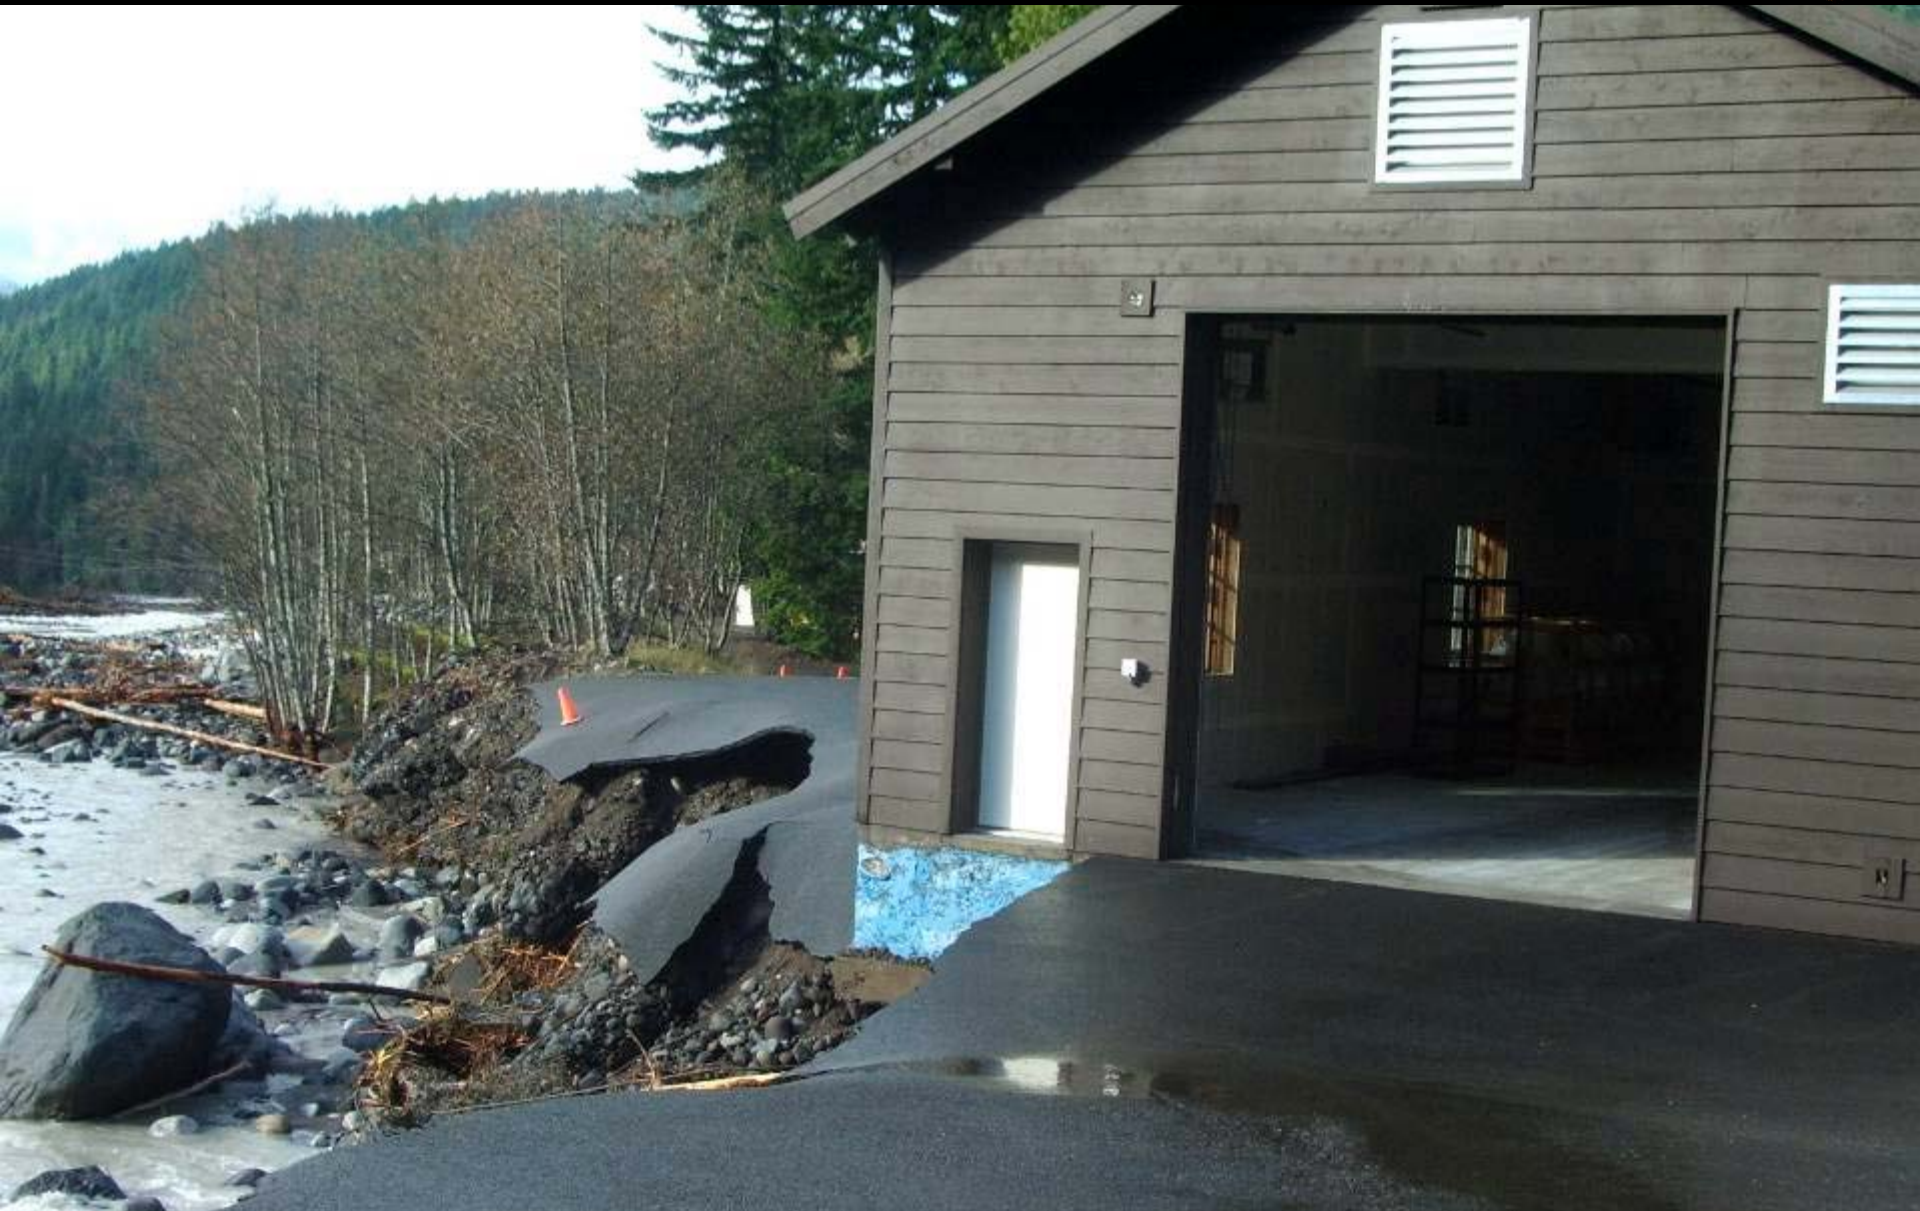
- Approximately 200 feet of primary sewer line were destroyed.
- A corner of the Emergency Operations Center was undercut by the river. Its parking lot was destroyed.
- The power lines across the river to the Community Building were knocked out.
- The access road to the Community Building and back gate was eroded down to one lane in several places.
- Excessive sediment collected in all system filters between Longmire and Paradise. The Edith Creek Basin water supply at Paradise was filled with rocks and dirt.

The Emergency Operations Center after the flood. The parking lot is destroyed.

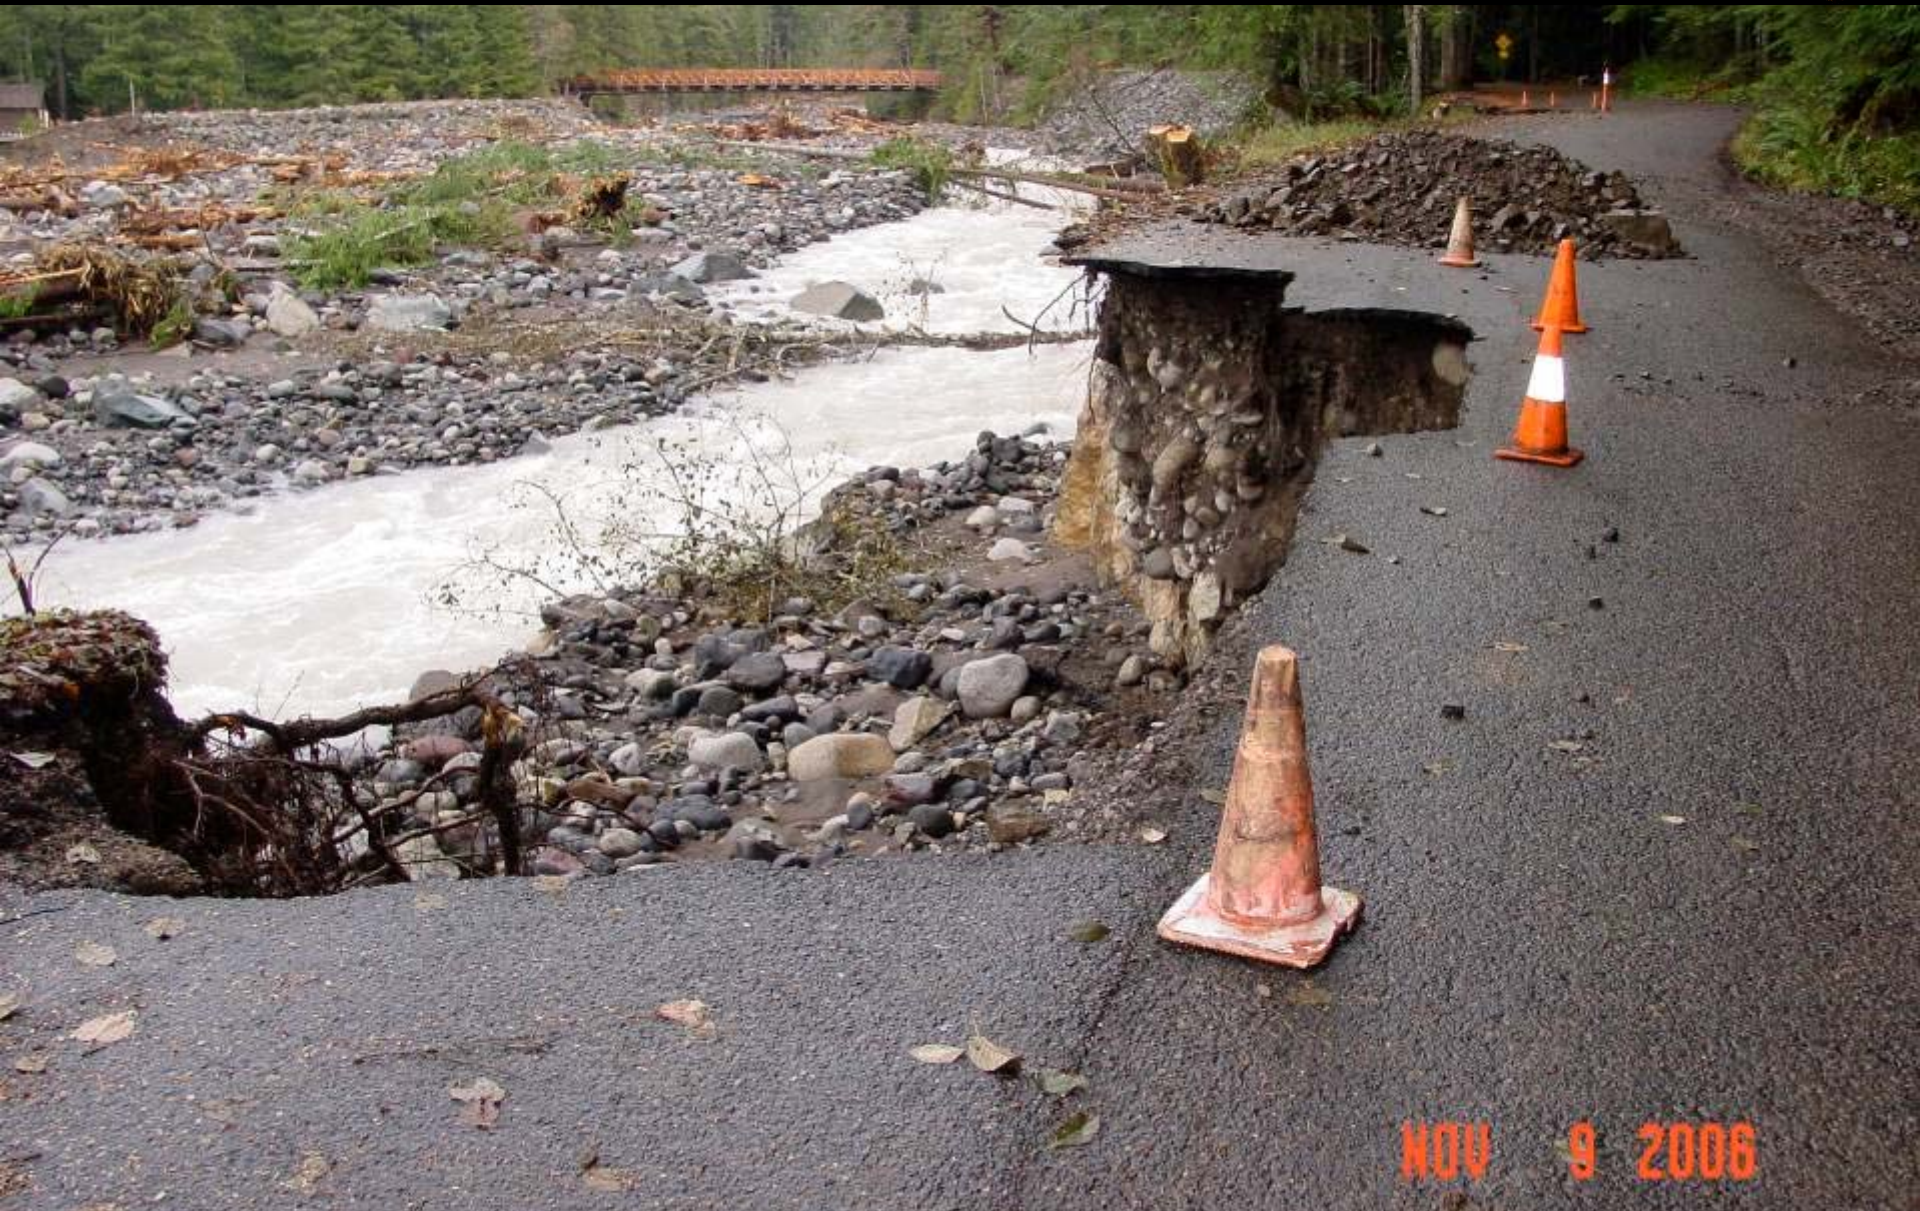
The road to the Community Building and back gate was washed out

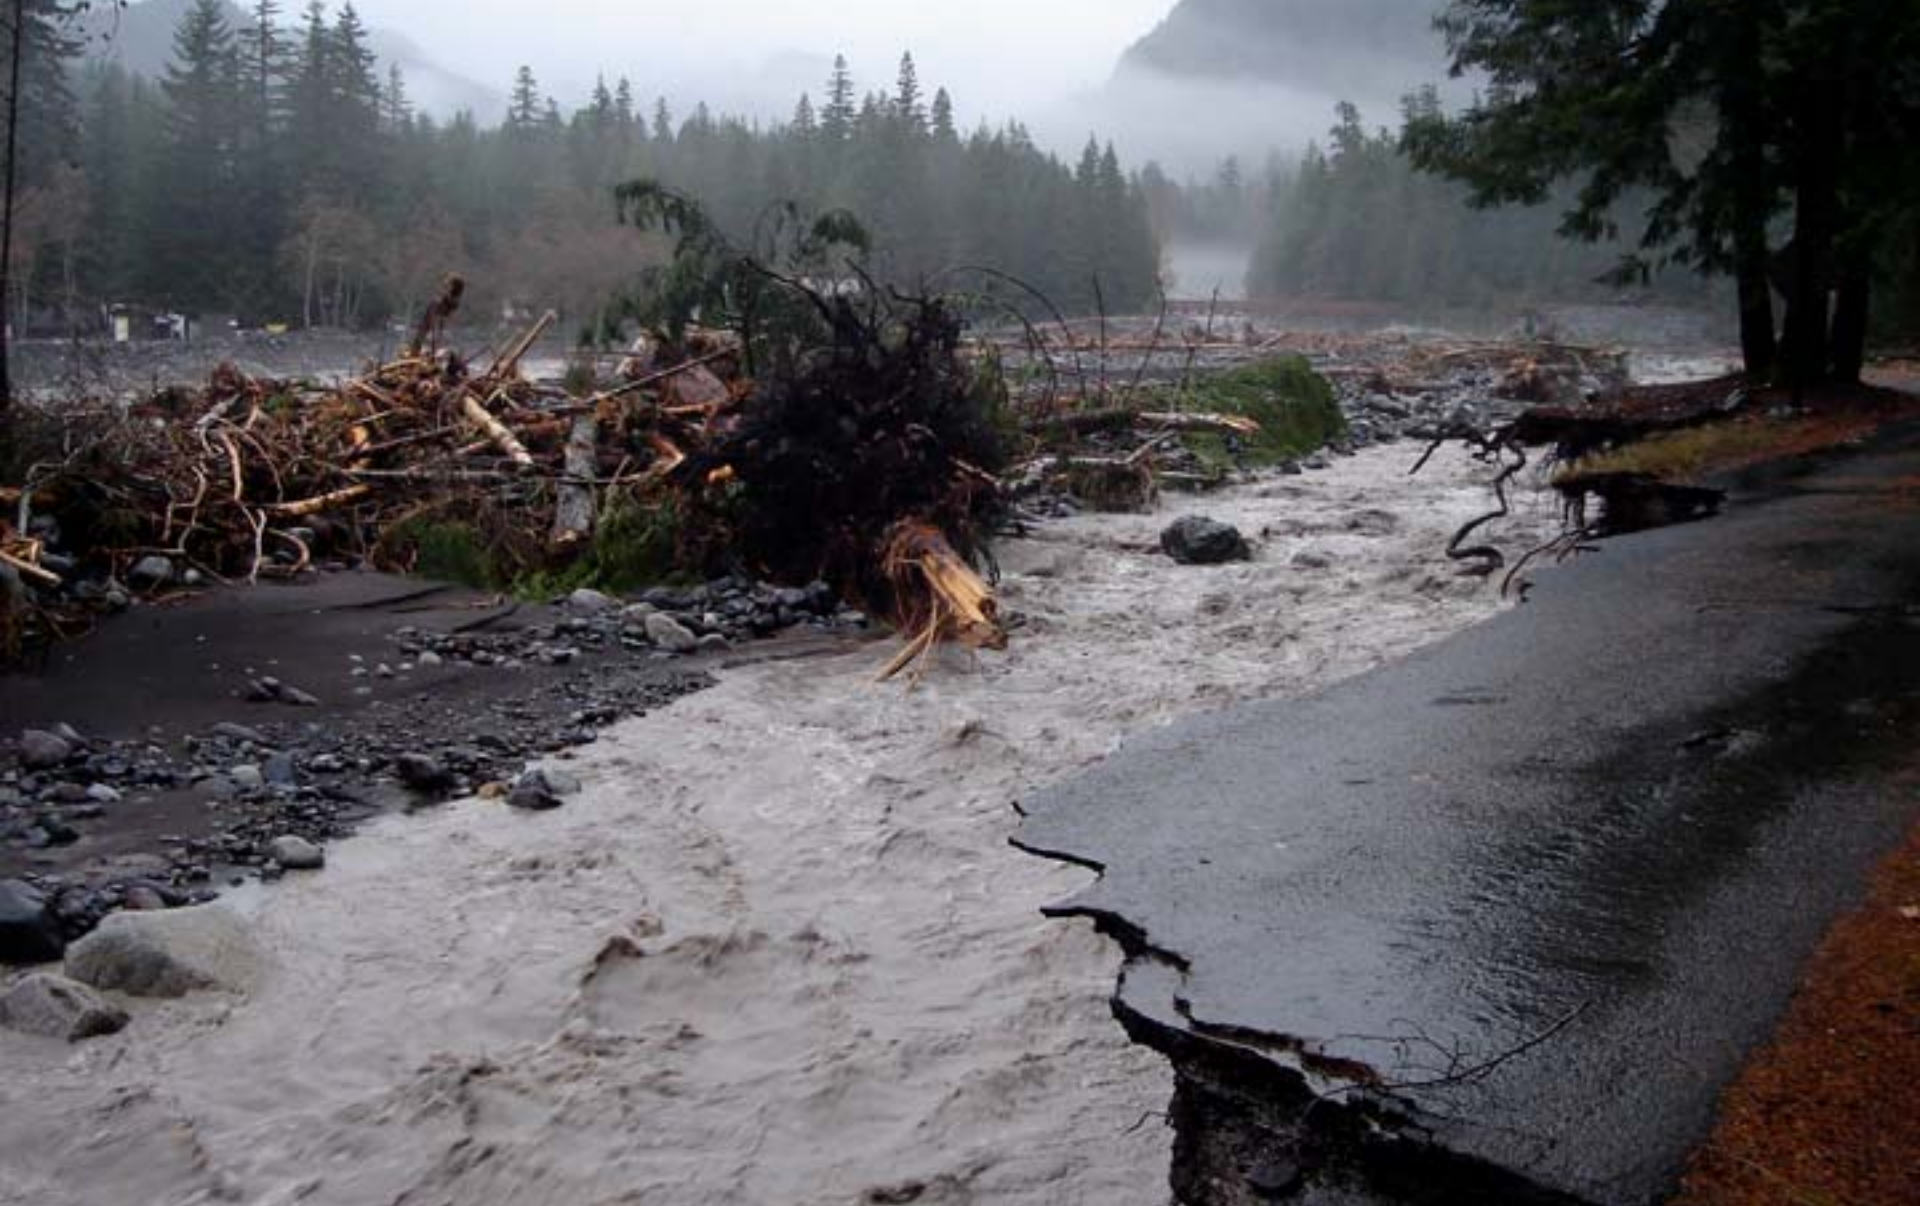
A new view, and reduced parking, in front of the Community Building

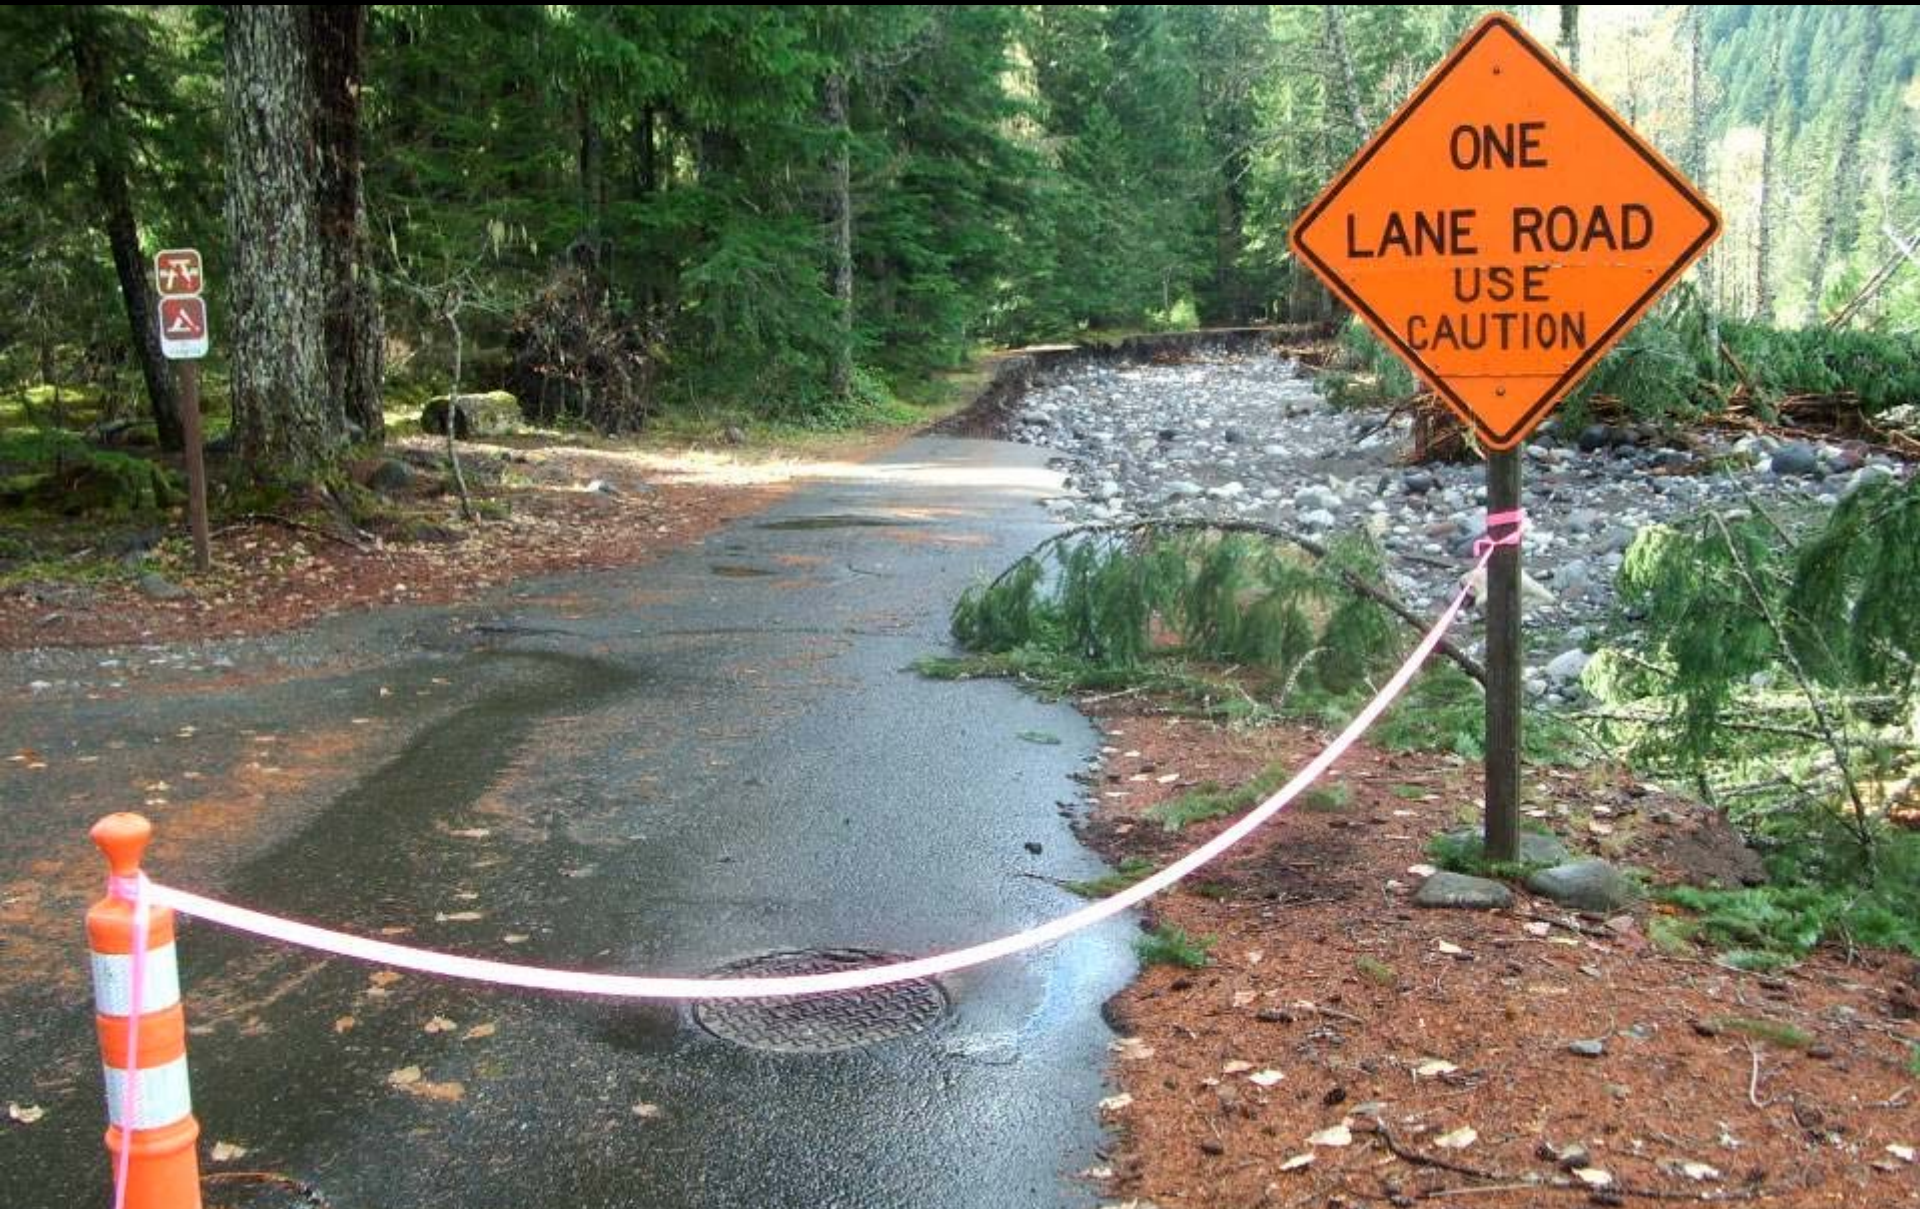
The road to the back gate is no longer one lane, but caution is still advised
