Mount Rainier National Park

November 2006 Flood Damage

On November 6 and 7, 2006, Mount Rainier National Park received 18 inches of rain in 36 hours. This presentation summarizes the extensive flood damage that occurred throughout the park.

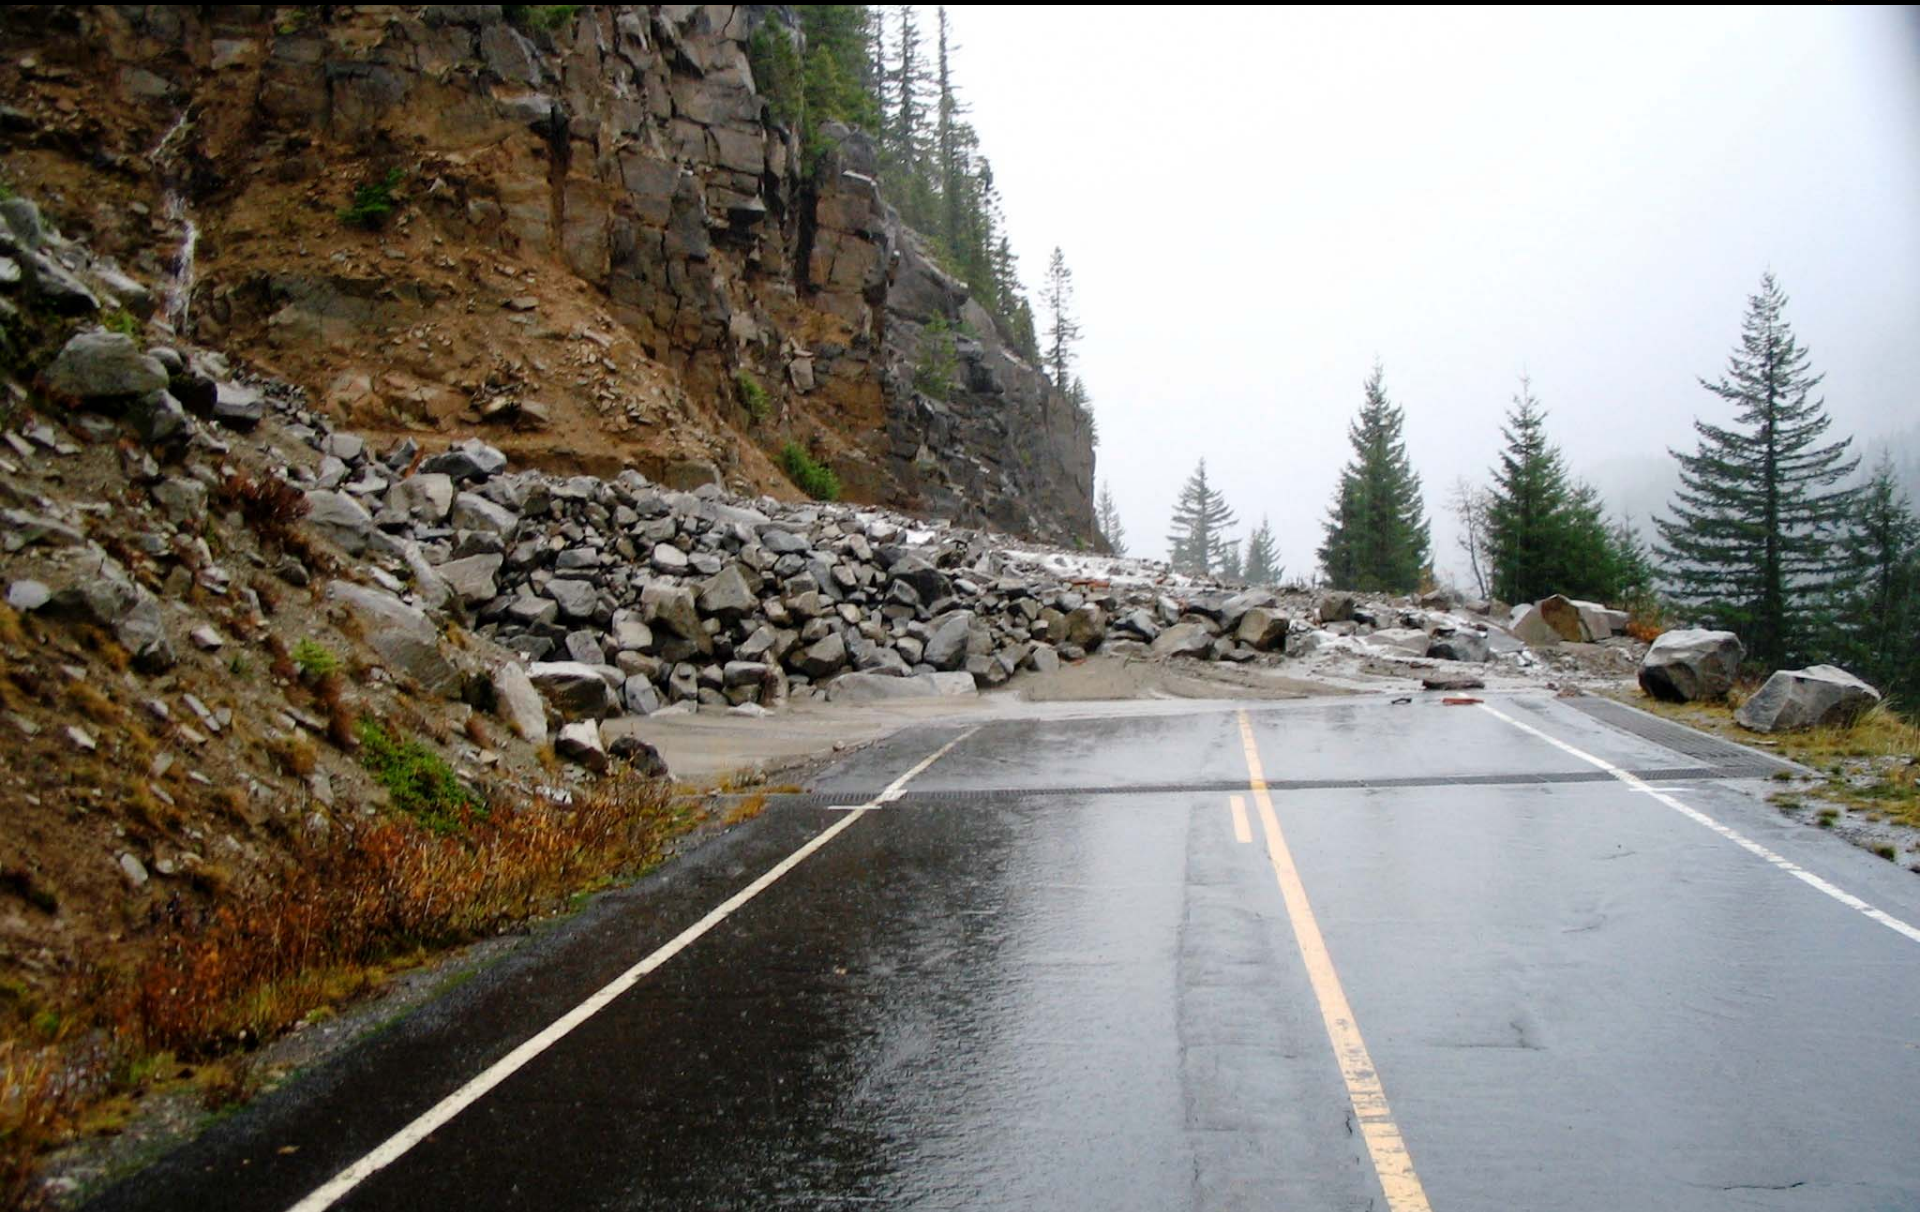
Landslide above Glacier Bridge on the Paradise Road

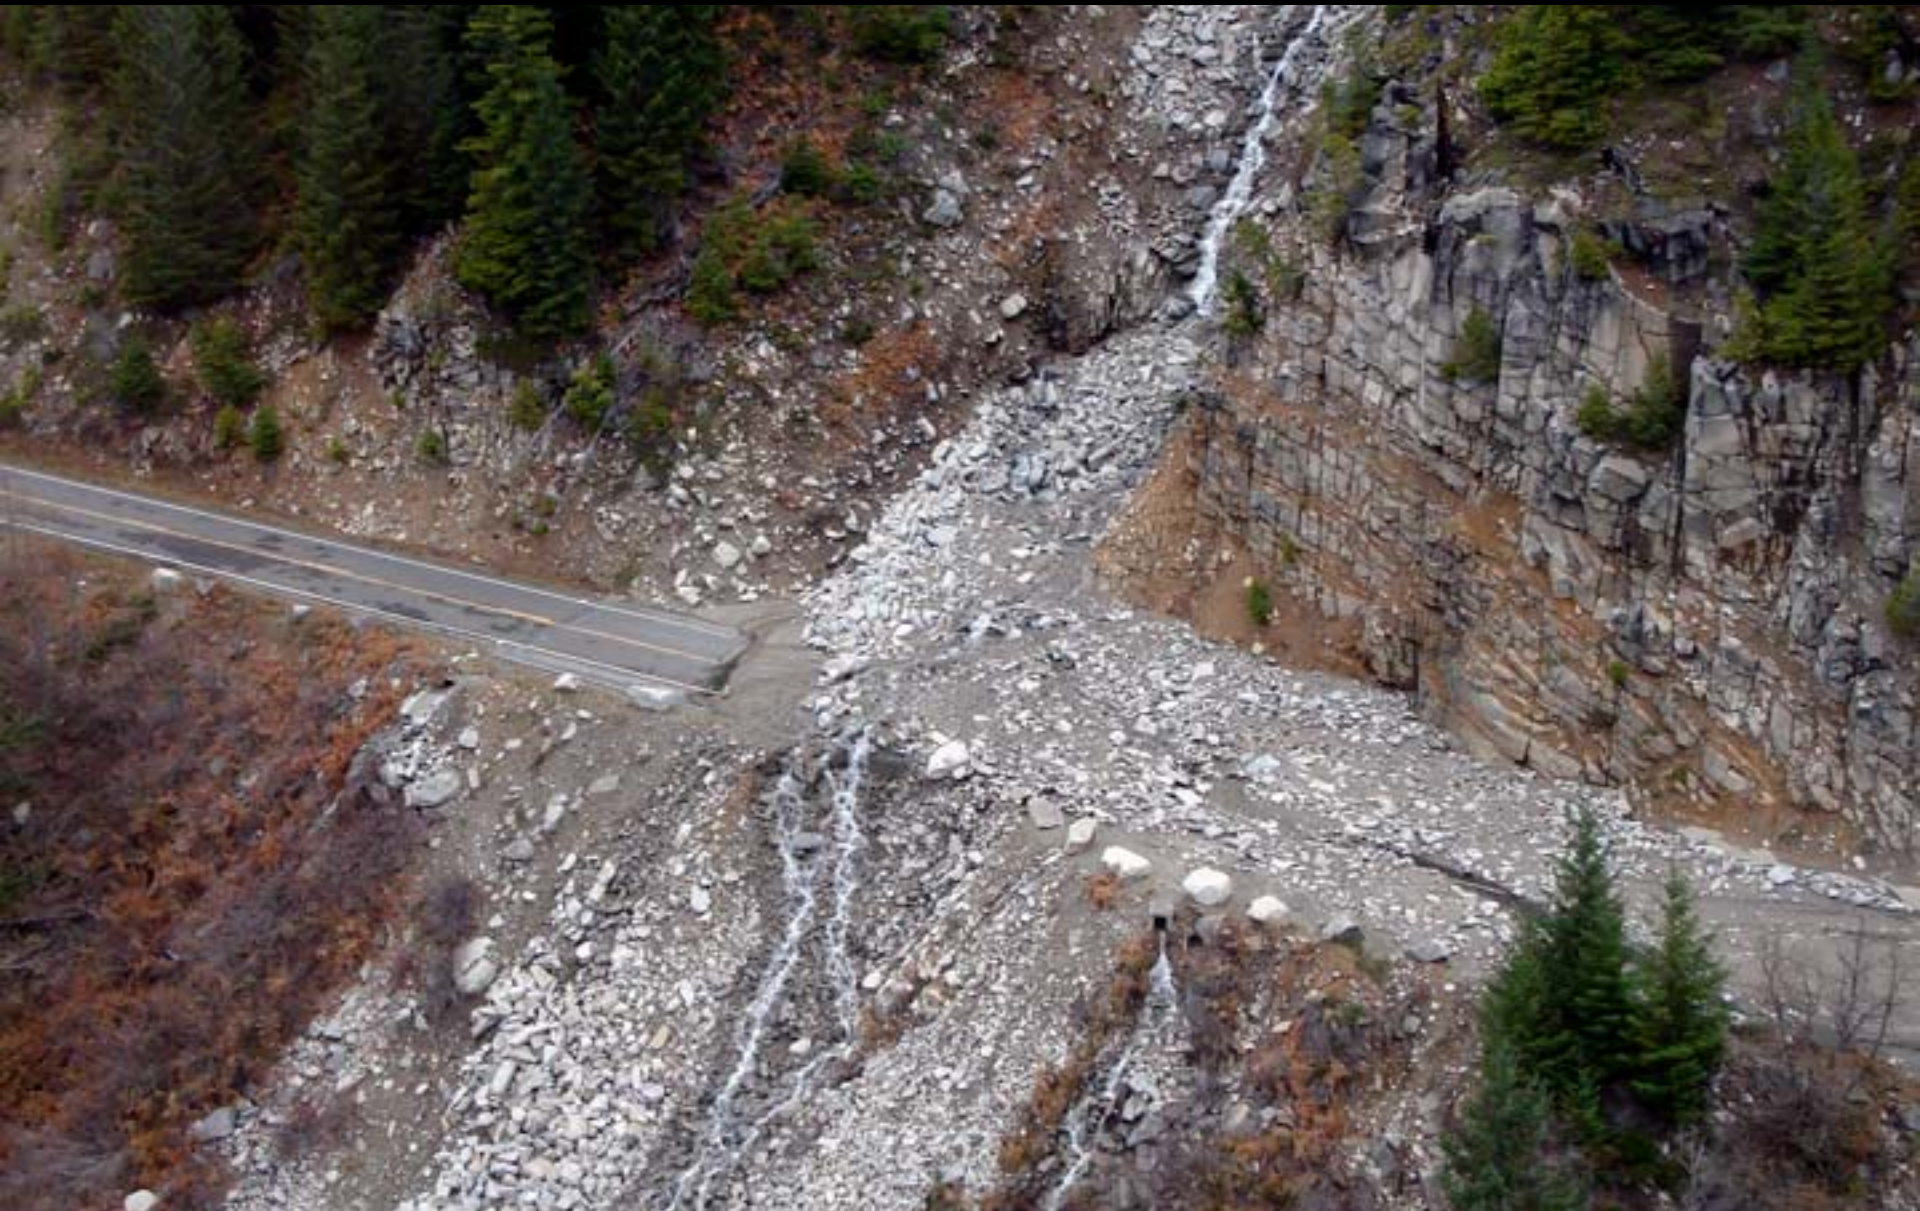
- Major slides blocked the road at mileposts 5.5 and 7.
- A large slide above the Ohanapecosh Campground damaged the Stevens Canyon Road above it in two places.

Landslide below Stevens Ridge in Stevens Canyon

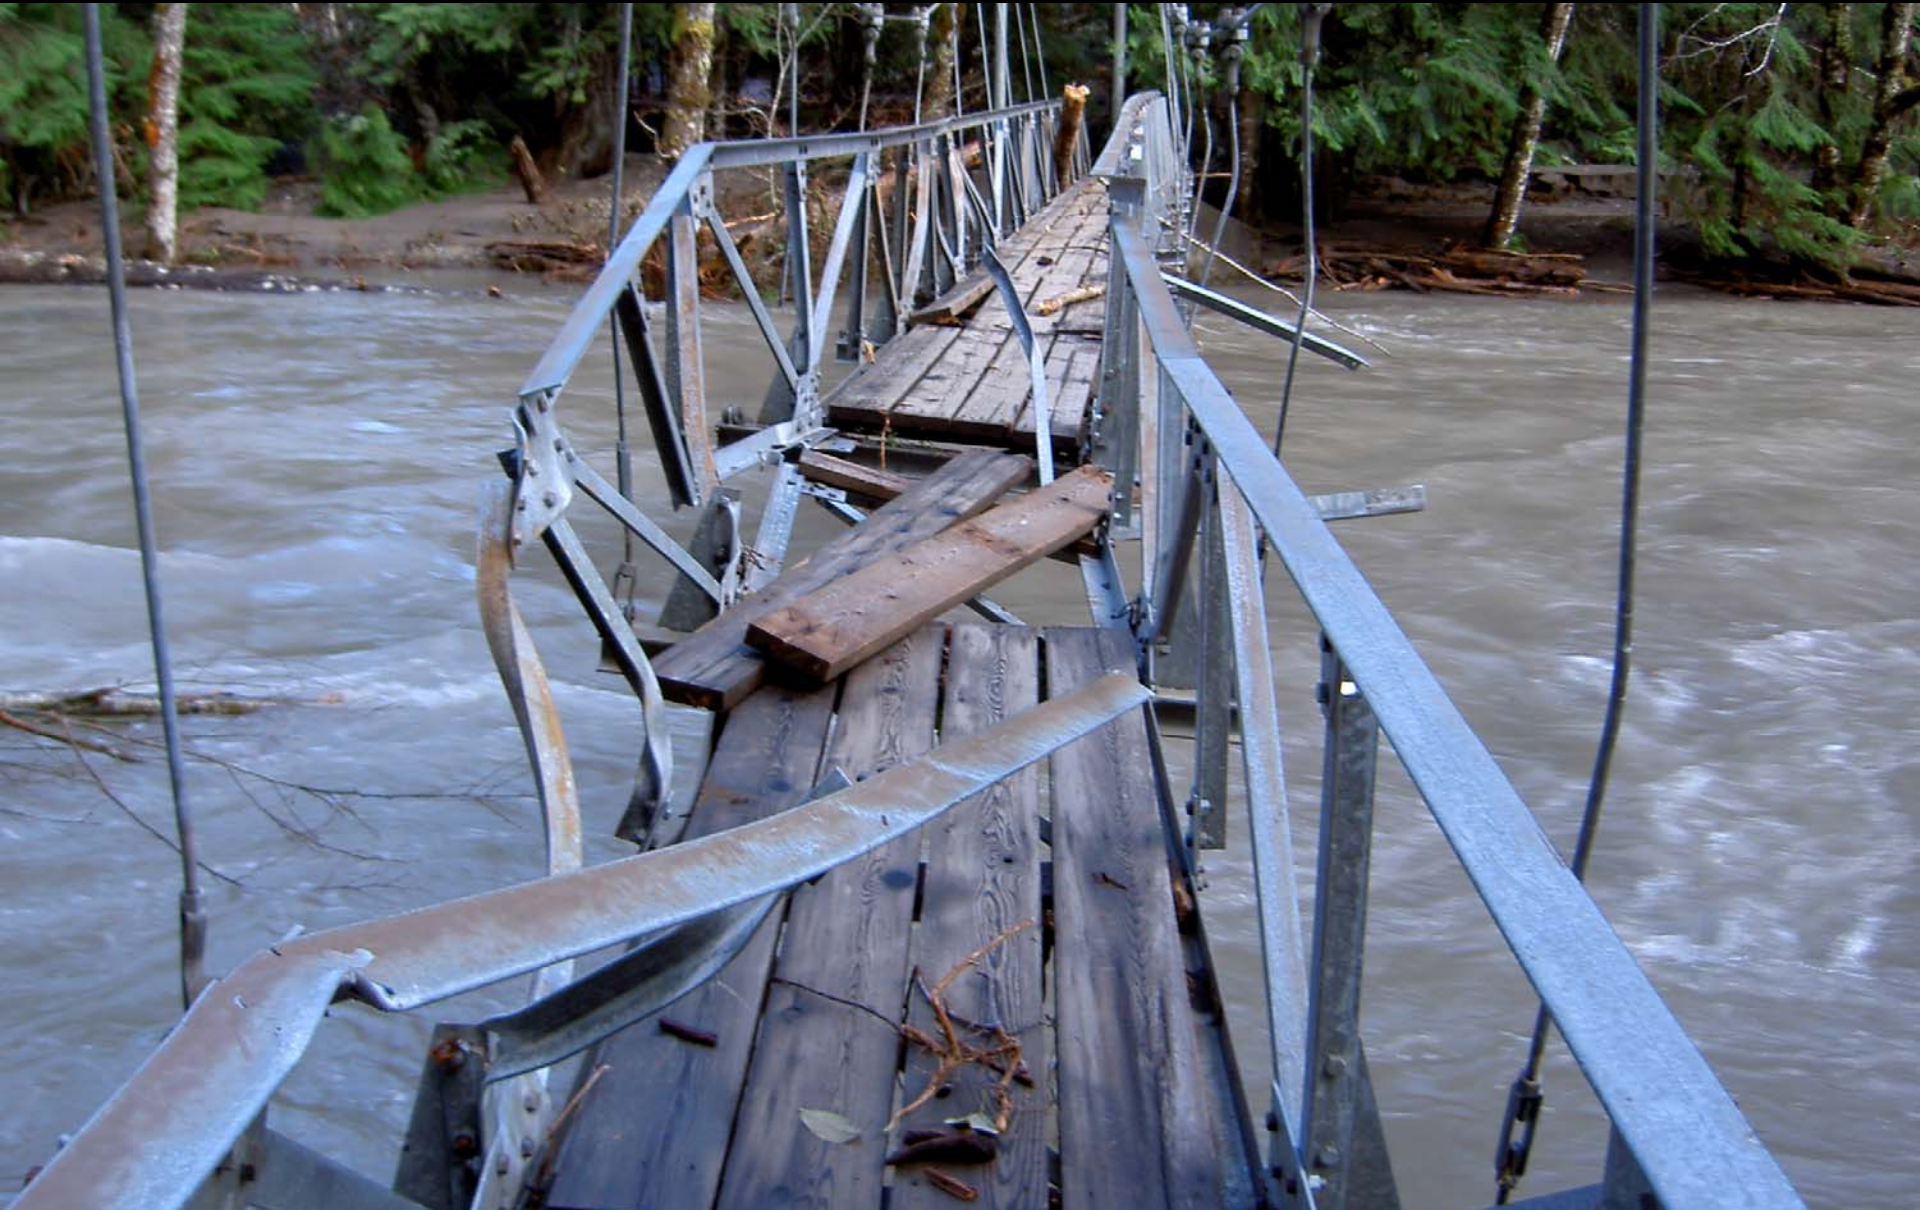
- The suspension bridge accessing the Grove was heavily damaged.
- The Grove itself was buried in a thick layer of mud.
- The boardwalk trail was displaced and damaged in numerous places.

The damaged suspension bridge

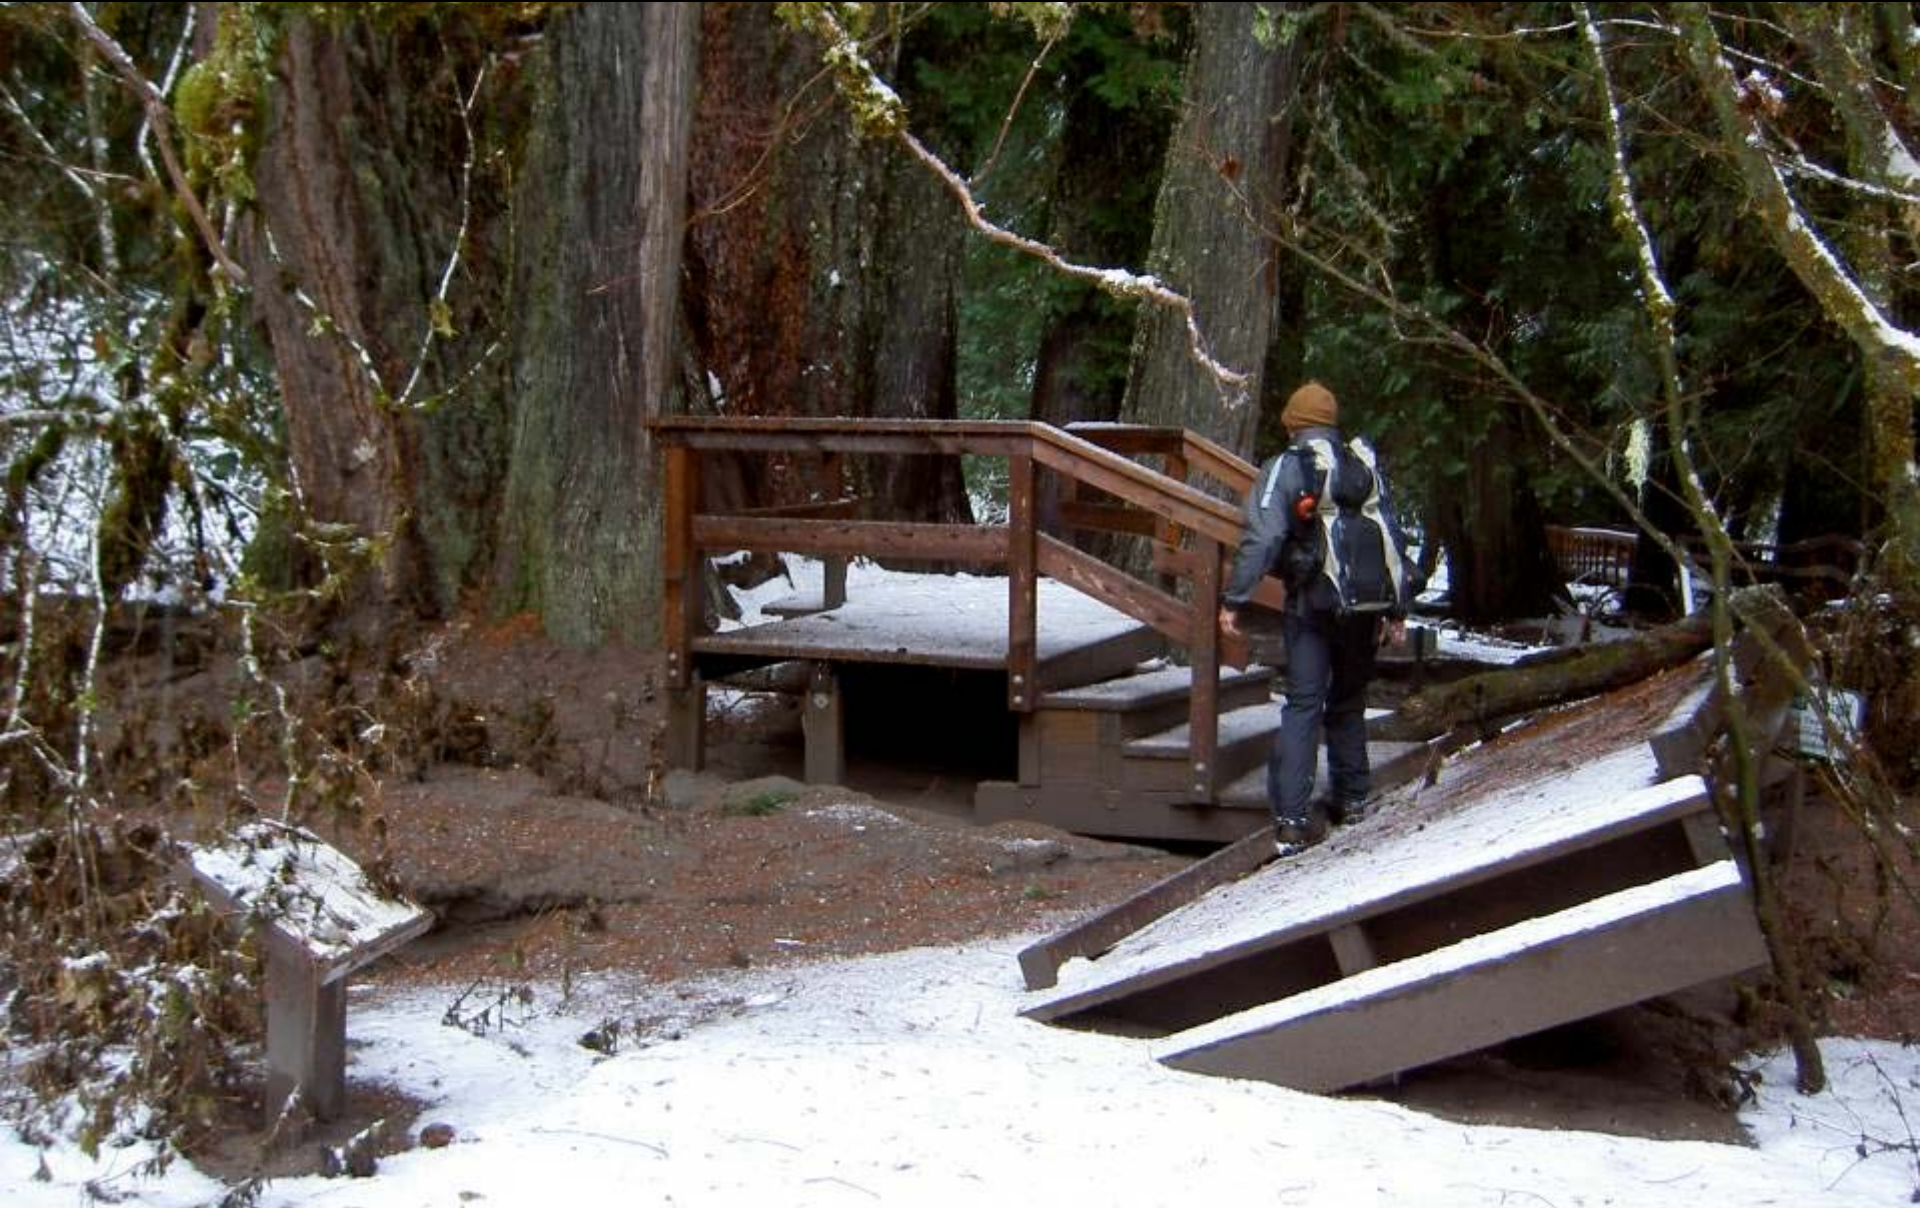
The boardwalk trails have been haphazardly realigned

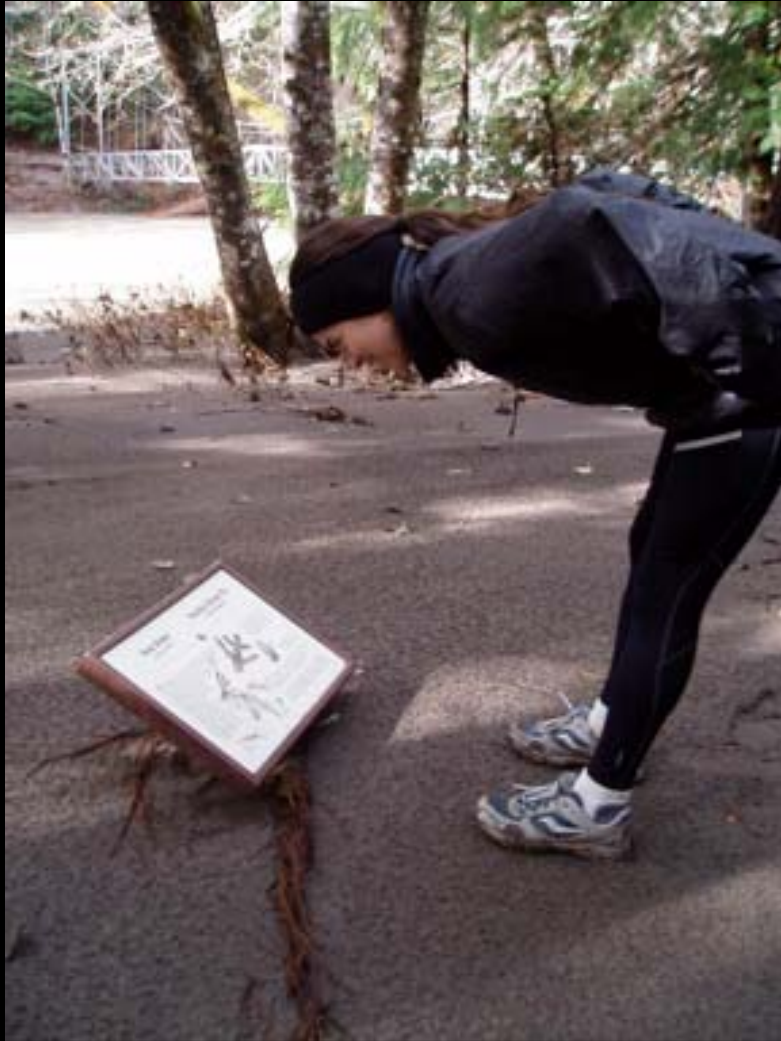
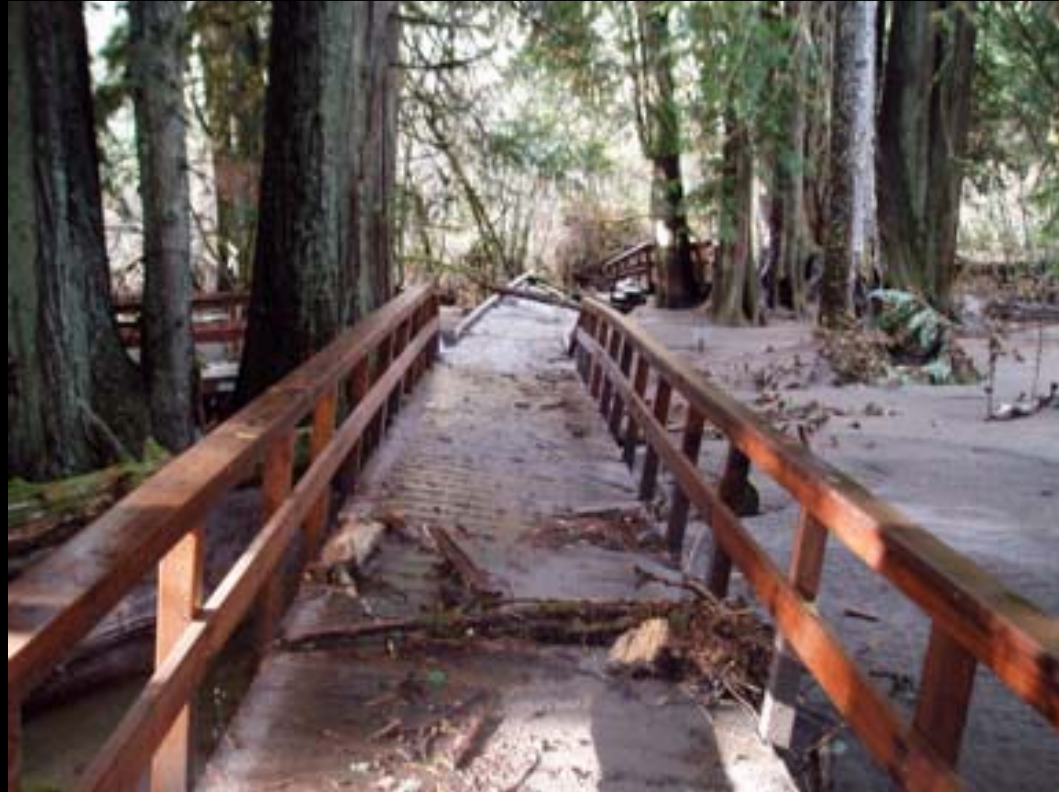
The grove was blanketed in three feet of mud

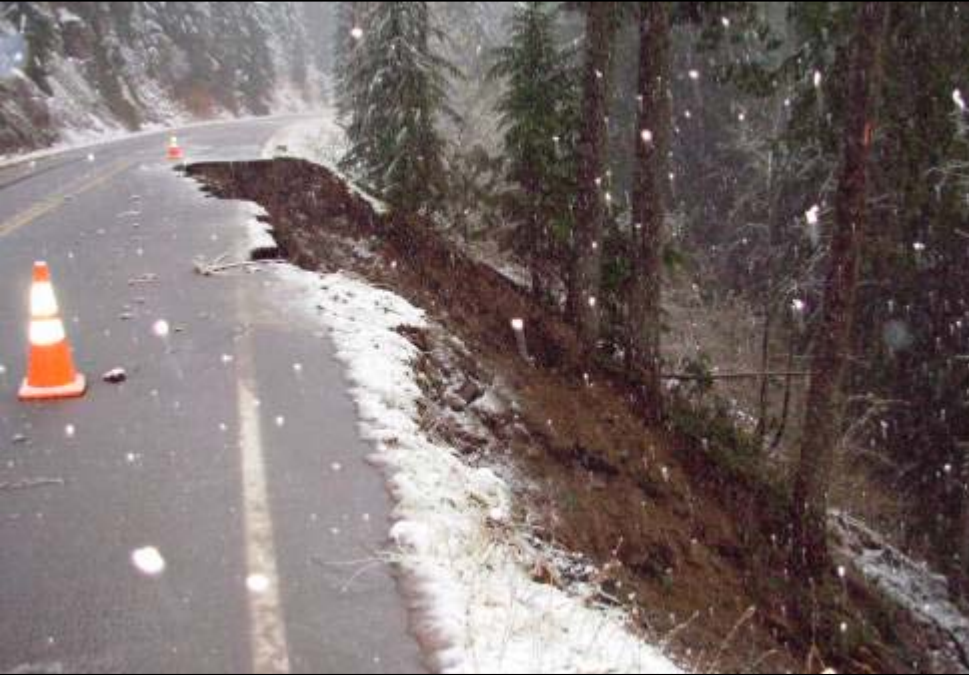
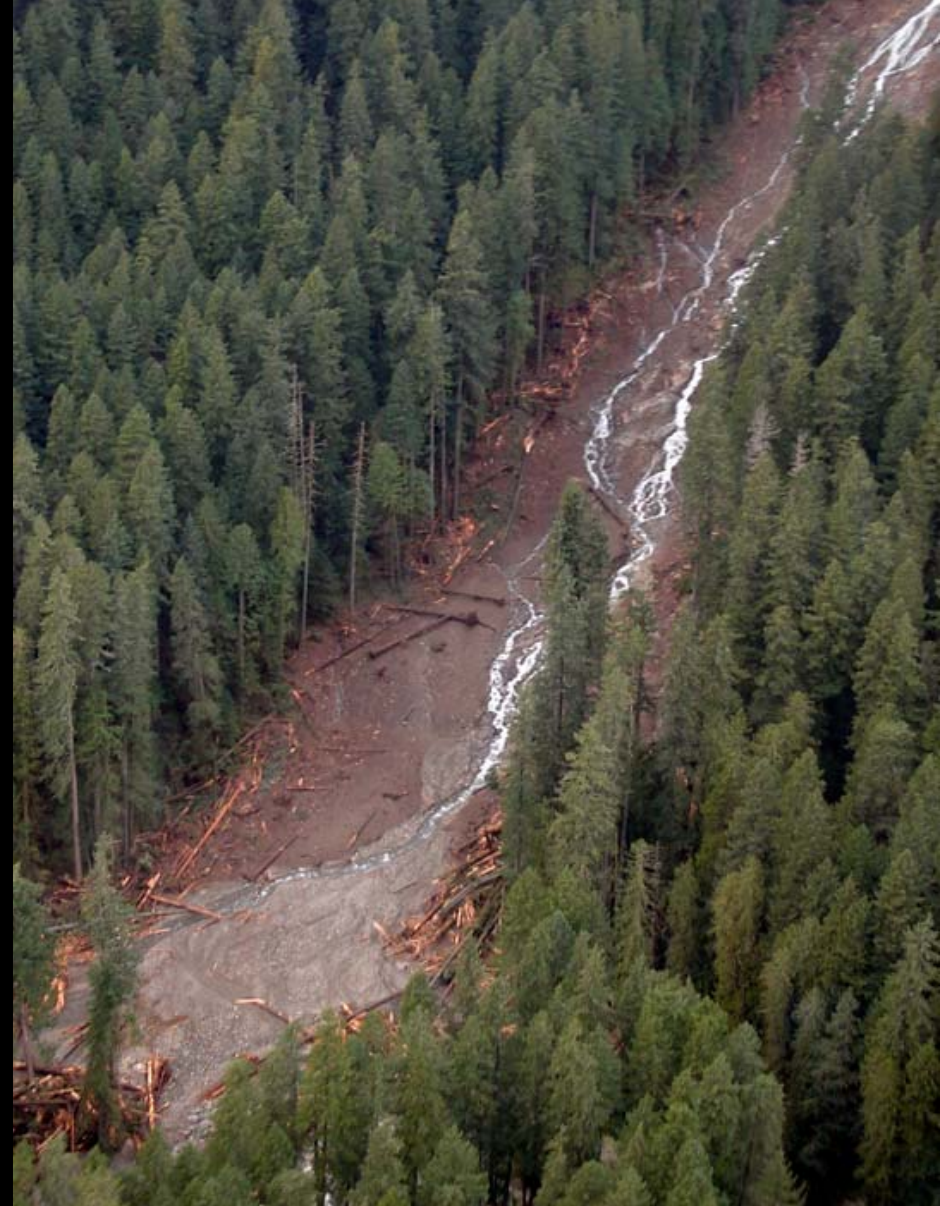
- A 5,000 foot long landslide below Stevens Canyon Road is visible across the river from C loop. Debris created a major logjam downstream.
- Erosion and falling trees destroyed several campsites and damaged the road in C loop.
- The Ohanapecosh Visitor Center sustained water damage from minor flooding.

The landslide stretches 5,000 feet between Stevens Canyon Road and the river

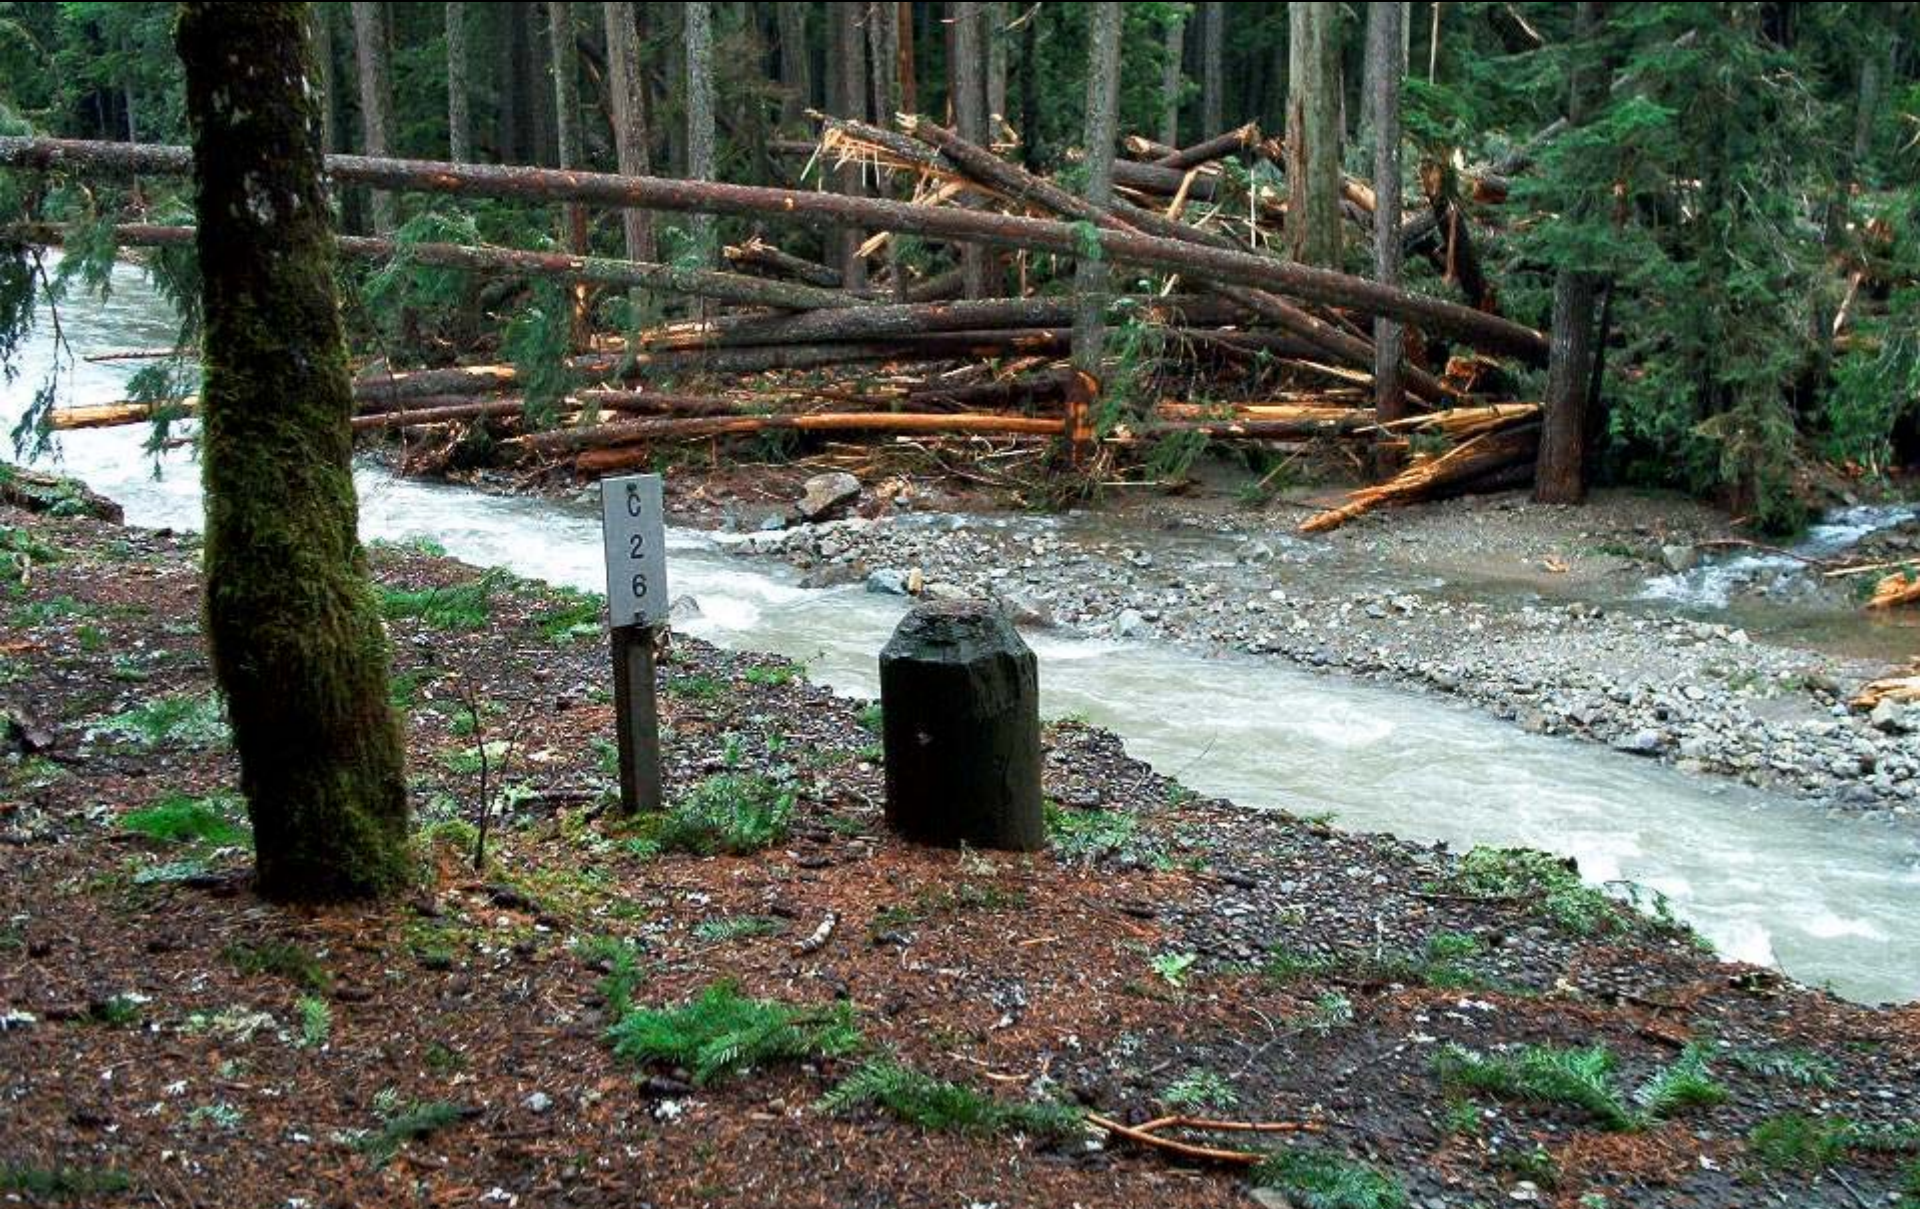
The walk-in campsites behind this marker were washed away

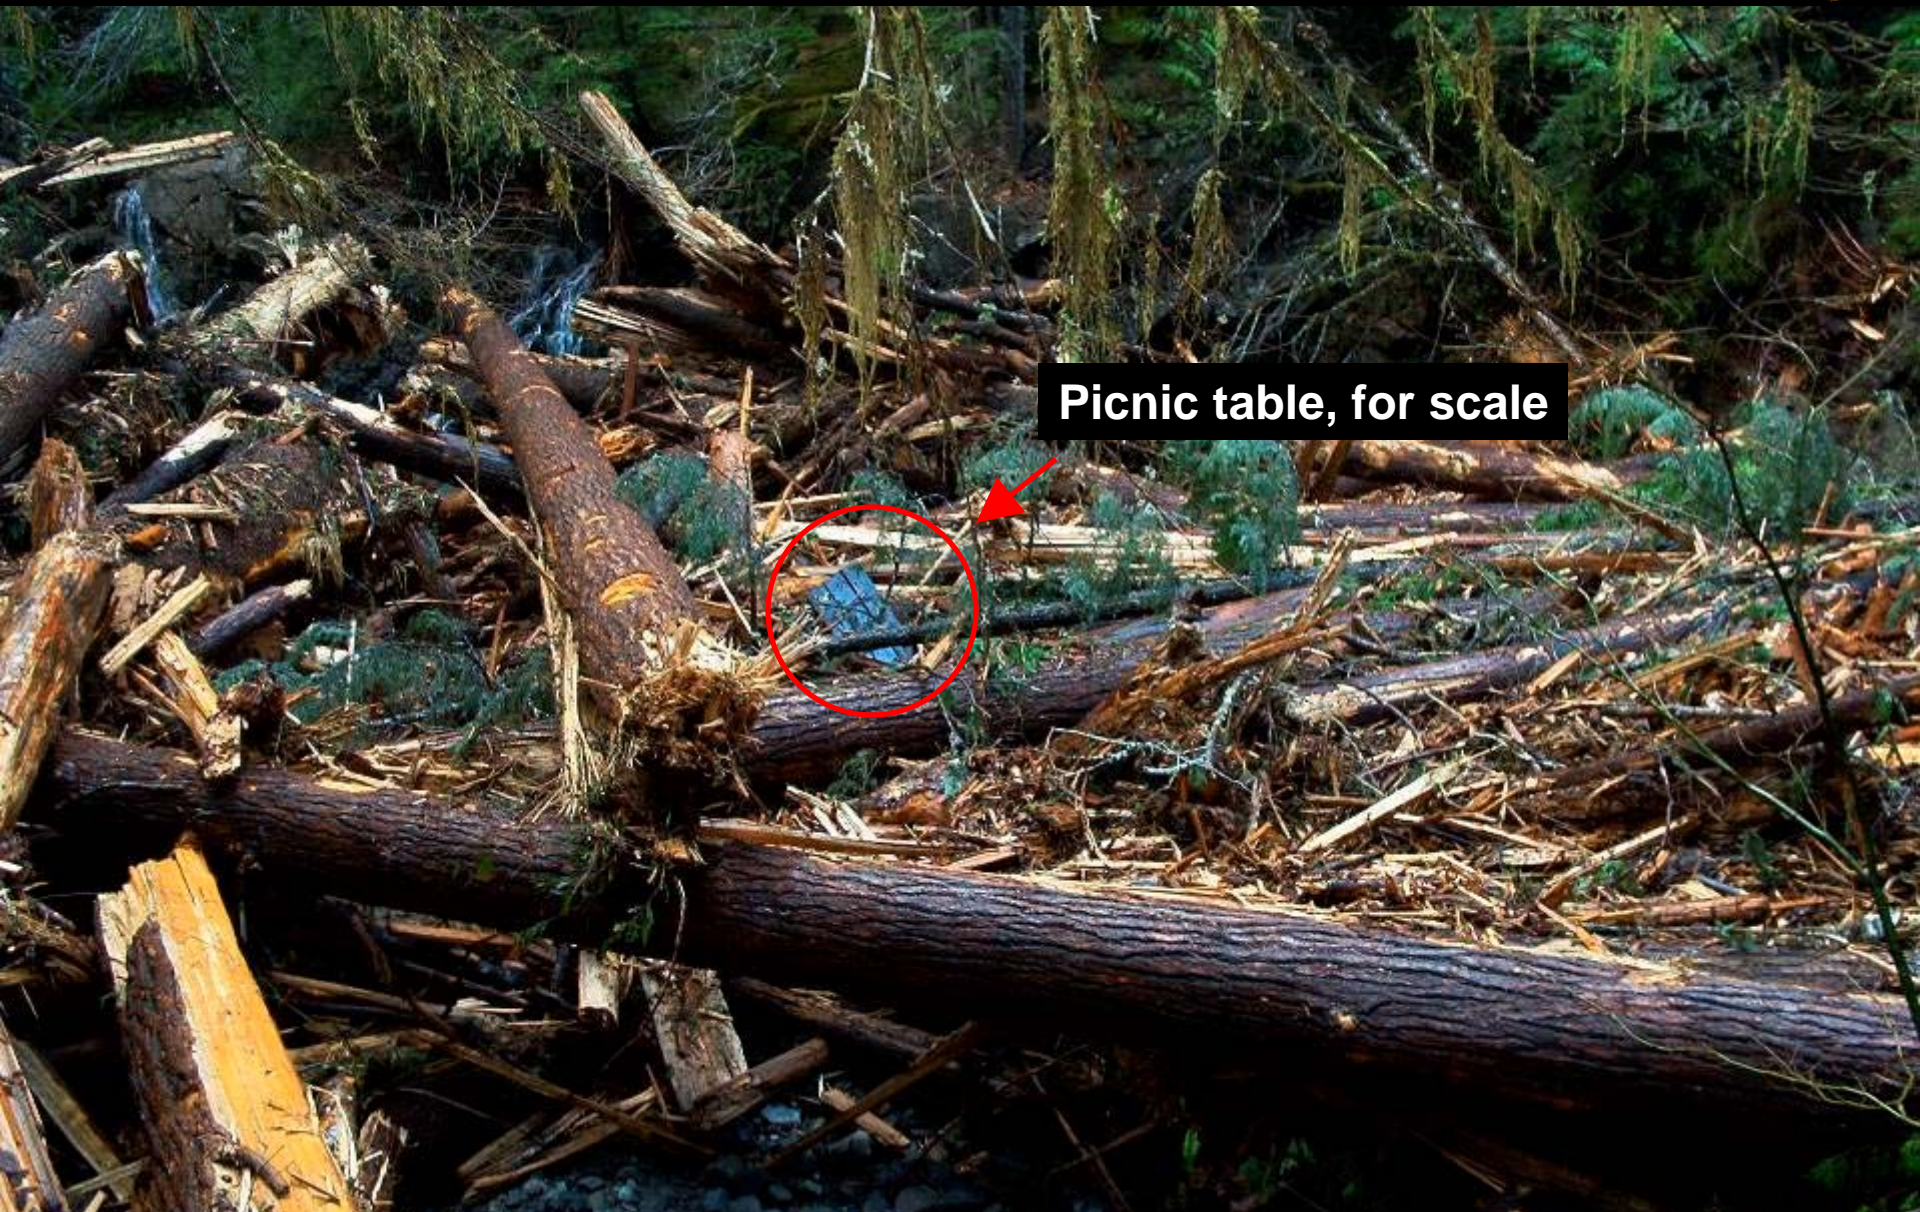
An enormous logjam formed below the Ohanapecosh Campground

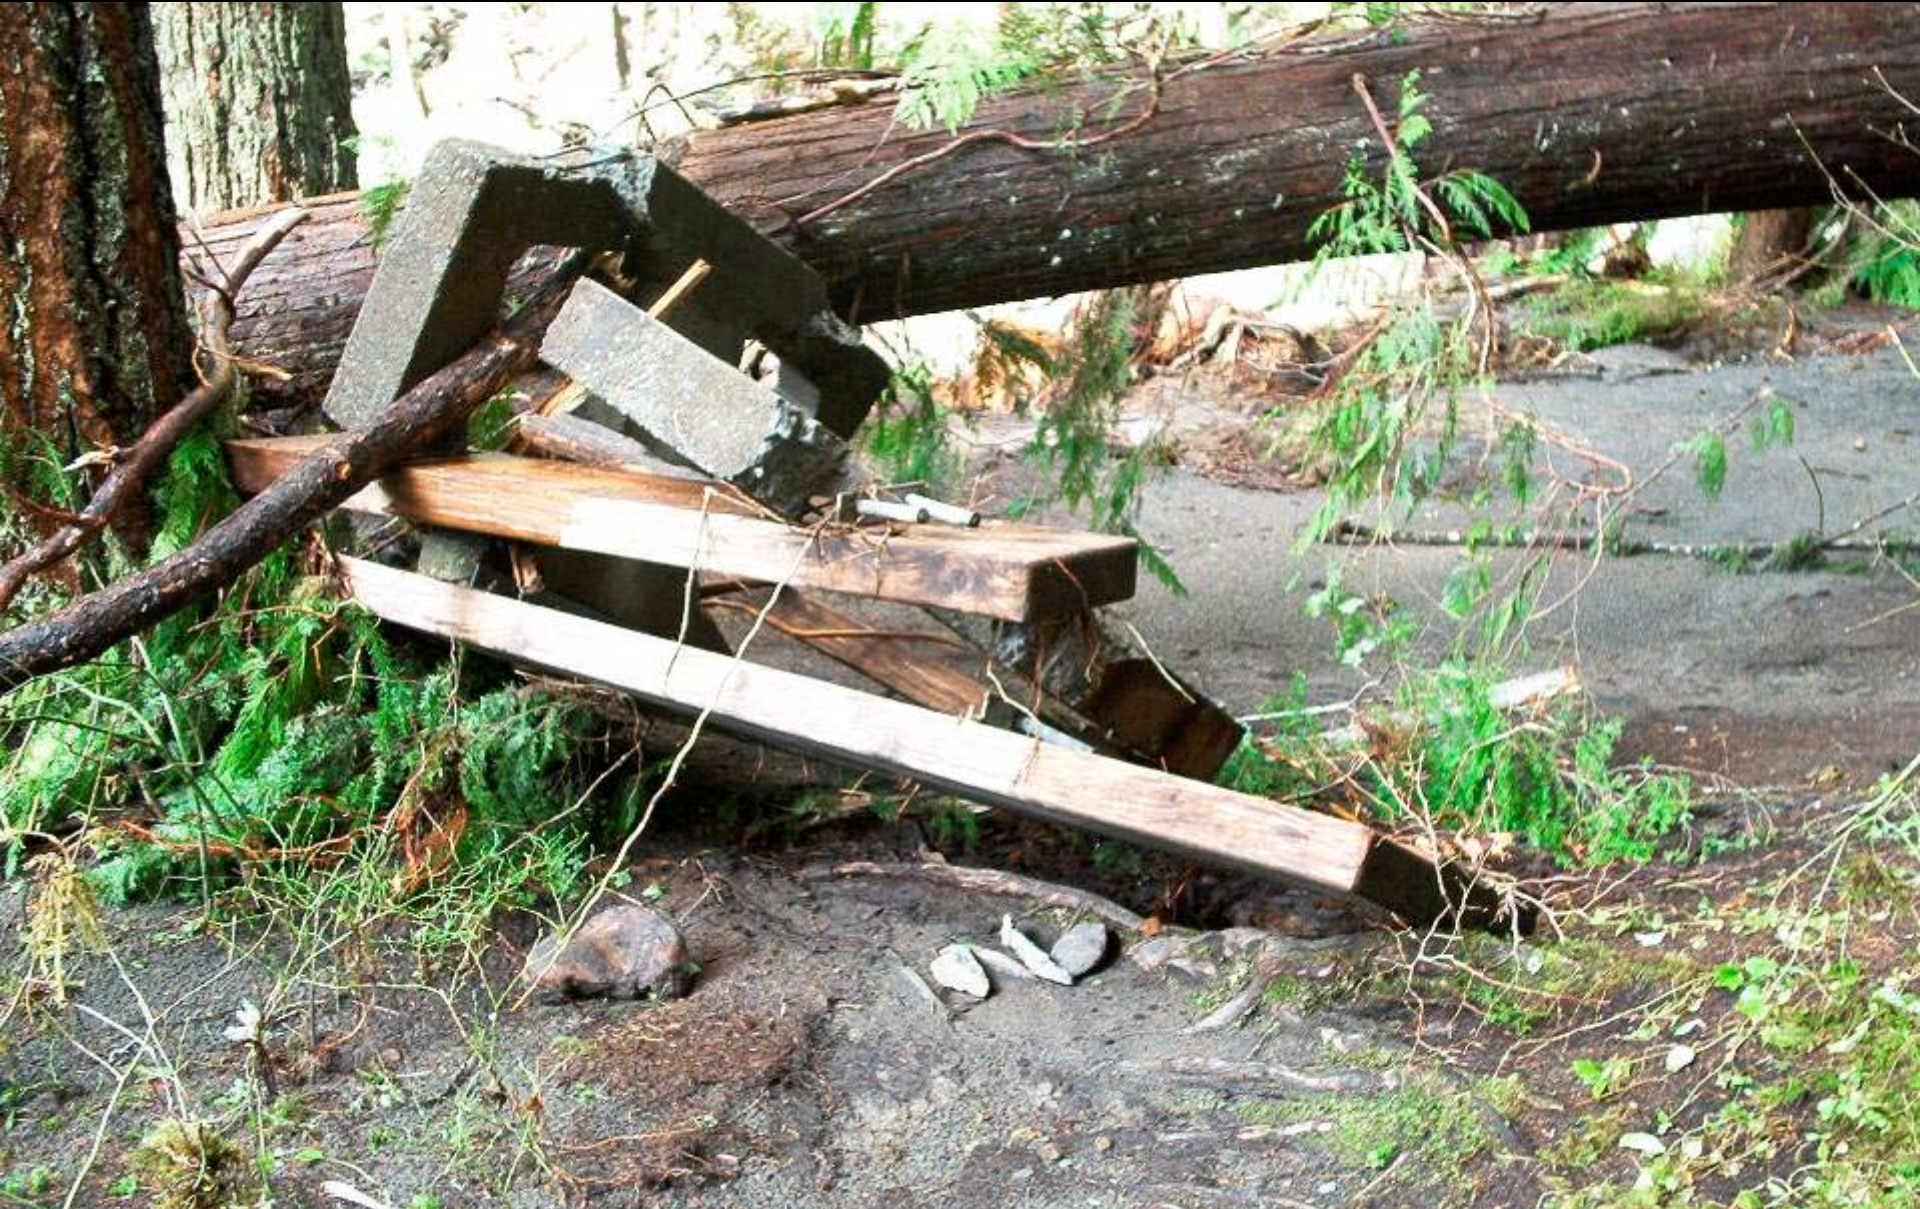
Destroyed picnic table at site C-18

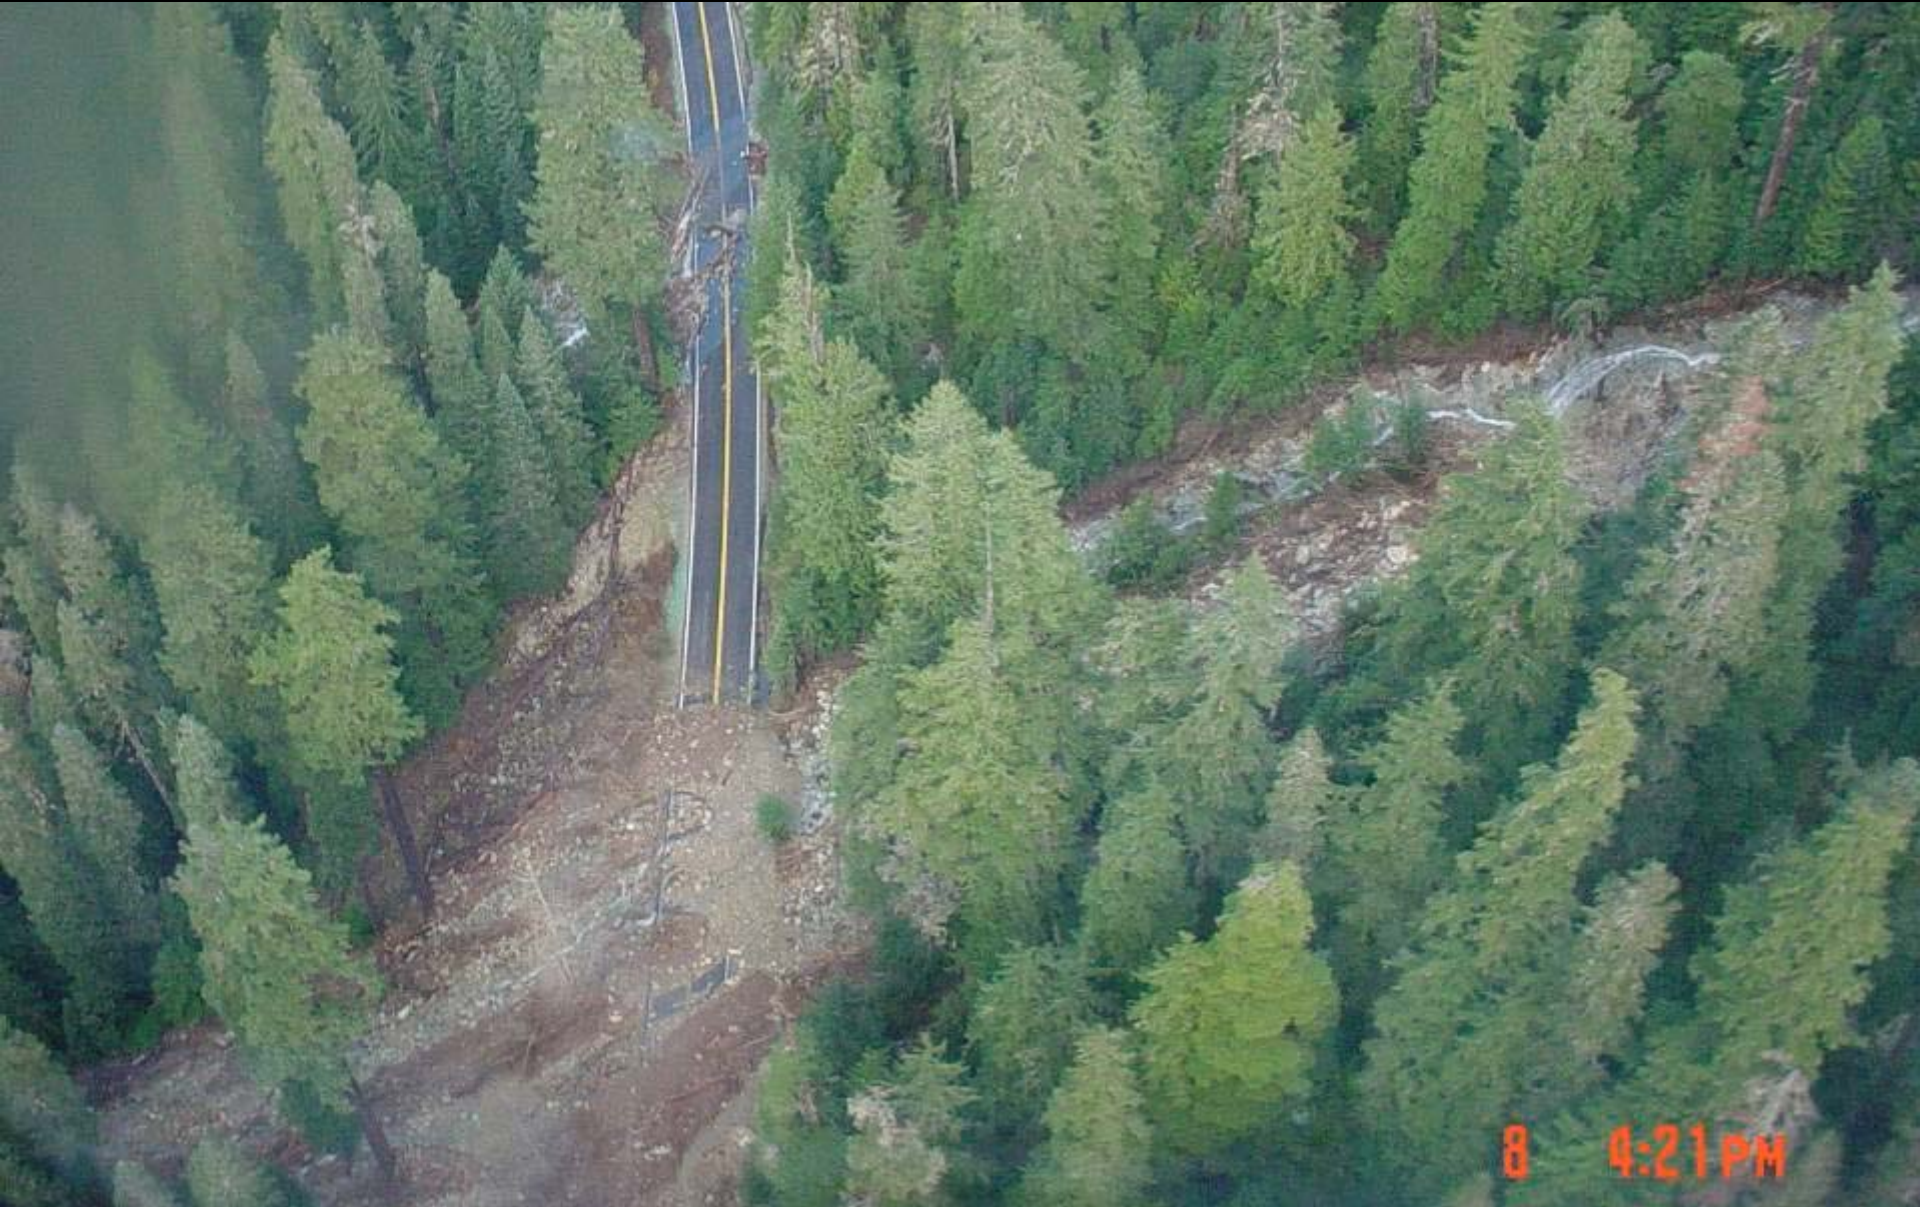
- A large washout occurred near Panther Creek, and a debris flow crossed the road near milepost 11.
- A major washout cut a channel 60 feet wide and up to 80 feet deep across both lanes at milepost 11.5.
- A portion of the road washed out just south of Cayuse Pass.

Washout on Highway 123 near Panther Creek
