Mount Rainier National Park

November 2006 Flood Damage

On November 6 and 7, 2006, Mount Rainier National Park received 18 inches of rain in 36 hours. This presentation summarizes the extensive flood damage that occurred throughout the park.

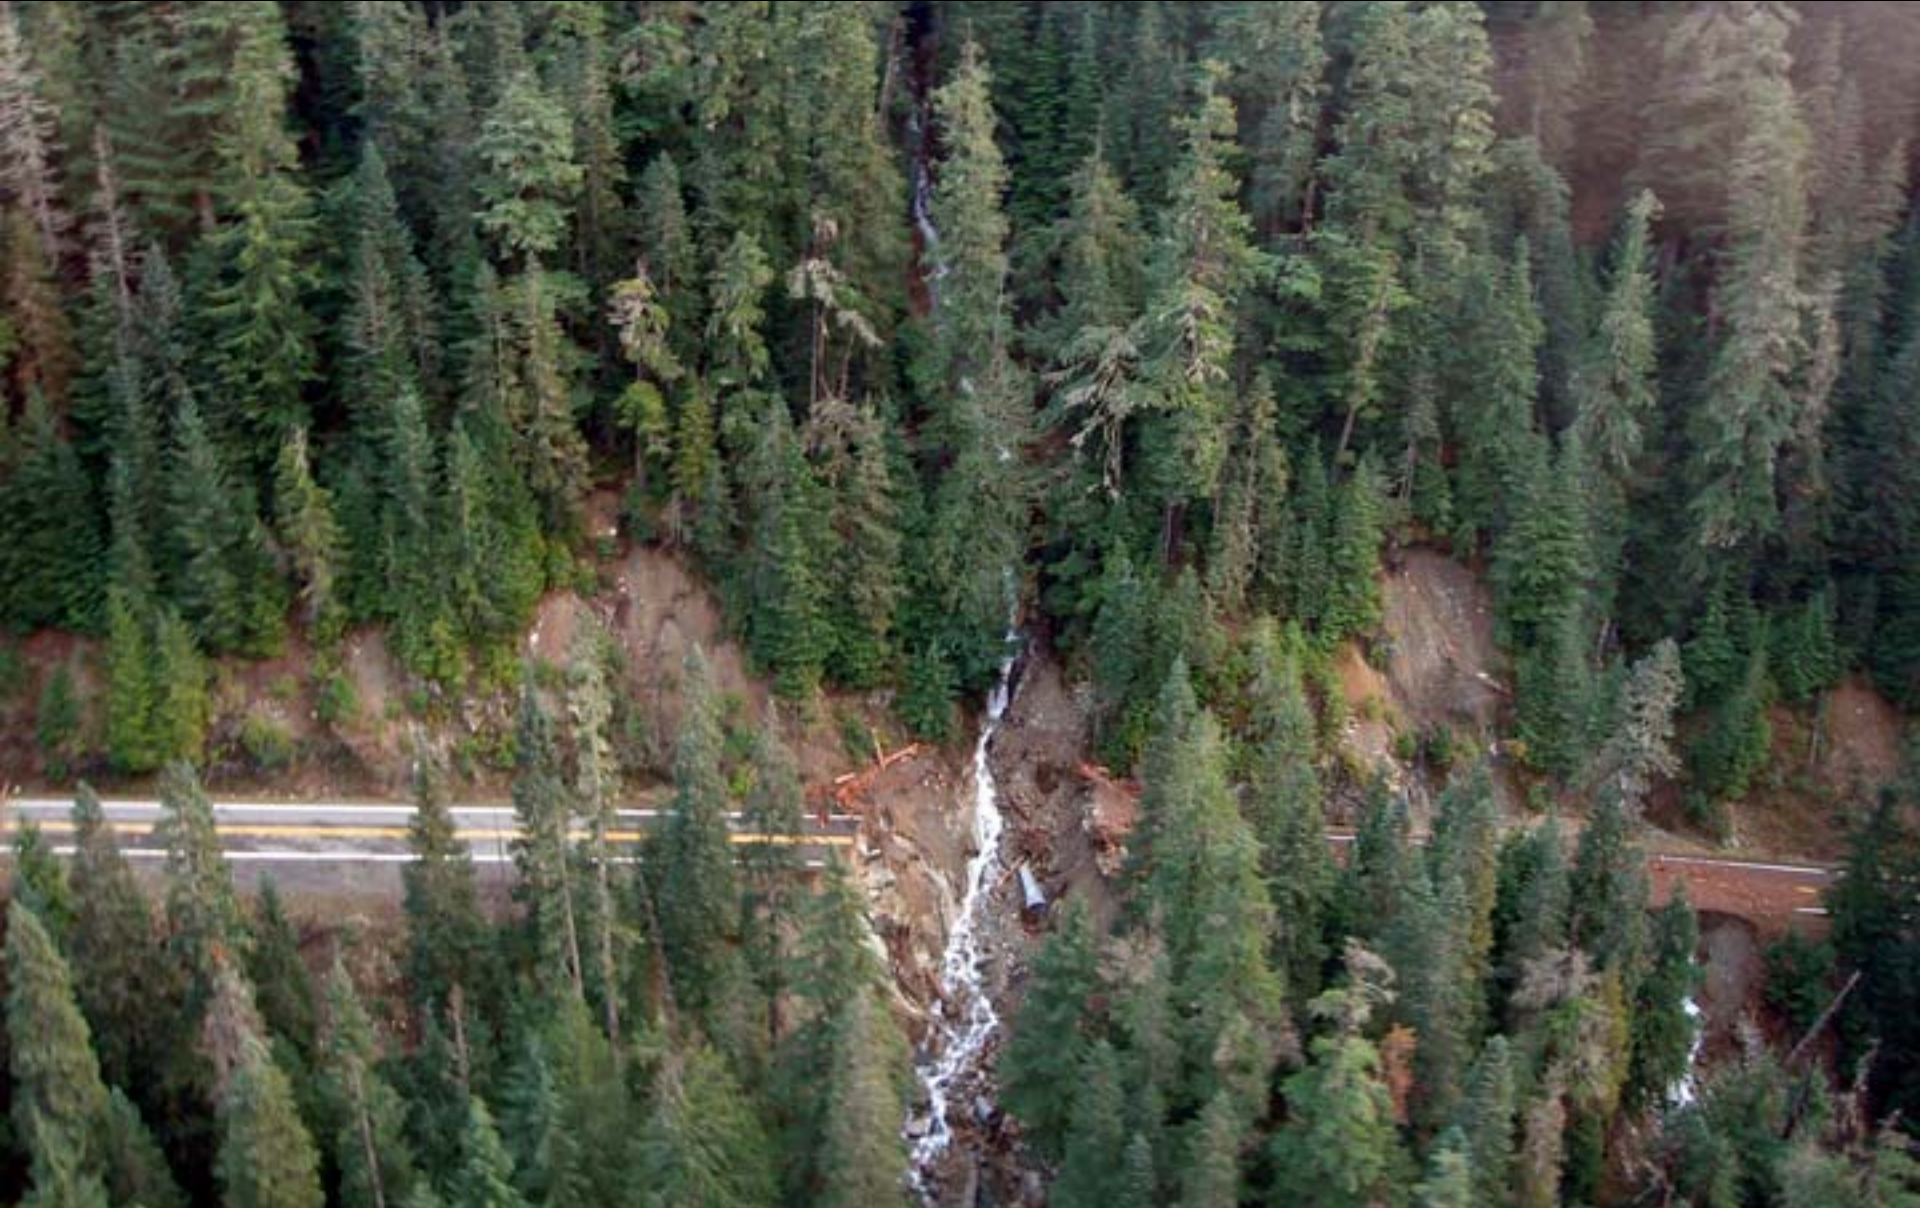
Washout at milepost 11.5 on Highway 123

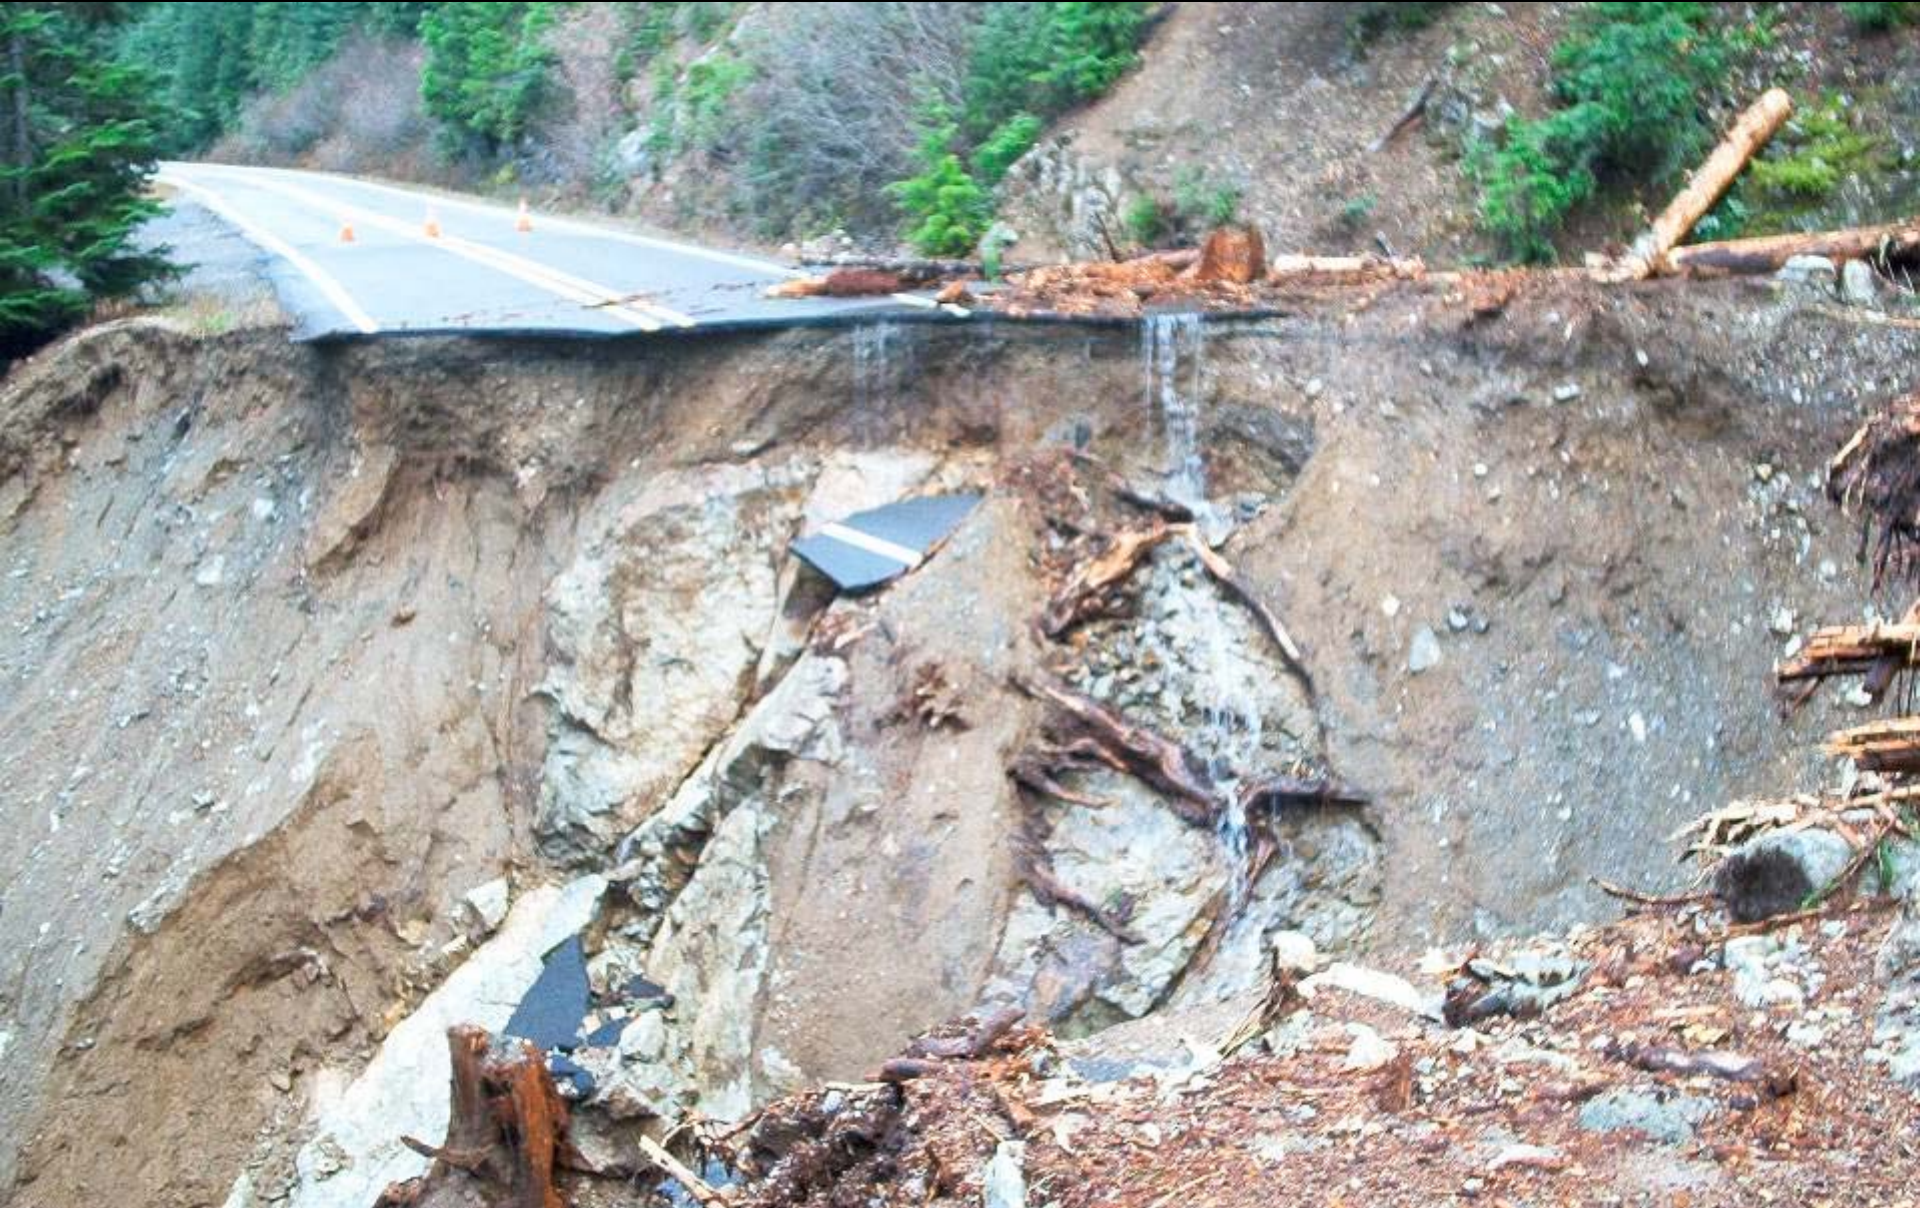
The washout at milepost 11.5 is about 80 feet deep

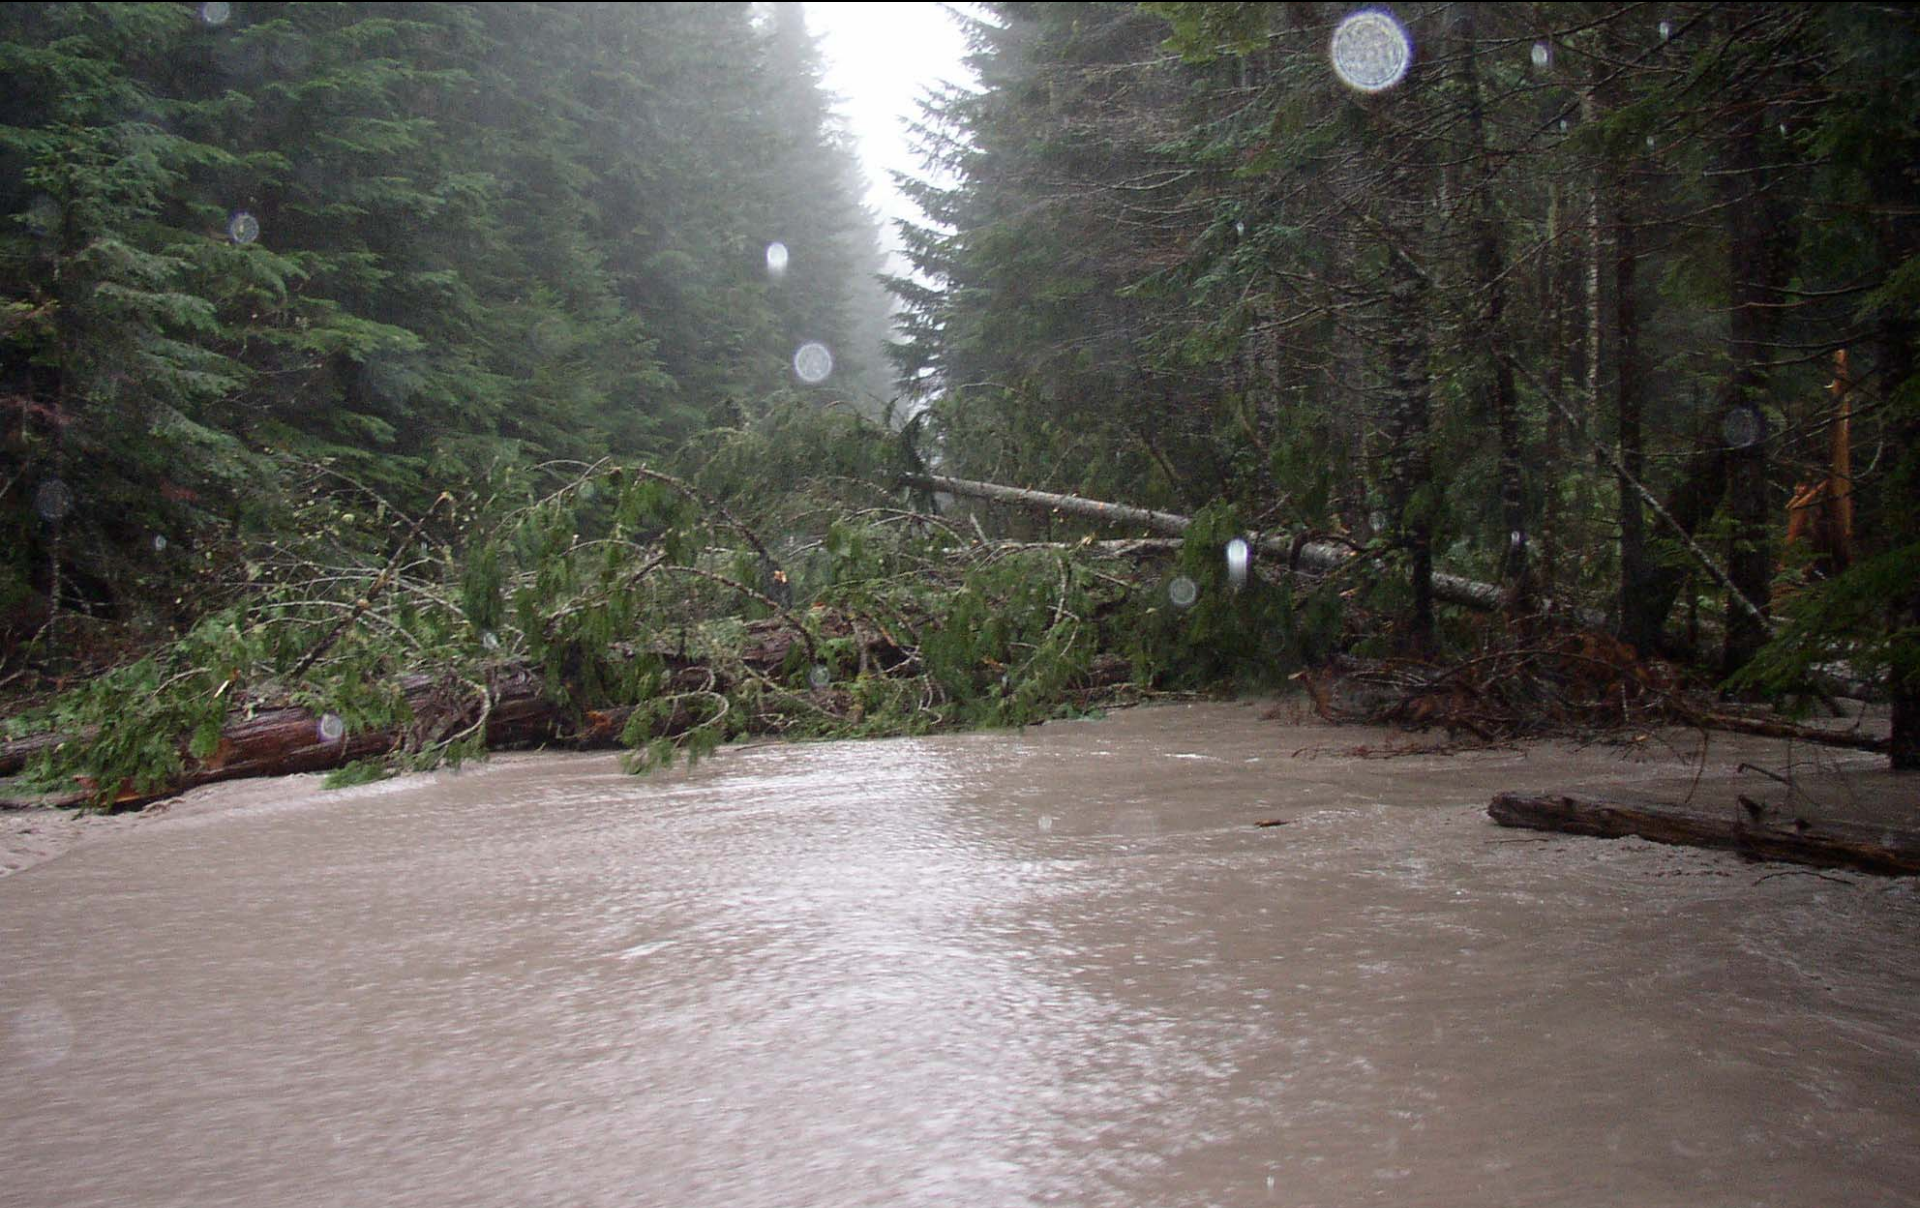
- The White River flooded the highway for several miles both inside and outside the park boundary. Park facilities were not significantly damaged.
- Small sections of the downhill lane sloughed off going into White River Campground. Some sites in A loop were damaged.

Flooding and fallen trees on Highway 410 near the park entrance

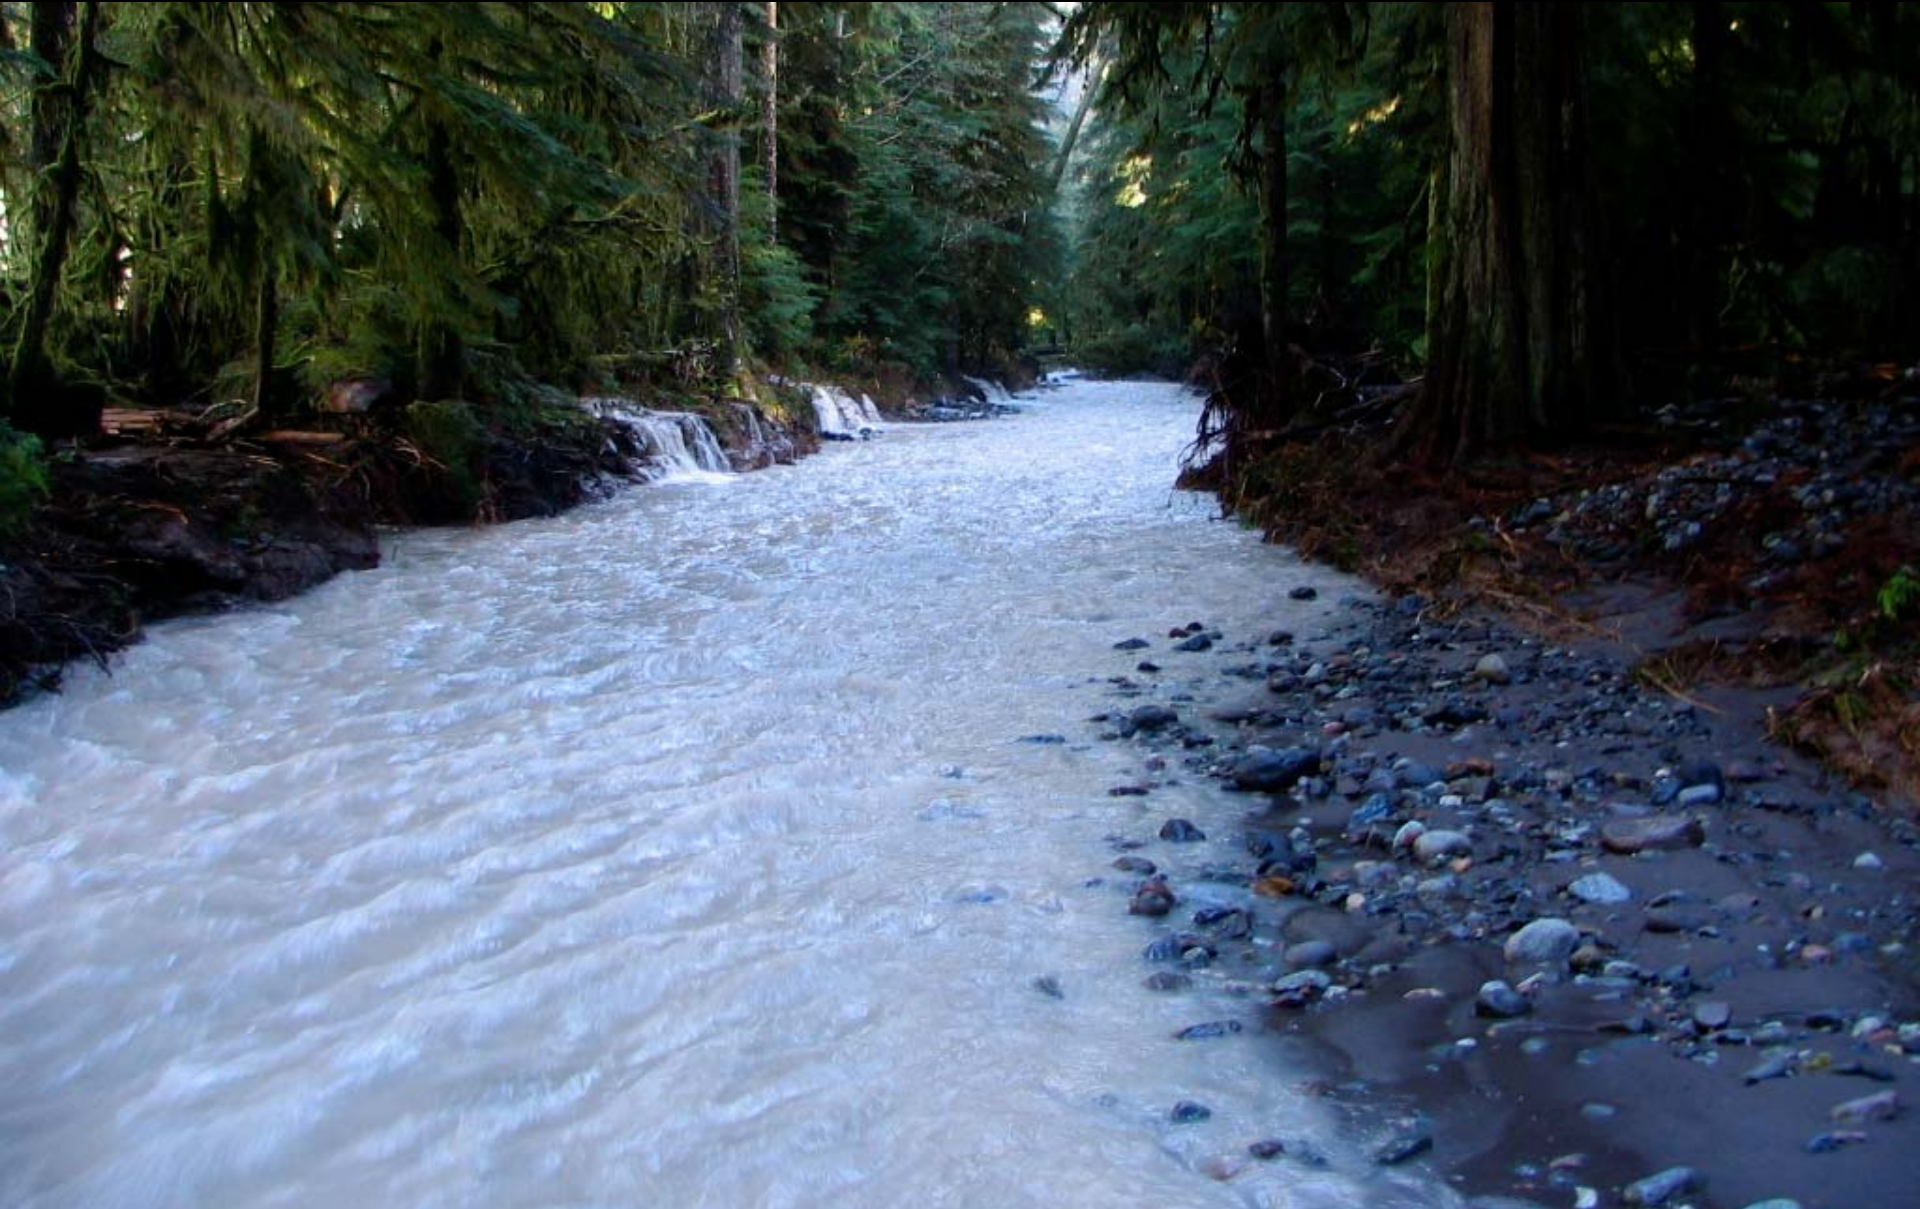
- More than two miles of road were lost. There are washed out sections in at least four places, and the Carbon River is now flowing down the road for half a mile.
- The Ipsut Creek Campground was inundated. The full extent of its damage is unknown.
- A deep erosion gully has undermined the Ipsut Cabin.

The Carbon River, flowing down the Carbon River Road

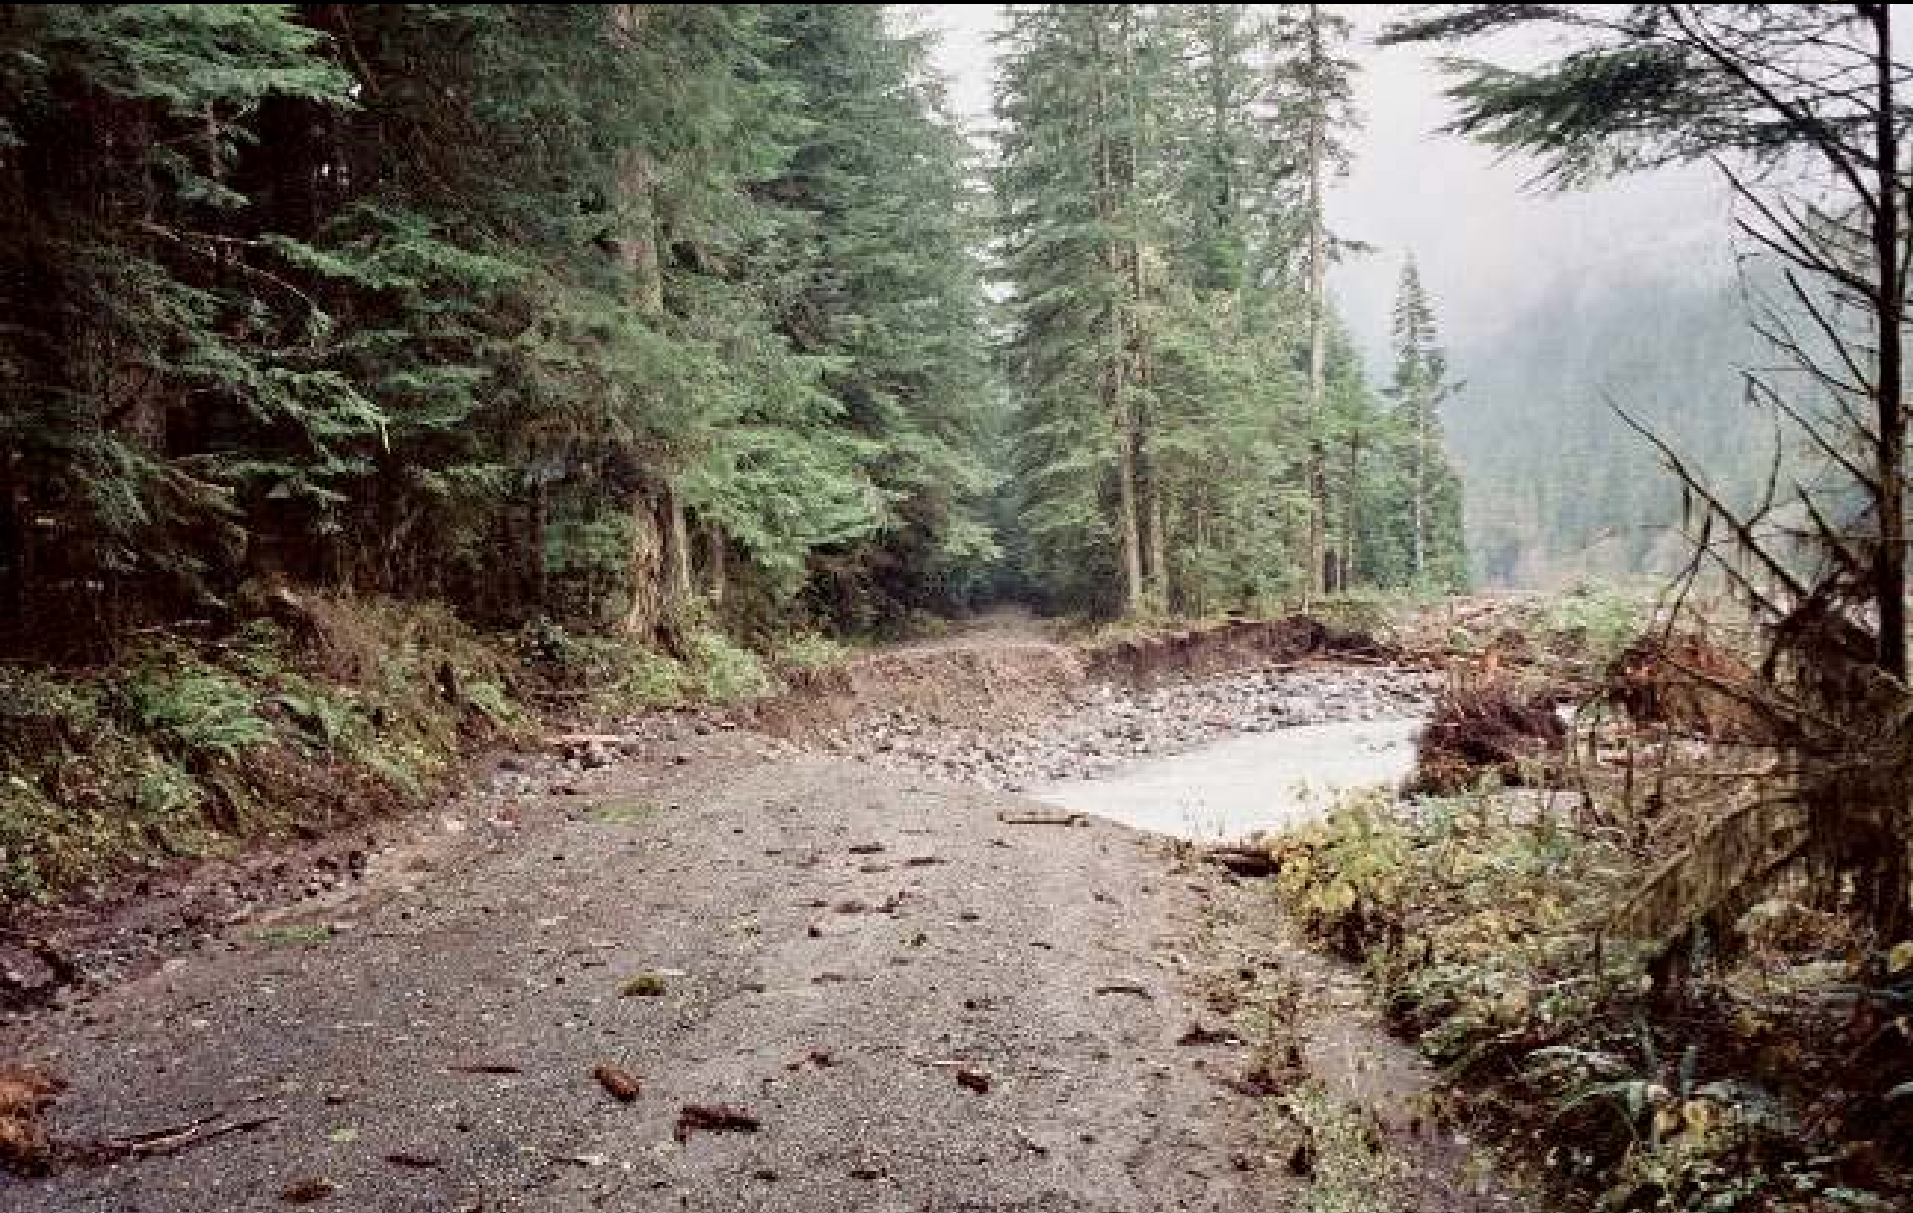
One of several gaps in the road near Ipsut Creek

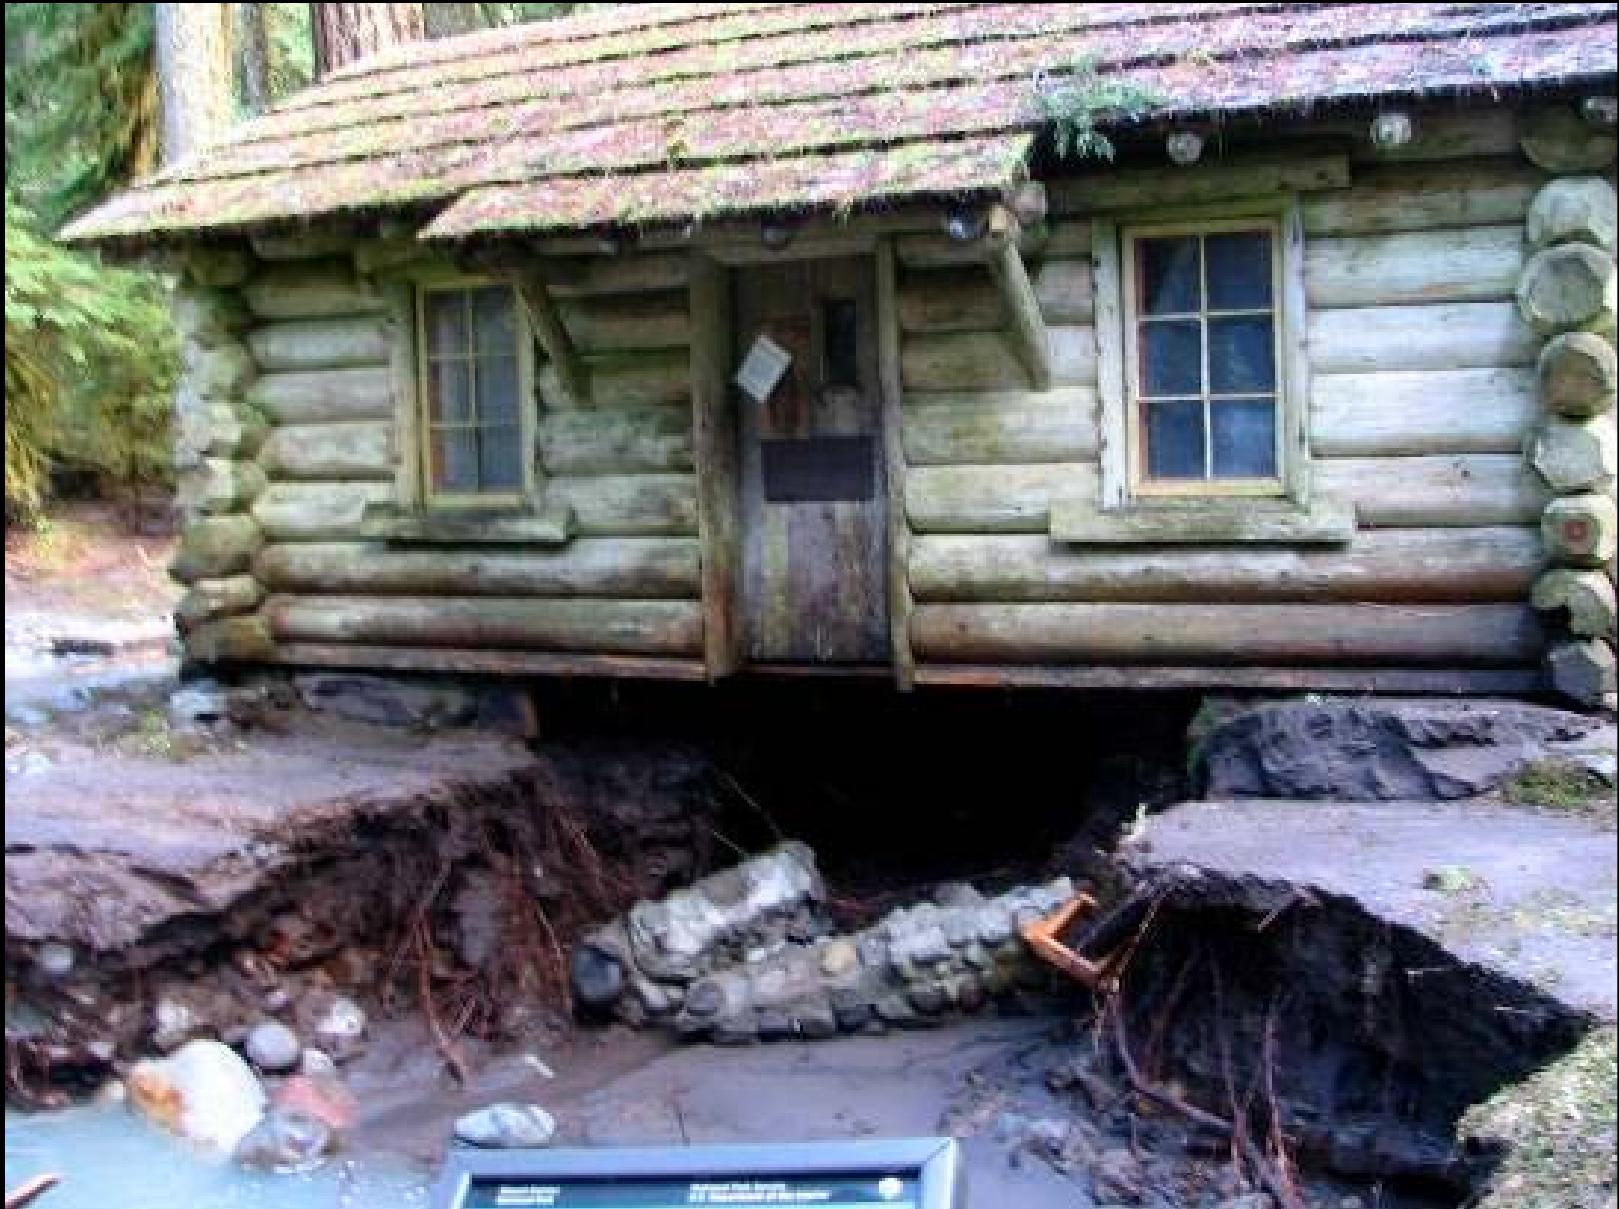
The historic Ipsut Creek Cabin was undercut by the river

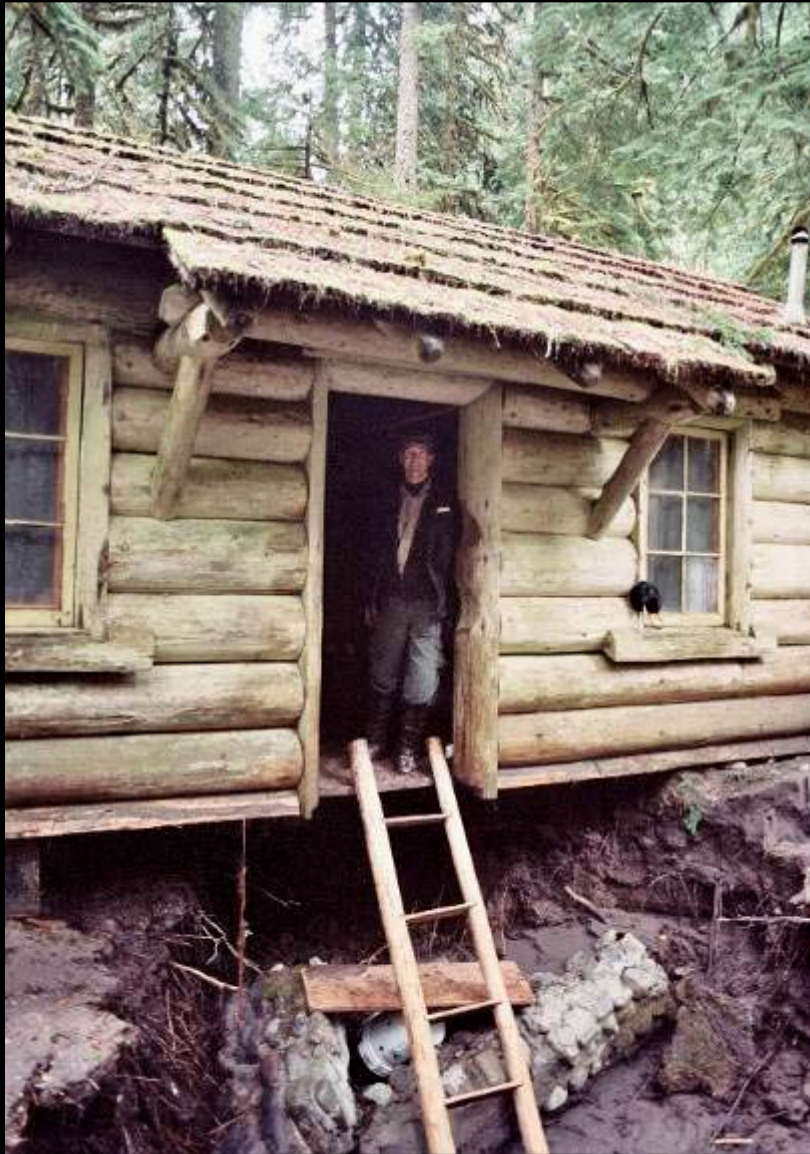
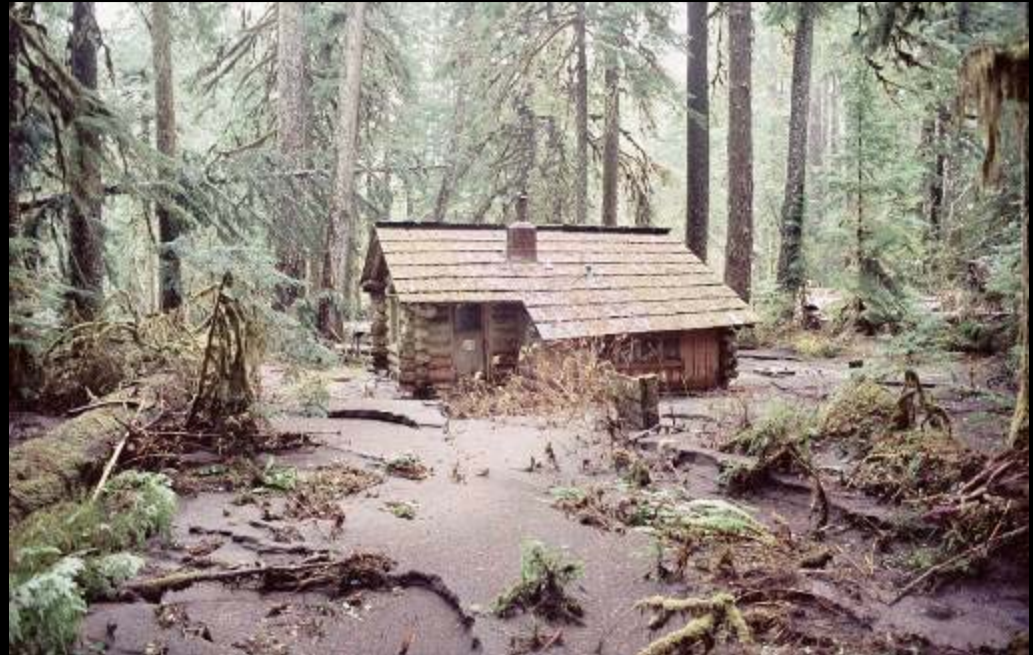
The cabin is now surrounded by a sea of mud

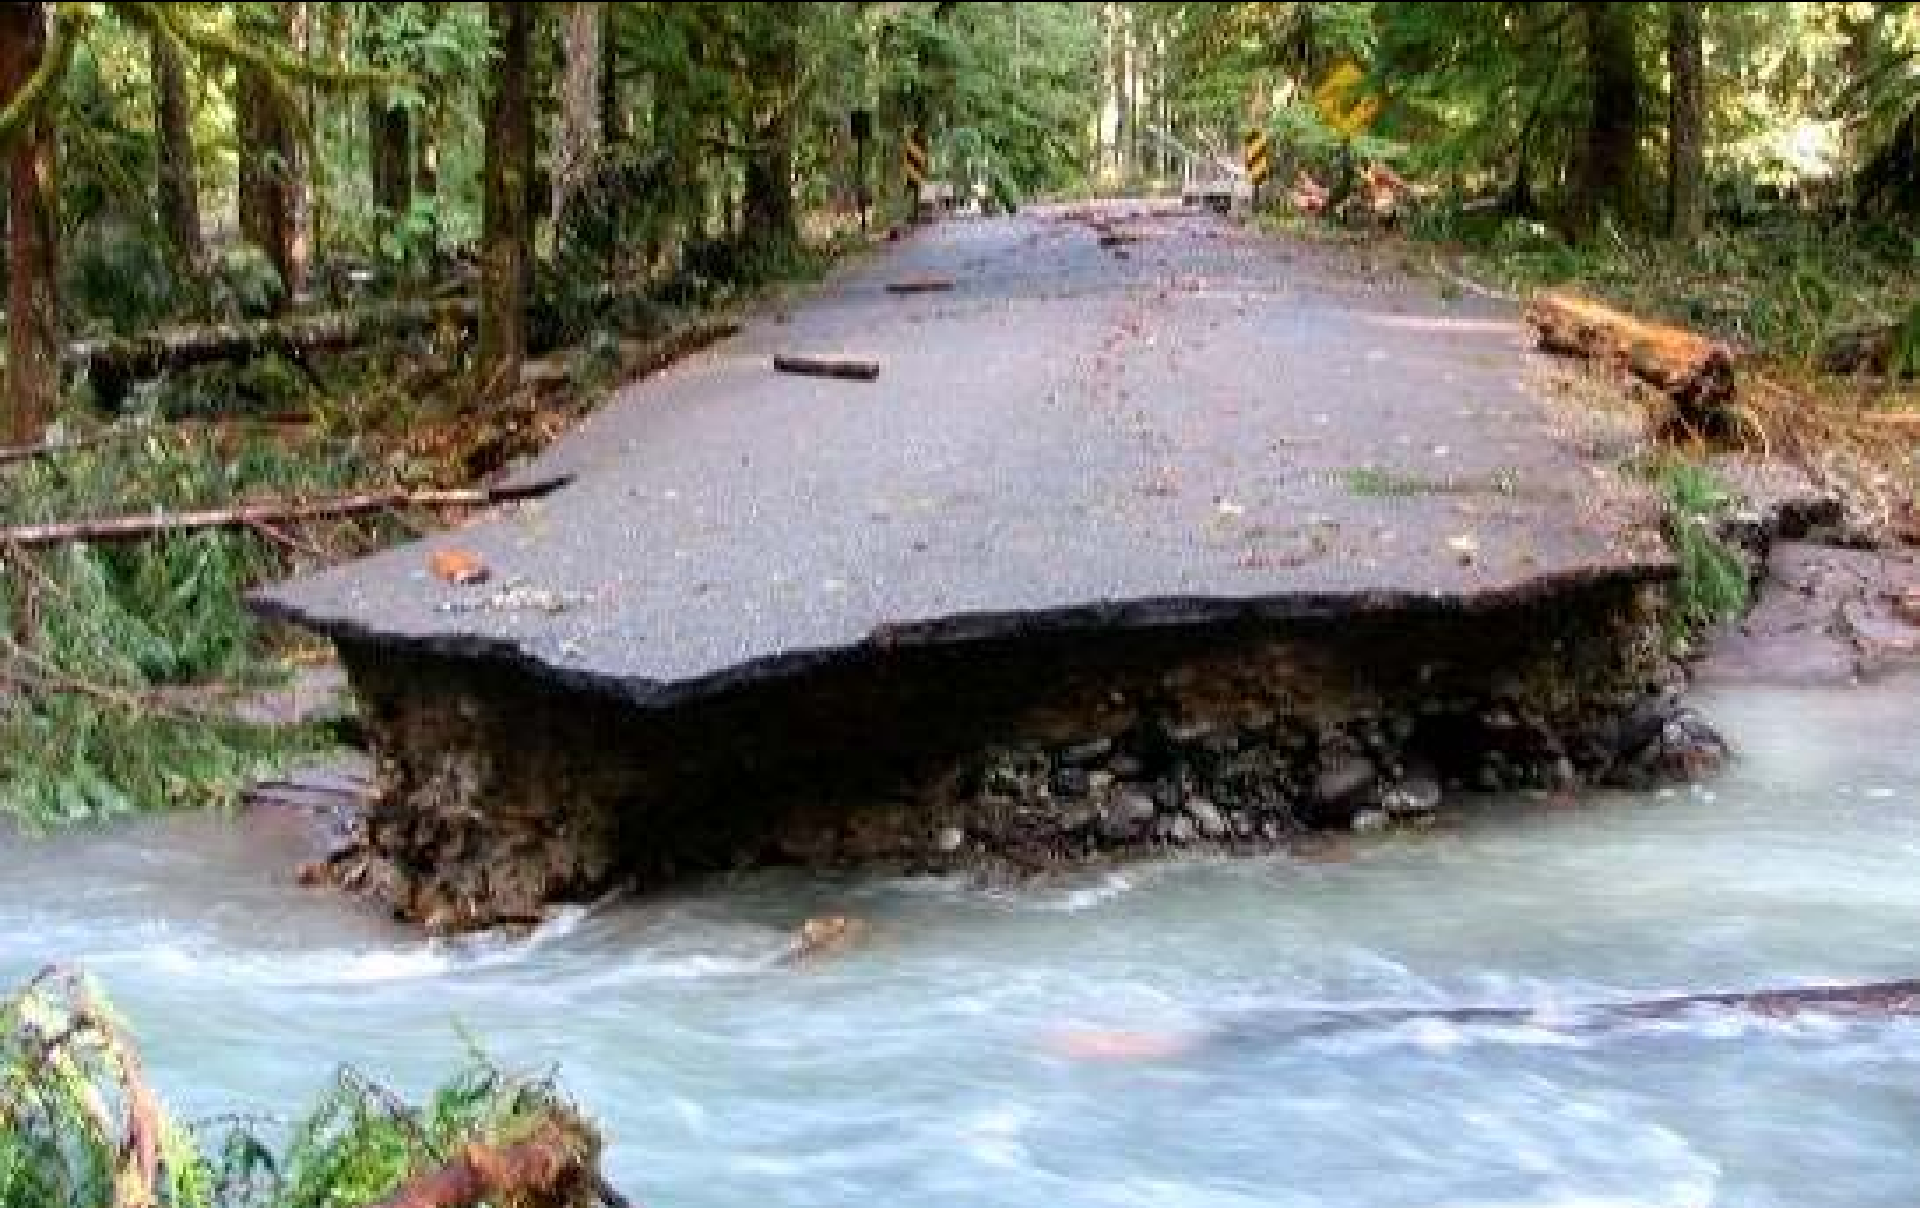
The end of the road at Ipsut Creek Campground

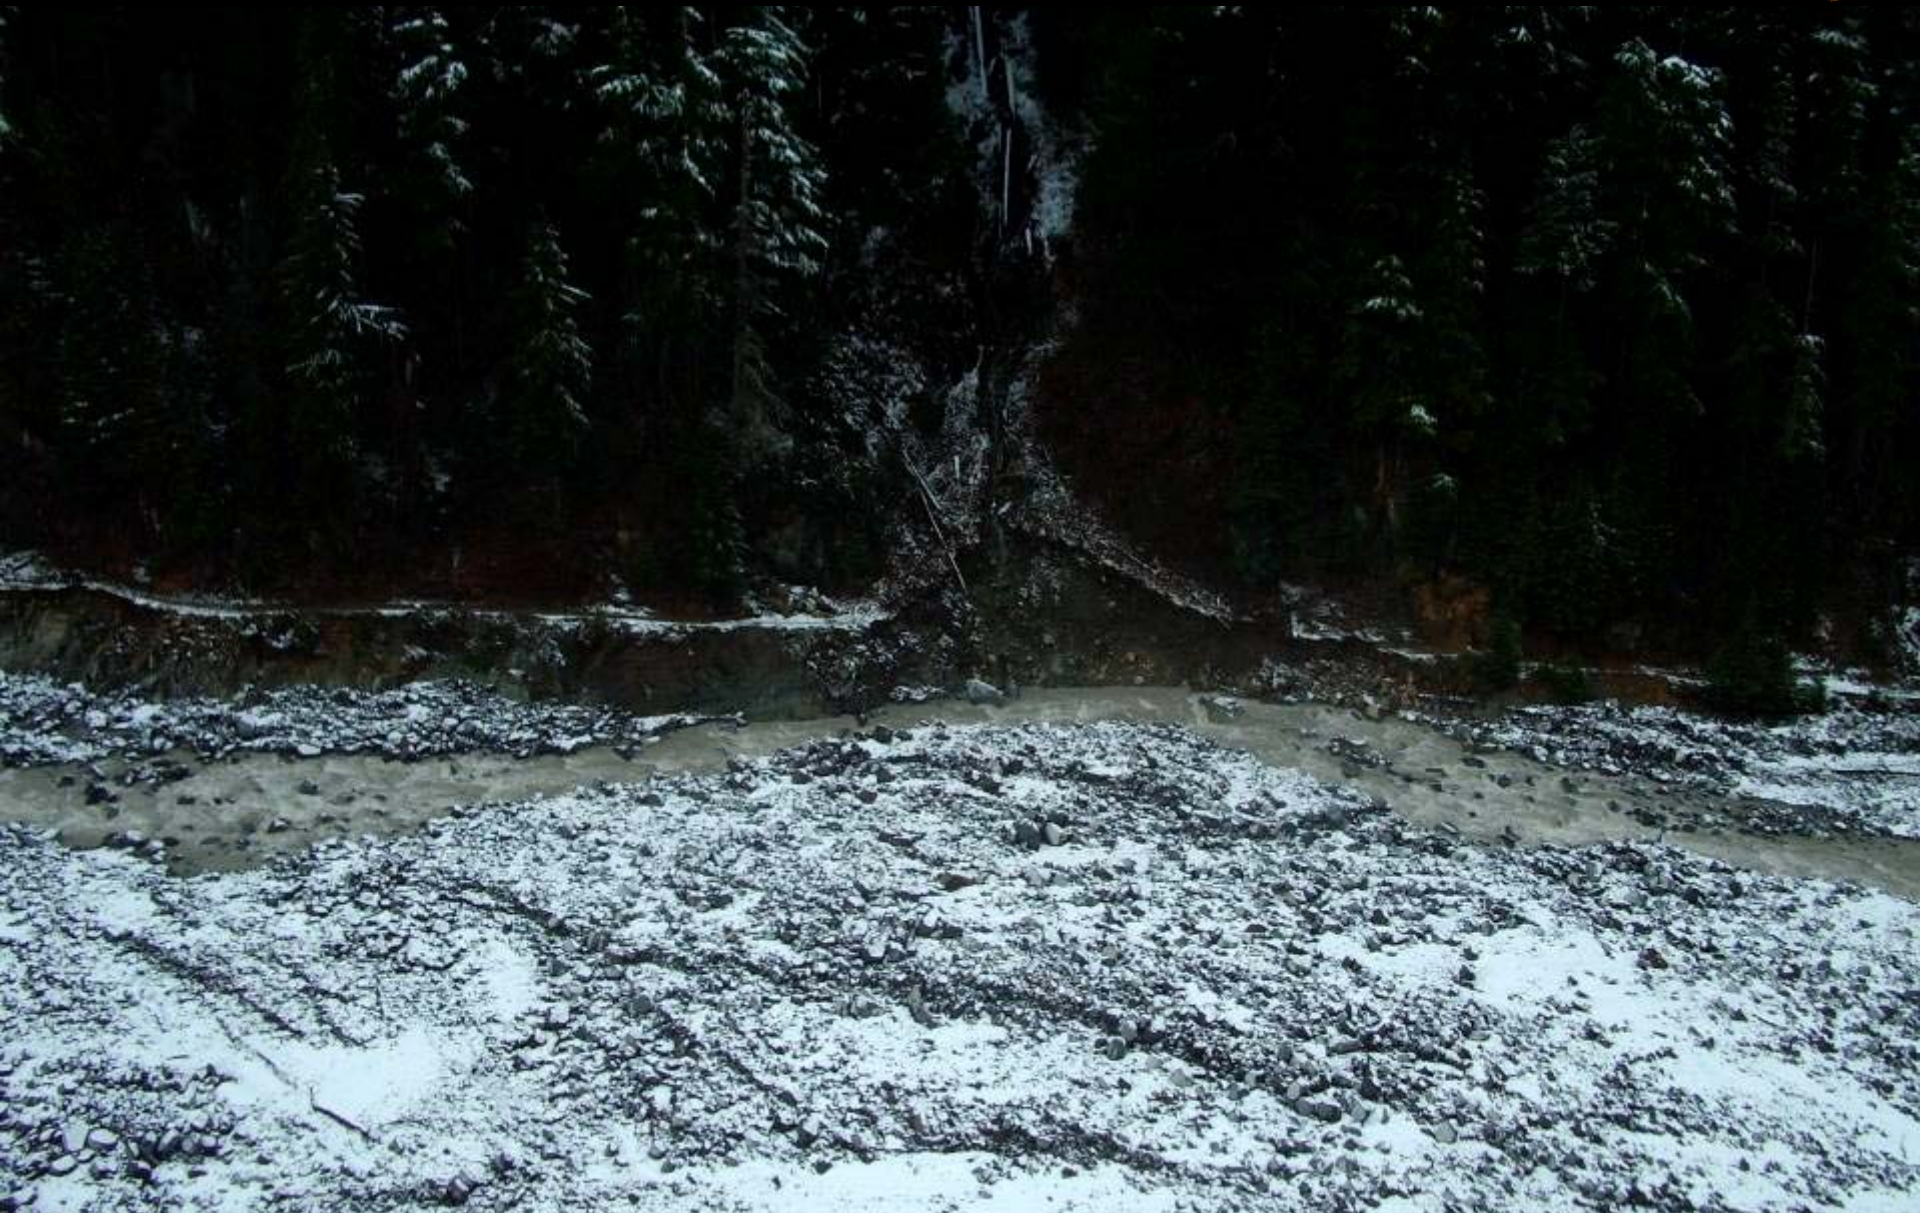
- Backcountry bridges and trails sustained extensive damage. Sections of the Wonderland Trail will likely be unusable next summer.
- At least 10 log bridges and 450 yards of river bar trail are gone.
- A new graded trail is needed in at least four places, including a half mile to be cut from bedrock between Lake James and Cataract Creek and a 750 foot reroute in Stevens Canyon.
- The full extent of damage will not be known until trails melt out next summer.

A missing section of the Carbon Glacier trail

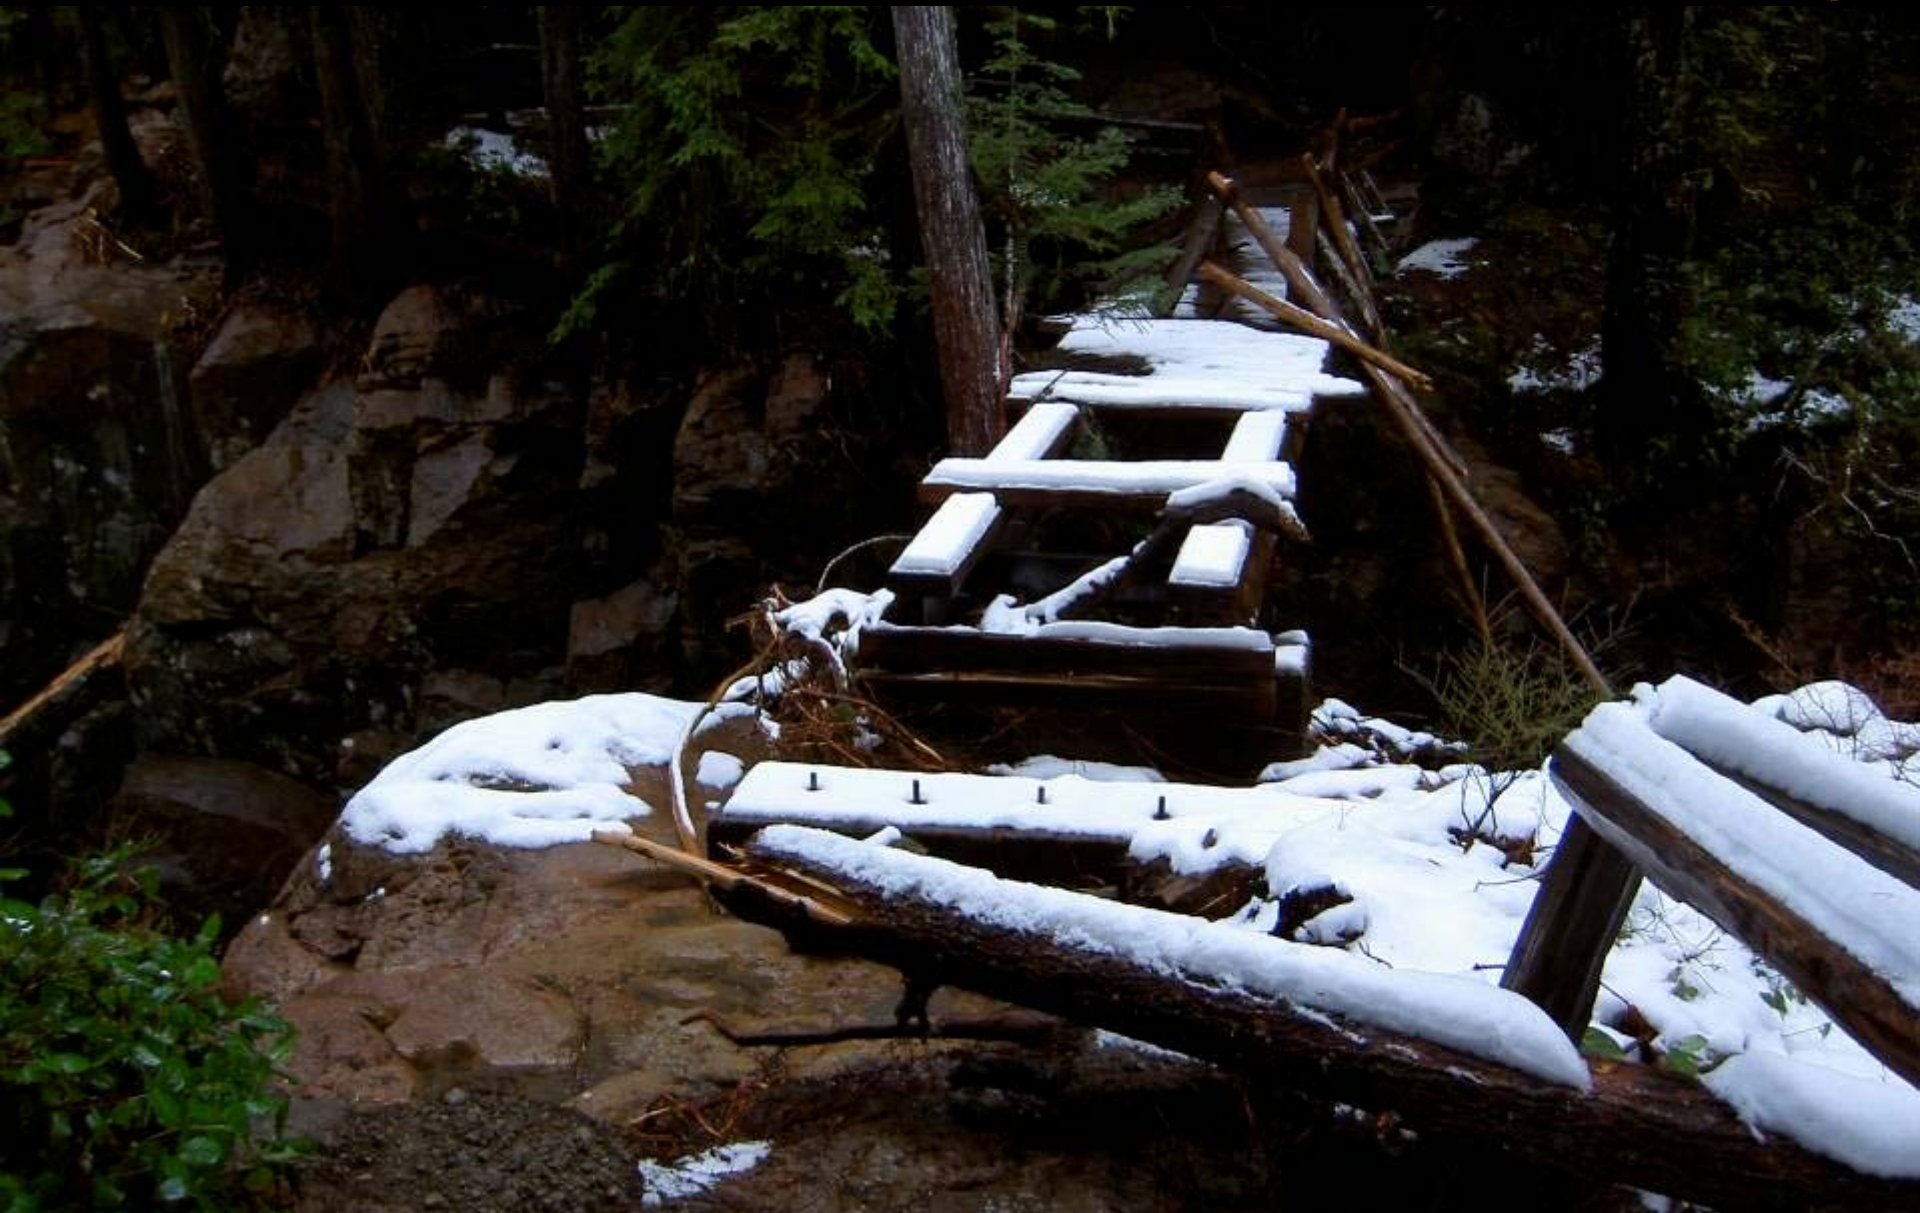
The Silver Falls bridge was heavily damaged
