Mount Rainier National Park

November 2006 Flood Damage

On November 6 and 7, 2006, Mount Rainier National Park received 18 inches of rain in 36 hours. This presentation summarizes the extensive flood damage that occurred throughout the park.

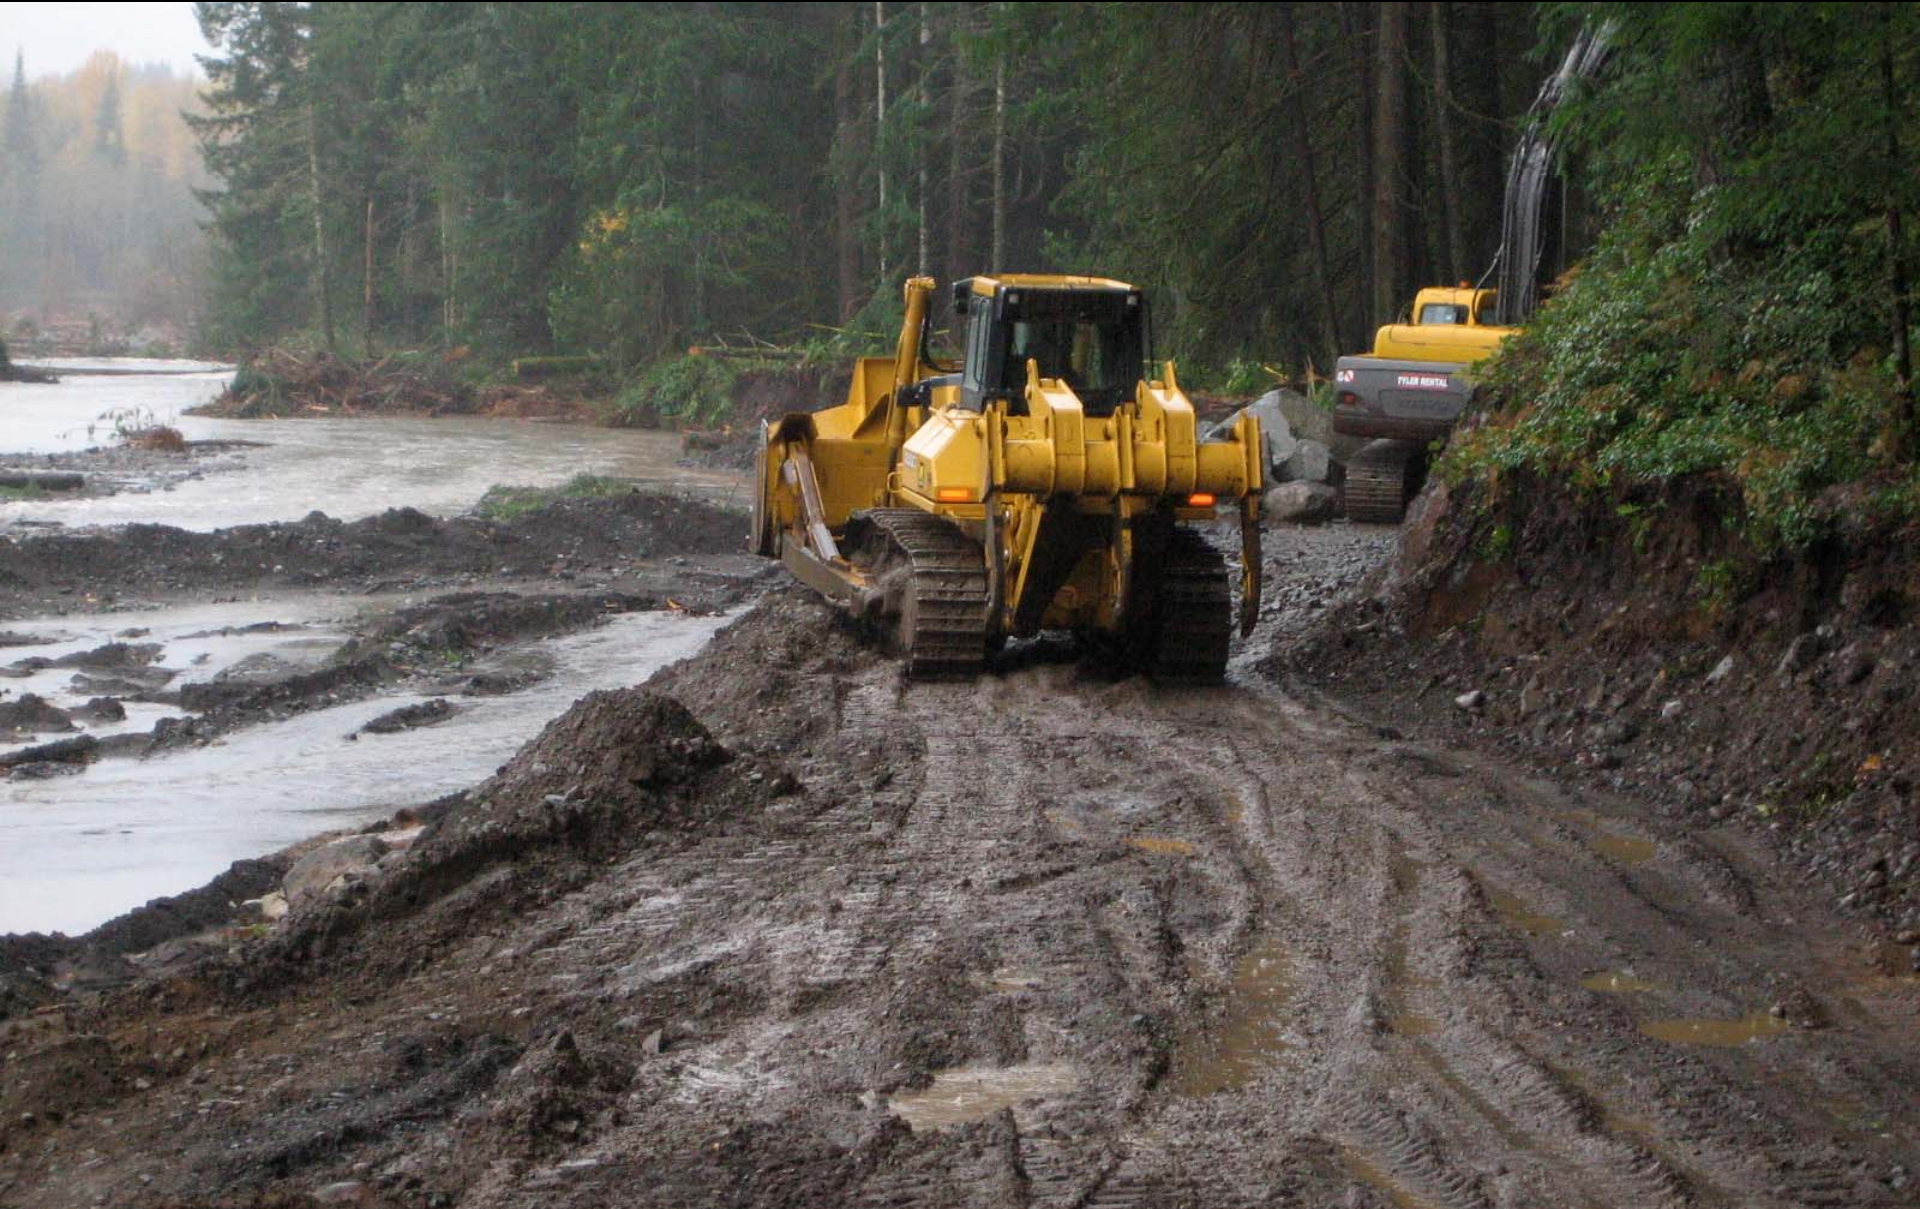
Reconstruction begins at Sunshine Bend

- Repair work has begun, primarily in the Nisqually to Paradise corridor.
- The road is being rebuilt at Sunshine Point.
- Washouts are being repaired and shored up at several places along the road.
- New electrical and sewer lines are being installed at Longmire.
- Maintenance rangers will attempt to coax Kautz Creek back into its former channel.
- Repairs will continue through the winter. Many places will be inaccessible until snowmelt next summer.

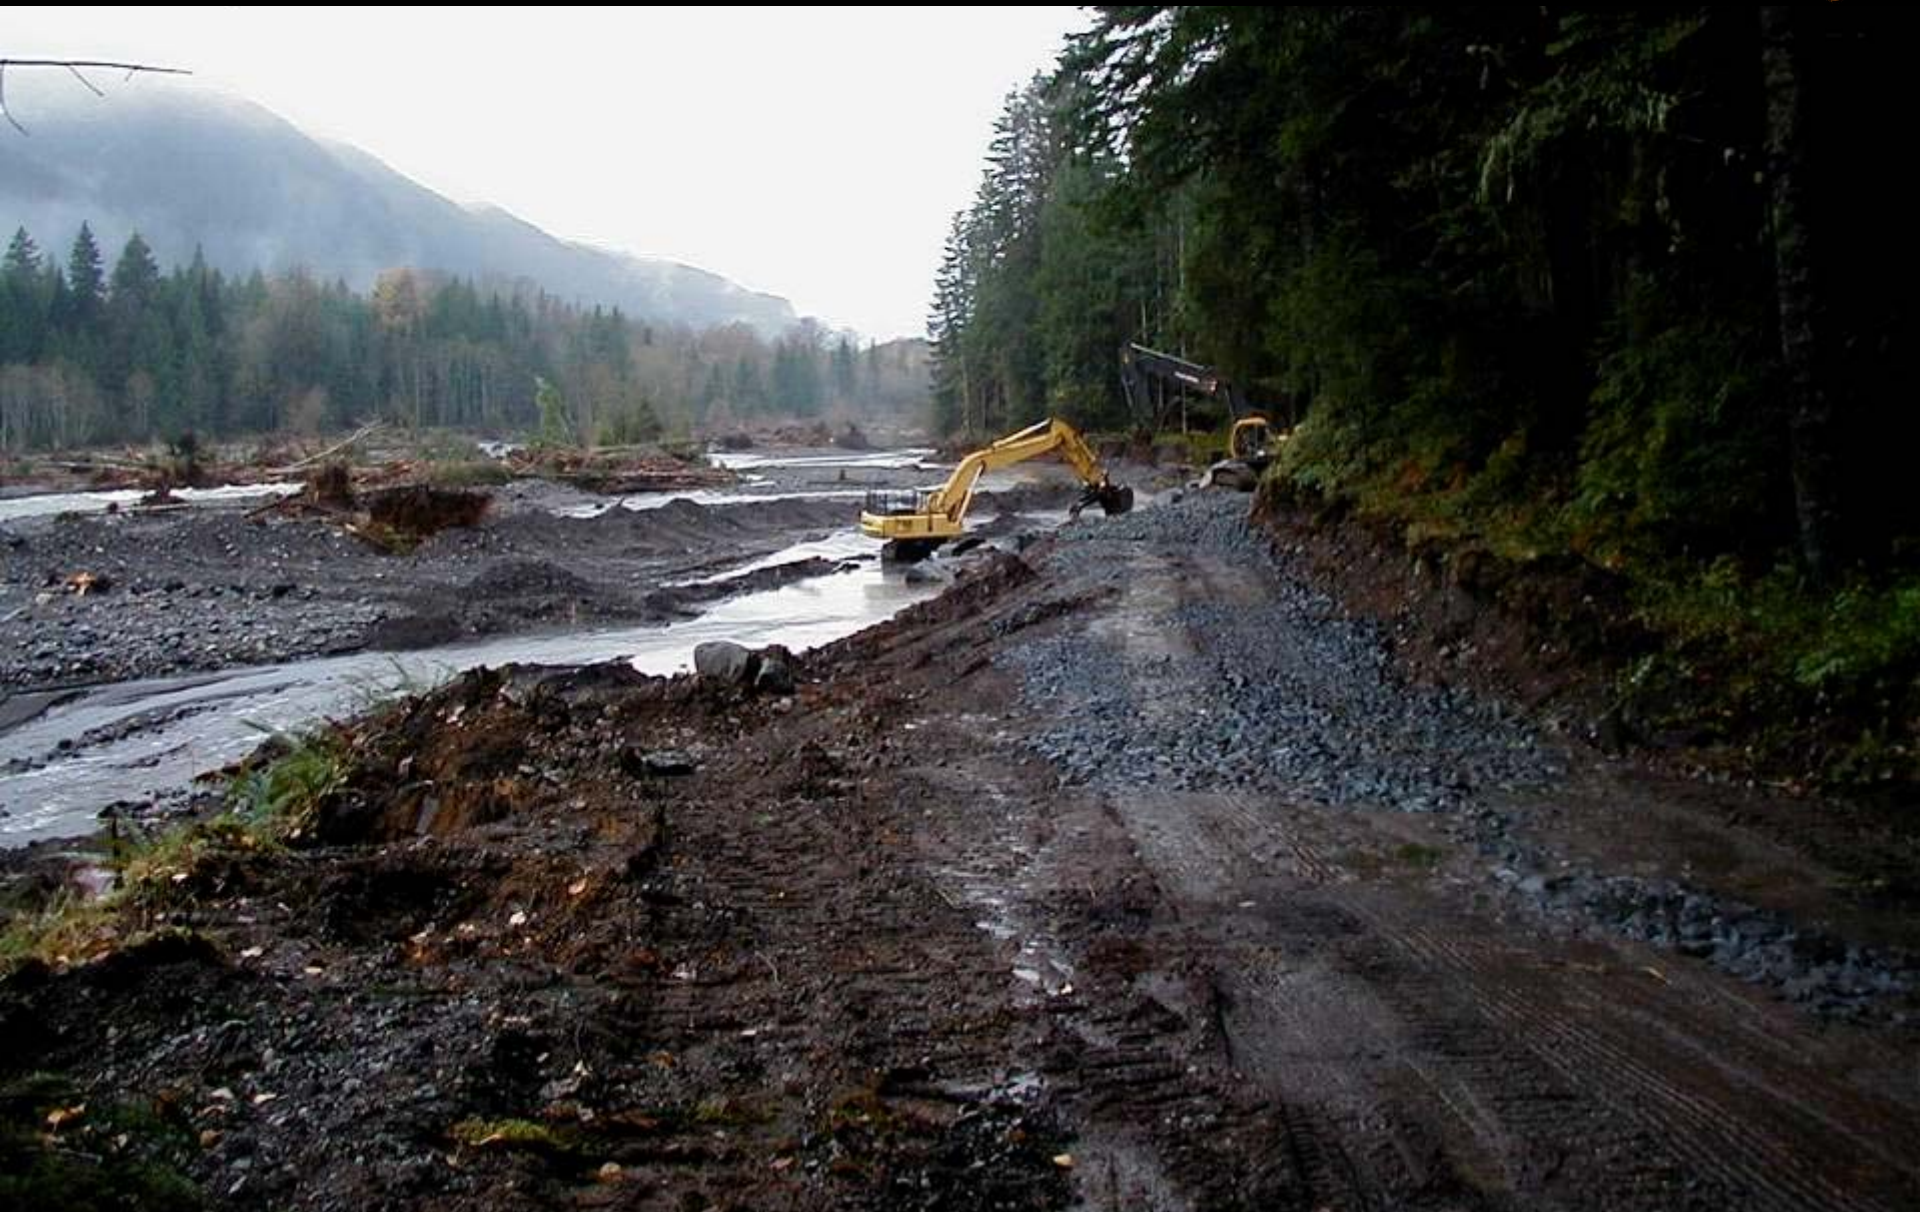
Rebuilding the Nisqually Road
